AIRPROX REPORT No 2017230

Date: 19 Sep 2017 Time: 1243Z Position: 5057N 00209W Location: Compton Abbas ATZ

PART A: SUMMARY OF INFORMATION REPORTED TO UKAB

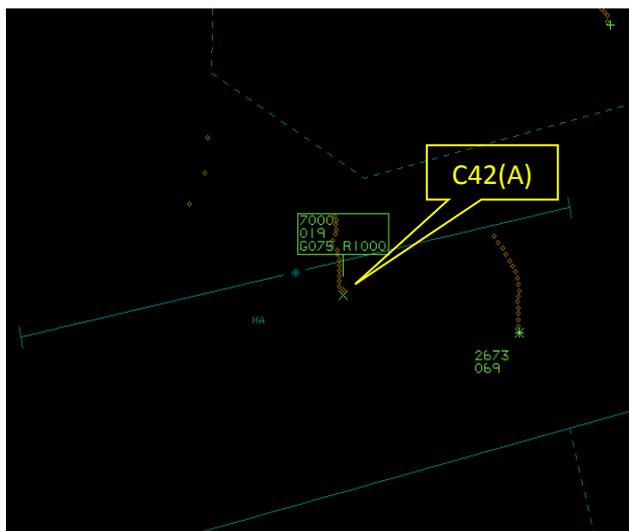
Figure 2: C42(A) deadside descending
1241:49

The radar replay shows C42(A), which can be identified from Mode 'S', joining from the north (figure 2). As the aircraft descends on the deadside the aircraft disappears from radar and doesn't reappear until after CPA, when the C42(A) climbs back into the overhead (figure 3).
