AIRPROX REPORT No 2017246

Date: 14 Oct 2017 Time: 1615Z Position: 5208N 00154W Location: 1.5nm NW Bidford

PART A: SUMMARY OF INFORMATION REPORTED TO UKAB

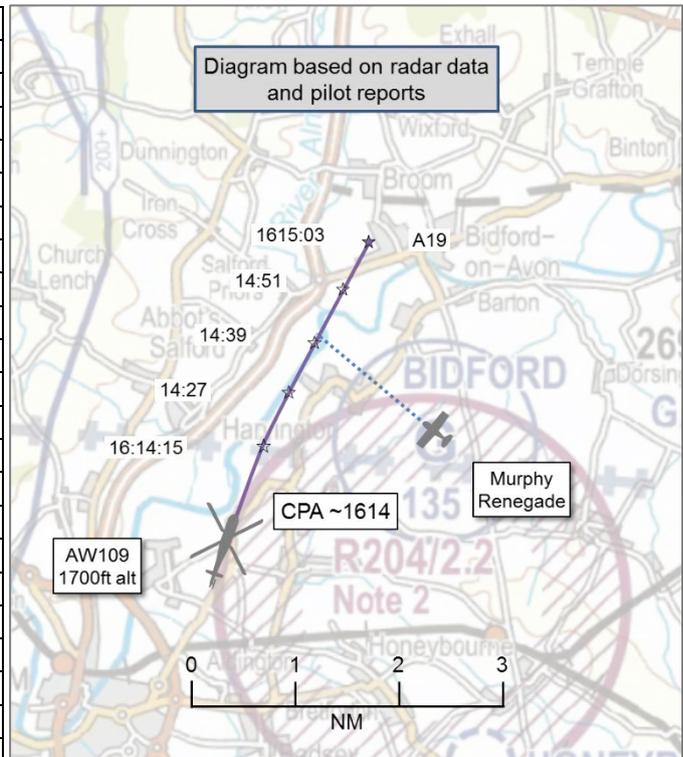
THE MURPHY RENEGADE PILOT reports climbing out to the west from a local airfield when, just after exiting EGR204, a helicopter crossed his track from left to right at the same level. The pilot noted that he only saw it at the last minute as it passed ahead, and the other pilot did not appear to see him. The pilot also noted that he was looking into a low sun and that the biplane configuration of his aircraft may have masked the approaching helicopter to some degree.

THE AW109 PILOT reports transiting back to home base under a Basic Service with Gloucester App, with just 2 pilots on board, when the PIC spotted a biplane off to the right-hand side at a range of approximately 0.5nm and on a converging course. The aircraft in question appeared to be approximately 200ft lower but, as a precaution, a slight left turn was initiated to ensure clearance. The biplane passed behind and below the helicopter and was then seen by the pilot occupying the left-hand seat, who confirmed that it was heading away. The biplane did not appear on the helicopter TAS and, due to the vertical separation, both pilots did not deem the event to be an Airprox.

Members first discussed the pilots' actions and agreed that, although the AW109 crew had seen the Murphy Renegade at 0.5nm range, with an assessed separation at CPA was no more than 200ft vertically and 100m laterally, members felt that more could have been done to increase separation. On sighting it and recognising that they should give way, the AW109 pilot should ideally have either turned to pass behind the Murphy Renegade or climbed to increase the height separation. That they did not do so caused the Board to conclude that the AW109 pilot had flown into conflict with the Murphy Renegade. Significantly, the Murphy Renegade pilot had reported that he was climbing, which seemed to have eroded the vertical separation which the AW109 pilot noted on first sighting. Members wondered why the Murphy Renegade pilot had not seen the AW109 earlier, and were informed by an Airprox Inspector that the line of sight between the aircraft was such that the AW109 was directly into sun to the Murphy Renegade, thereby significantly reducing the probability of visual detection. Members agreed that this had been contributory to the Airprox.

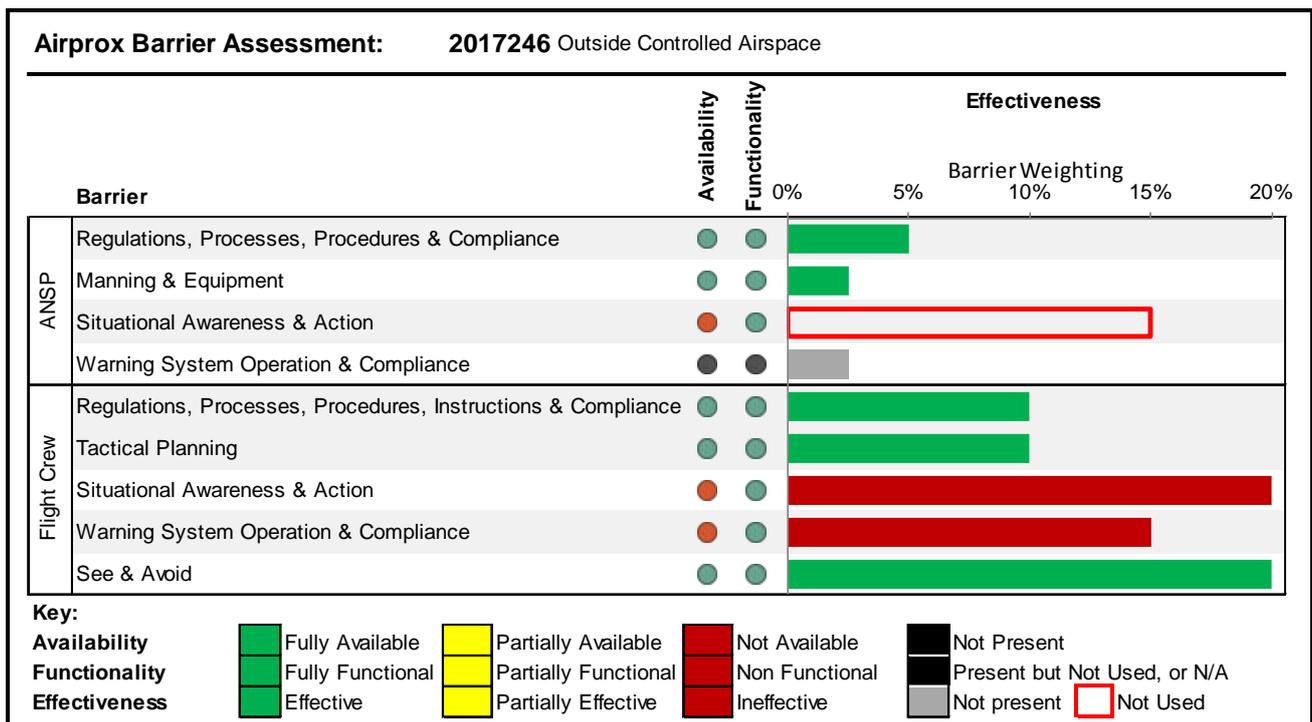
Situational Awareness and Action were assessed as **not used** because Gloucester ATC provides a non-surveillance based Basic Service.

Situational Awareness and Action were assessed as **ineffective** because the Renegade pilot was not aware of the AW109's proximity until a late stage, and the AW109 pilot's actions to give way to the Renegade resulted in a reported separation of only 200ft V/100m H at CPA

Warning System Operation and Compliance were assessed as **ineffective** because although the AW109 was fitted with a TAS, the Murphy Renegade was not fitted with compatible systems.
