## AIRPROX REPORT No 2017260

Date: 01 Nov 2017 Time: 1529Z Position: 5355N 00114W Location: 2nm SW Rufforth Glider Site

### PART A: SUMMARY OF INFORMATION REPORTED TO UKAB

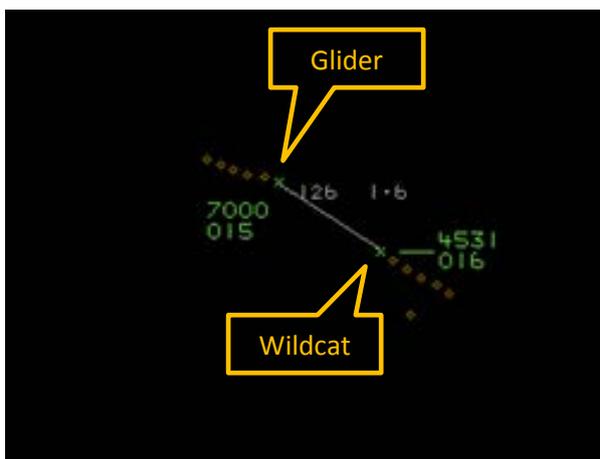
Figure 1: Geometry at 15:28:05

At 15:28:05 (Figure 1), the Linton Controller passed Traffic Information (TI) to the Wildcat pilot on traffic left, 8 o'clock, ½nm, manoeuvring, no height information and traffic 12 o'clock, 3nm, crossing left to right ahead, indicating 100ft below, descending slowly. The Wildcat pilot acknowledged the TI but did not report visual.

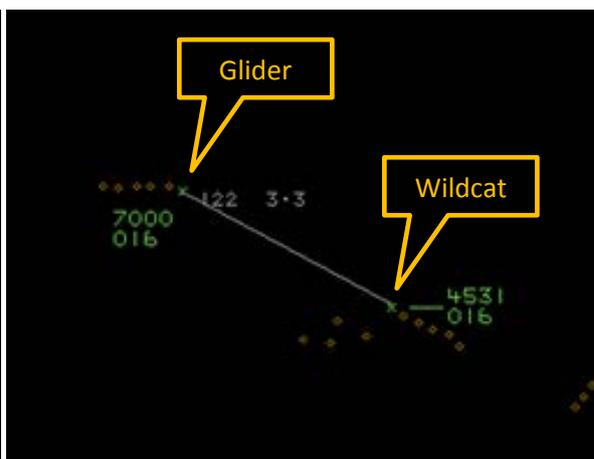
Figure 2: Geometry at 15:28:31

At 15:28:31 (Figure 2), the Linton Controller passed updated TI on traffic now 12 o'clock, 1.5nm, crossing left to right, indicating 100ft below, opposite direction. The Wildcat pilot responded that he was looking and climbing to height 2000ft although the radar height readout does not indicate a change of height until the 2 aircraft were within 0.8nm (somewhere between Figures 3 and 4).

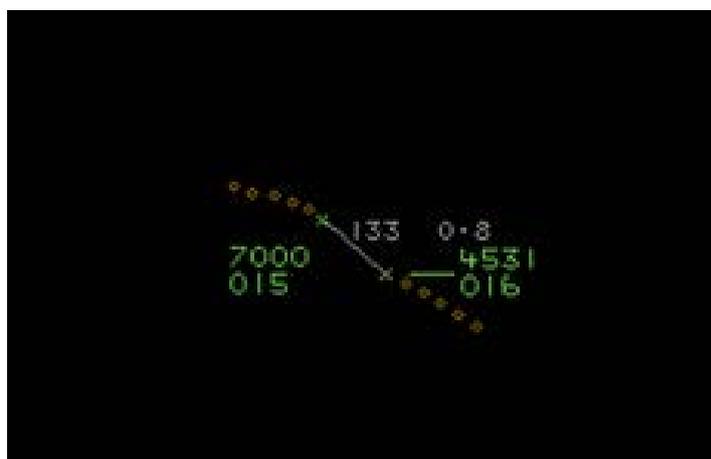
Figure 3: Geometry at 15:28:50

At 15:28:50 (Figure 3), the Linton Controller updated the TI once more; at 15:29:01 (Figure 4), the Wildcat pilot stated on frequency that he had just had an Airprox with a Glider.

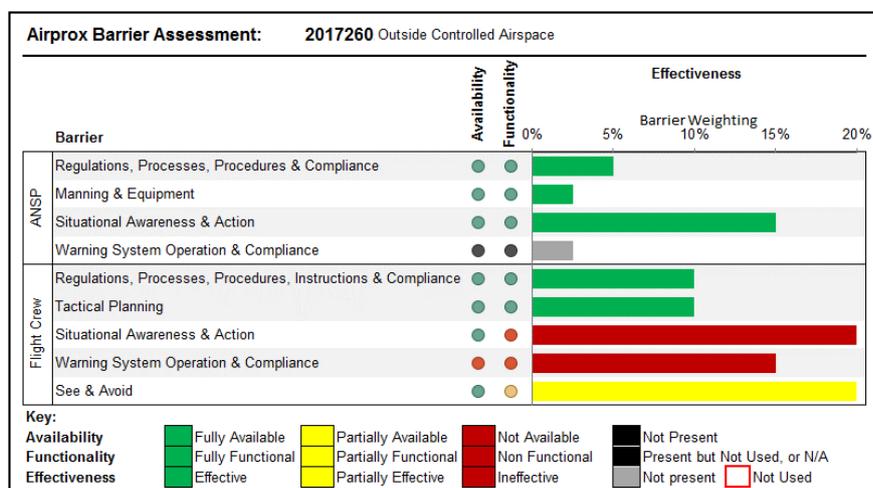
**Situational Awareness and Action** were assessed as **ineffective** because the Wildcat pilot did not act on the available situational awareness provided by the Linton Controller.

**Warning System Operation and Compliance** were assessed as **not available** because the Wildcats electronic warning system was not serviceable.

**See and Avoid** were assessed as **partially effective** because both pilots saw each other late, and the glider pilot had to take emergency avoiding action.
