AIRPROX REPORT No 2017282

Date: 27 Nov 2017 Time: 1306Z Position: 5235N 00109E Location: 25nm E Mildenhall

PART A: SUMMARY OF INFORMATION REPORTED TO UKAB

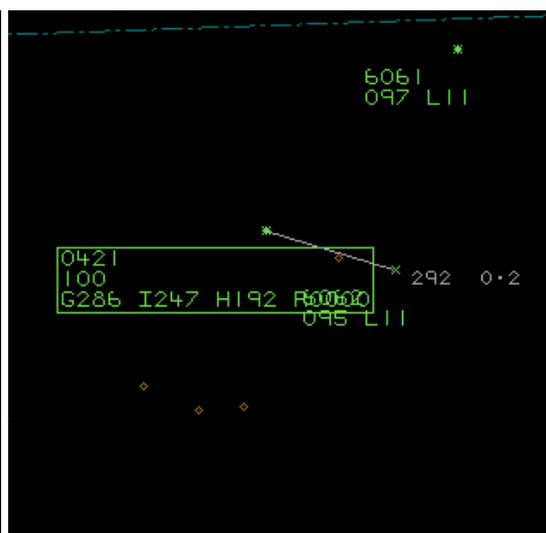
Figure 4 Geometry at 1305:56 (CPA).

Turning to the risk, the RC135 pilot reported that he had seen the F15s on TCAS at about 5nm and had then obtained visual contact. The F15 pilots reported seeing the RC135 at about 1nm and turned away. The radar recordings show that one of the F15s passed within 0.2nm of the RC135, but the vertical separation at the time was 500ft. Consequently, it was considered that although safety had been degraded, there had been no risk of a collision and the Board therefore categorised the Airprox as risk Category C.
