## AIRPROX REPORT No 2017002

Date: 05 Jan 2017 Time: 1409Z Position: 5321N 00058E Location: AARA8<sup>1</sup>

### PART A: SUMMARY OF INFORMATION REPORTED TO UKAB

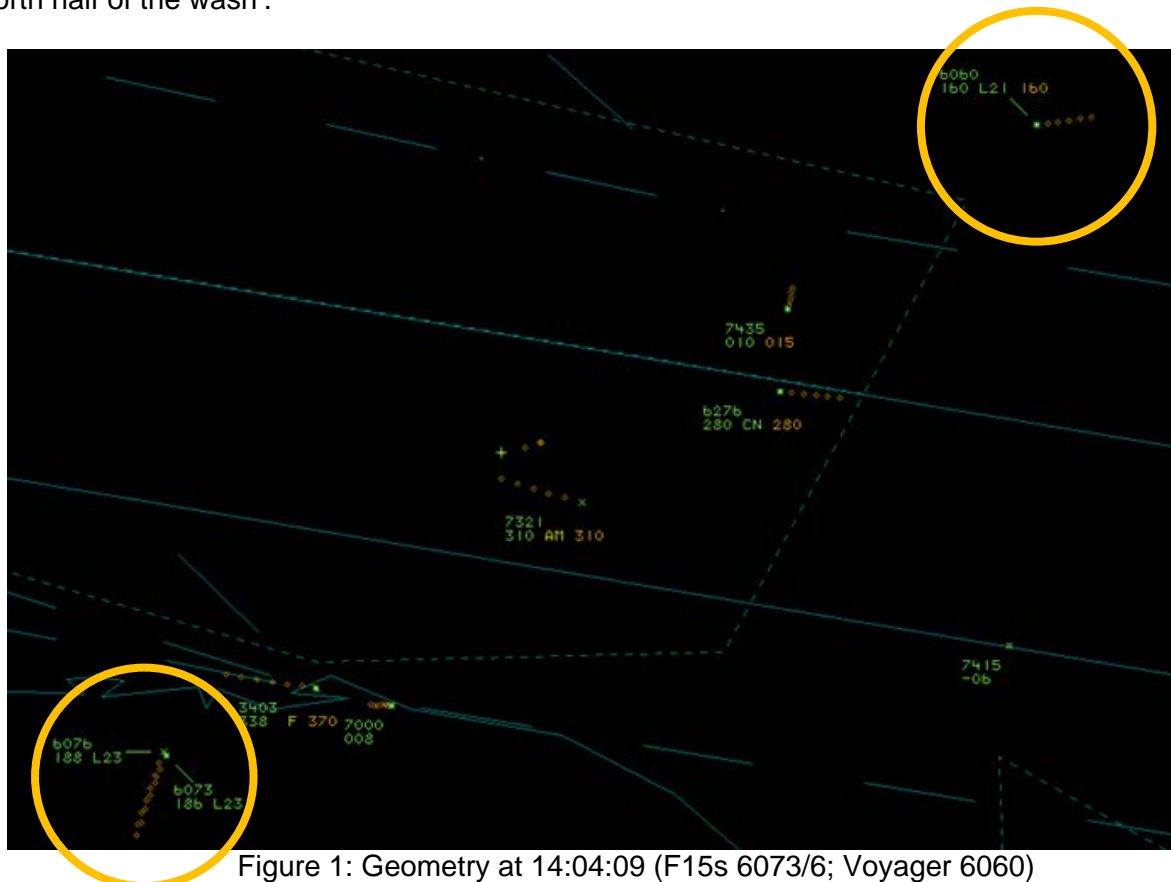
At 14:04:09 (Figure 1), the pair of F15s was instructed to operate between the surface and FL240. There was no lateral restriction passed, though the pair had earlier requested to 'general handle north half of the wash'.

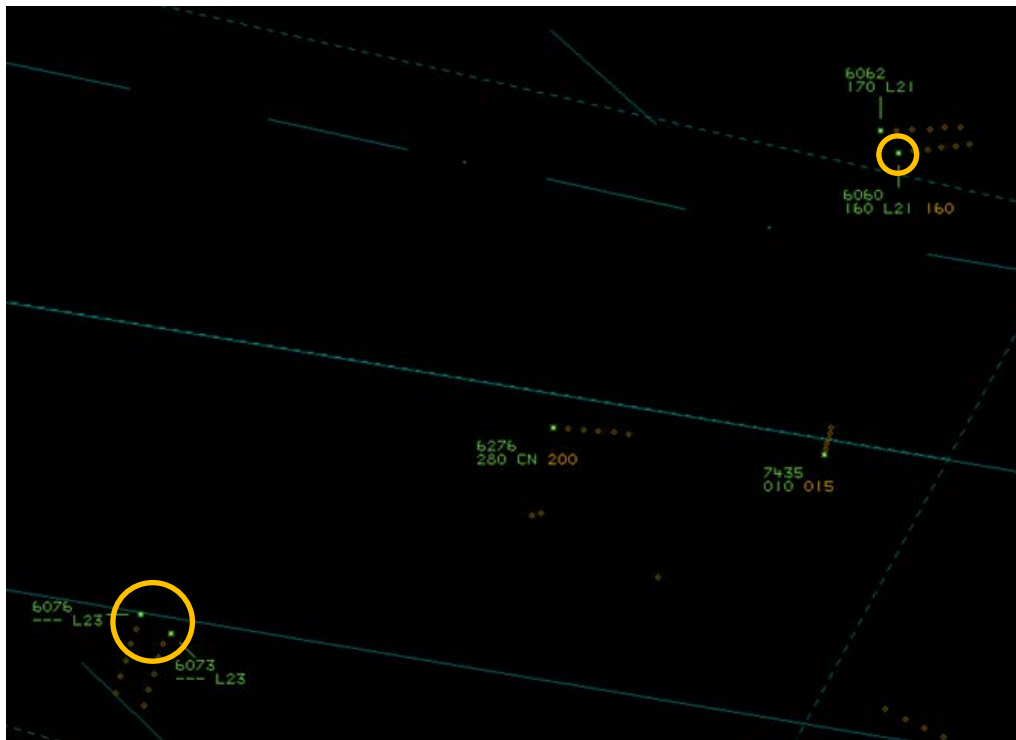
Figure 2: Geometry at 14:05:43 (F15s 6073/6; Voyager 6060)

At 14:05:43 (Figure 2), the Swanwick E Tac R controller gave the F15s avoiding action as they penetrated controlled airspace (CAS). They had already been advised, with 3nm to run, that they were to remain outside of CAS.

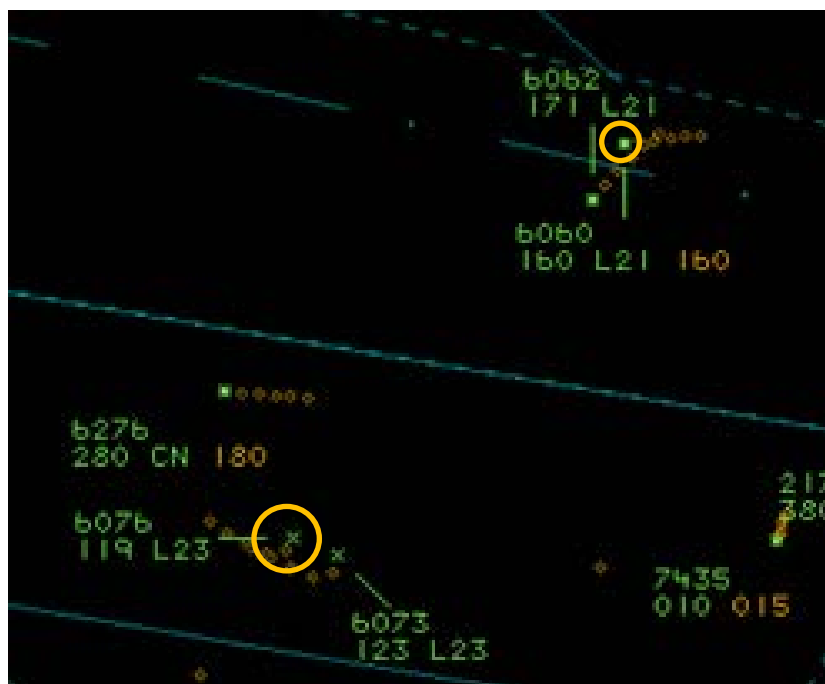
Figure 3: Geometry at 14:07:08 (F15s 6073/6; Voyager 6060)

At 14:07:08 (Figure 3), the Swanwick E Tac R controller passed Traffic Information TI, to another formation of F15s under his control, operating in the western portion of East Anglia (squawking 6070-2 in Figure 3). Shortly afterwards, they answered a landline and began taking a prenote from Marham.

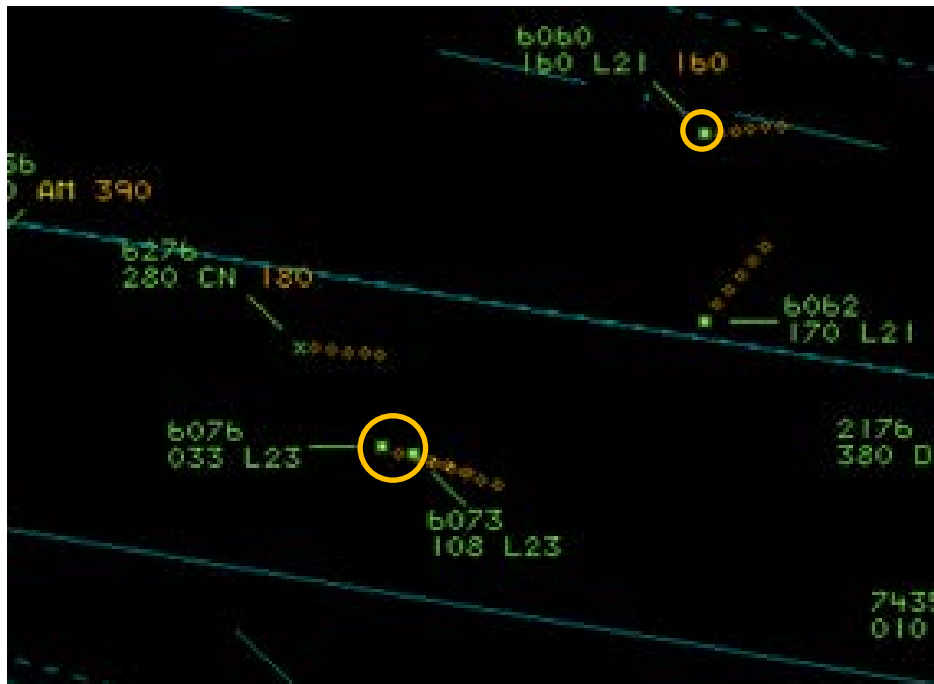
Figure 4: Geometry at 14:07:57 (F15s 6073/6; Voyager 6060)

At 14:07:57 (Figure 4), the Swanwick E Tac R controller passed further TI to the formation of F15s operating in the western portion of East Anglia. The TI was repeated and then the prenote from Marham continued.

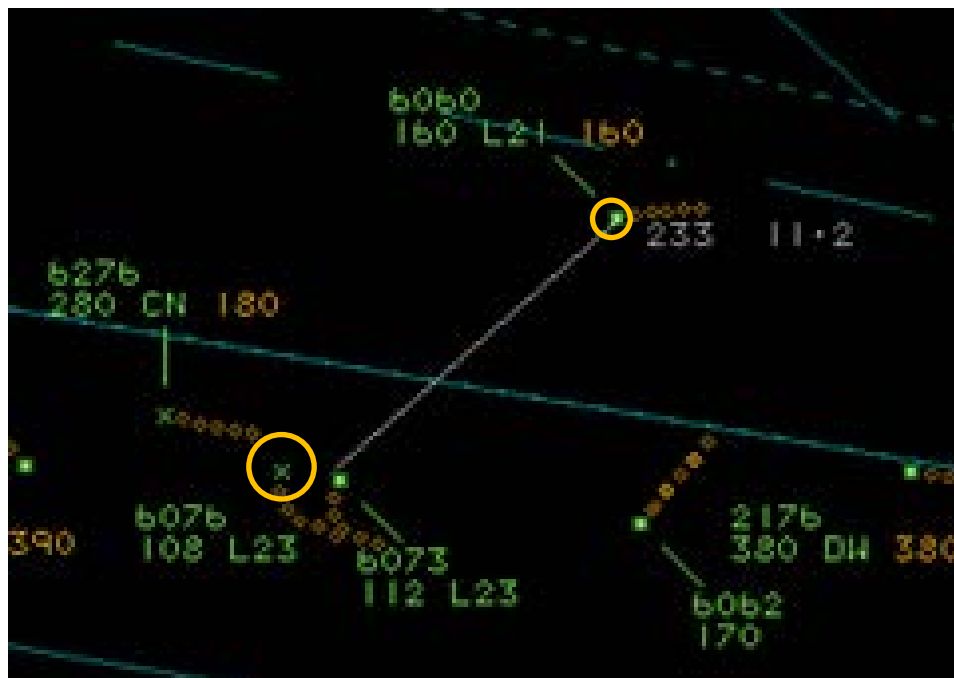
Figure 5: Geometry at 14:08:36 (F15s 6073/6; Voyager 6060)

At 14:08:36 (Figure 5), the Swanwick E Tac R controller passed further TI to the formation of F15s operating in the western portion of East Anglia, then continued the prenote from Marham.

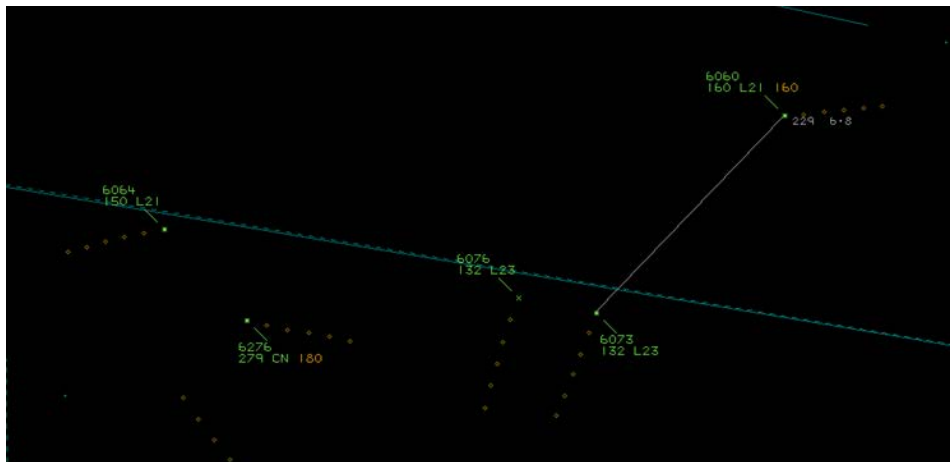
Figure 6: Geometry at 14:08:59(F15s 6073/6; Voyager 6060)

At 14:08:59 (Figure 6), the Swanwick E Tac L controller, who was controlling the Voyager, passed TI to a formation of Typhoons (squawking 6064 in Figure 6) on the general handing pair of F15s. No TI was passed to the Voyager on the same traffic.

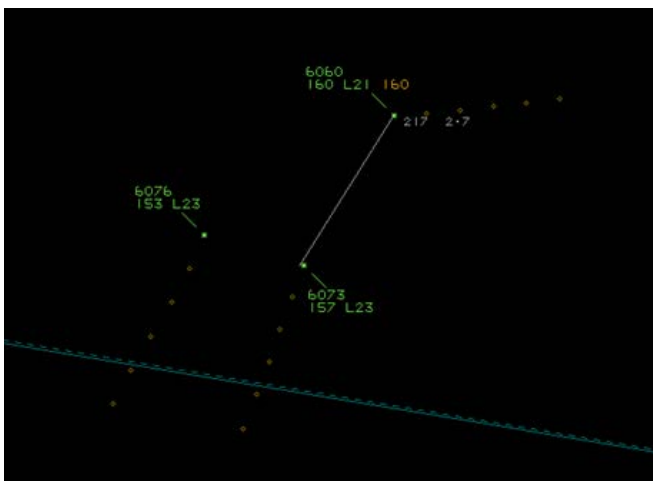
Figure 7: Geometry at 14:09:22

At 14:09:22 (Figure 7), the F15s were advised, for the first time, by the Swanwick E Tac R controller, that AARA 8 was active. No specific TI was passed, but avoiding action to operate below FL140 was given. The F15s asked if they could work to the south of the Wash, and the controller iterated that AARA 8 was active. At the same time, the Voyager queried the F15 traffic with the Swanwick E Tac L controller, who responded that the traffic had been called to the Typhoons, and that the F15s had been told to avoid.

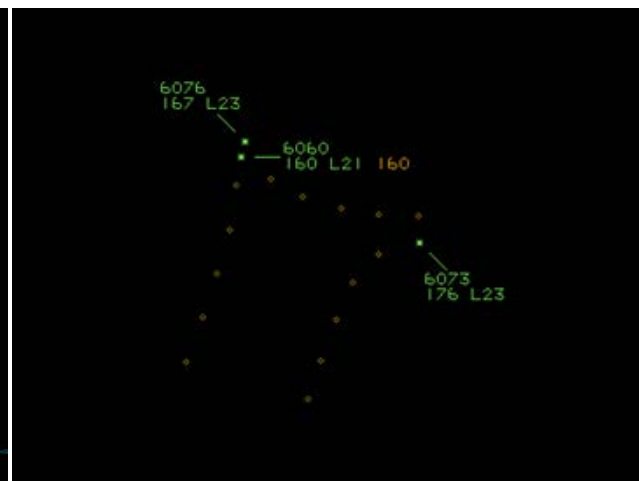
Figure 8: Geometry at 14:09:48  
(F15s 6073/6; Voyager 6060)

At 14:09:48 (Figure 8), the second F15 and Voyager were at CPA, officially recorded as 0.2nm.
