AIRPROX REPORT No 2017003

Date: 05 Jan 2017 Time: 1542Z Position: 5154N 00118W Location: 3.5nm NE Oxford airport

PART A: SUMMARY OF INFORMATION REPORTED TO UKAB

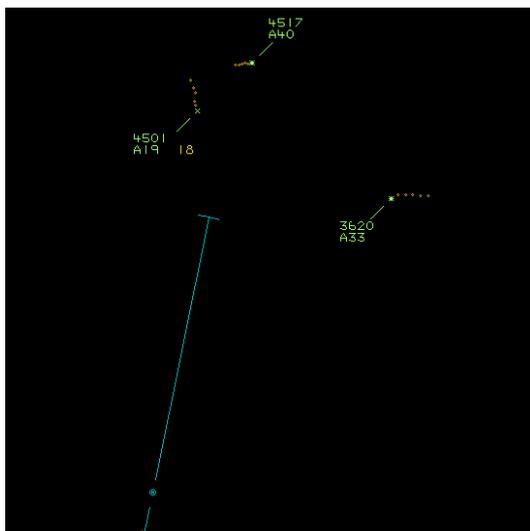
Figure 1 – 1539:50.

The PA34, (transponding 4501), pilot had been receiving a Traffic Service from Oxford Radar whilst flying a procedural NDB approach to RW19 at Oxford. He had been transferred to Oxford Tower after the aircraft had reported the base turn complete. The Chinook, (initially transponding 3620, (RAF Benson)), had been visible for some time prior to this and observed to be maintaining 3500ft on a west-north-westerly track. The Chinook was then observed to commence a descent at 1539:50 (Figure 1).

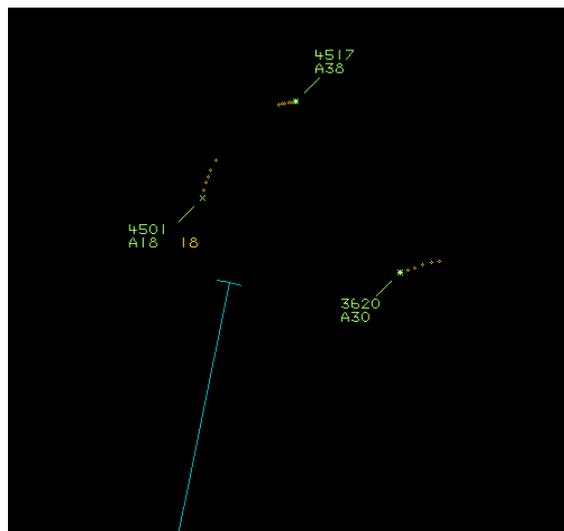
Figure 2 – 1540:08.

The PA34 pilot reported on the Oxford Tower frequency at 1540:08 (Figure 2). At 1540:45 the Chinook transponder code changed to 3707 (RAF Brize Norton). At 1541:06 the Aerodrome controller observed the Chinook, initially on the ATM and subsequently visually from the VCR, to be converging with the PA34, and passed Traffic Information (Figure 3).

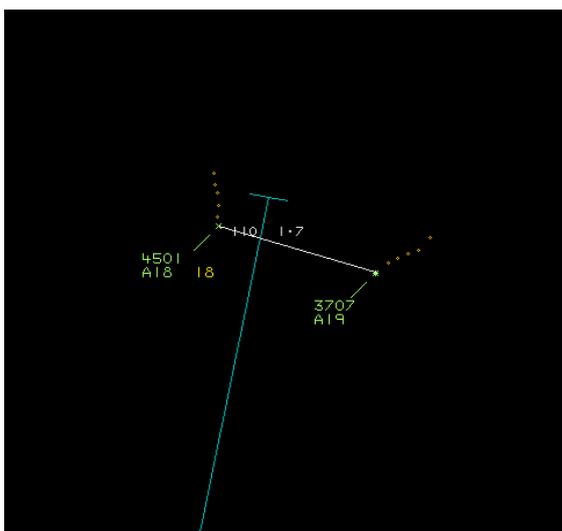
Figure 3 – 1541:06.

Although the Traffic Information passed by the Oxford Aerodrome controller was not wholly accurate, with the controller admitting in his report that he had referenced the Chinook as being in the PA34's 3 o'clock rather than its 9 o'clock, it still assisted the PA34 pilot in visually acquiring the Chinook.

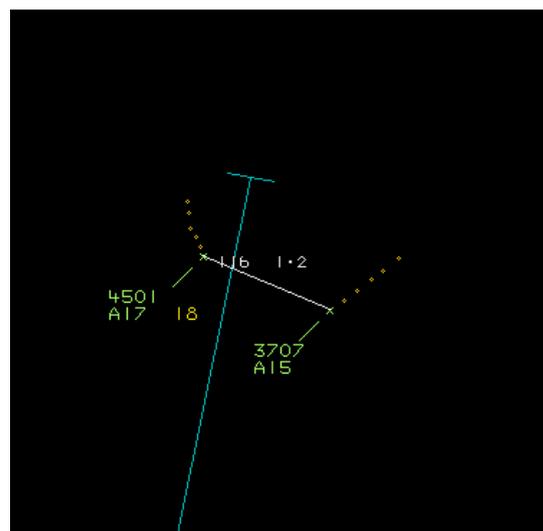
Figure 4 – 1541:20.

At 1541:20 the PA34 pilot reported becoming visual with the Chinook (Figure 4).

The Aerodrome controller asked if the PA34 pilot wished to break-off the approach, but this was declined by the PA34 pilot, who stated their intention was to maintain their current level, as the Chinook was passing beneath them.

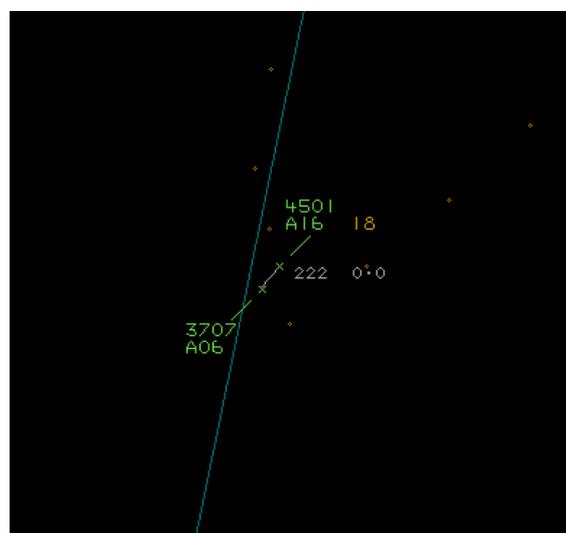
Figure 5– 1541:55.

(CPA took place at 1541:55 with the aircraft separated by <0.1nm laterally and 1000ft vertically (Figure 5).

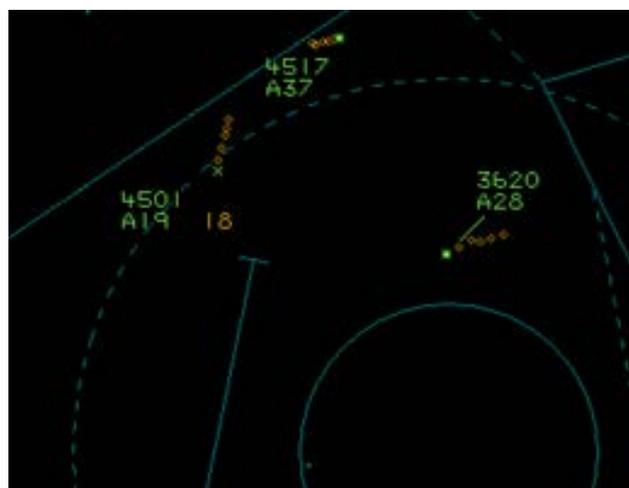
Figure 6: Geometry at 15:40:15 (PA34 4501; Chinook 3620).

At 15:40:15 (Figure 6), the Chinook pilot first called Brize Zone requesting a Basic Service. He was instructed to squawk 3701.

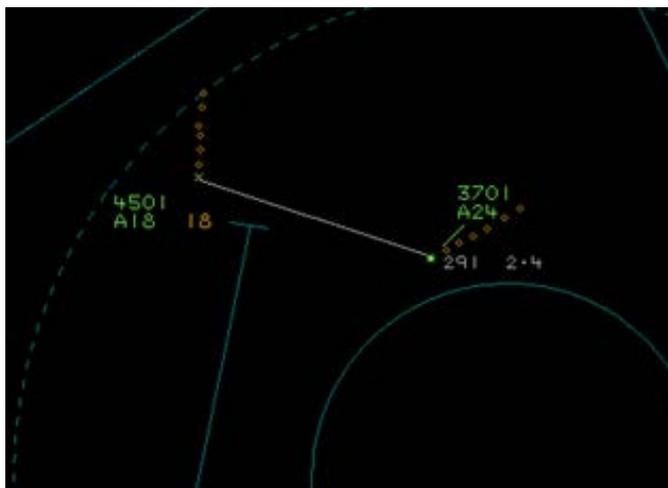
Figure 7: Geometry at 15:40:37 (PA34 4501; Chinook 3707).

At 15:40:37 (Figure 7), the Chinook's SSR changed to 3701 part-way through the pilot's transmission of route and intentions. Once the Brize Zone controller knew the intentions, the Chinook pilot was asked to reset squawk to 3707.

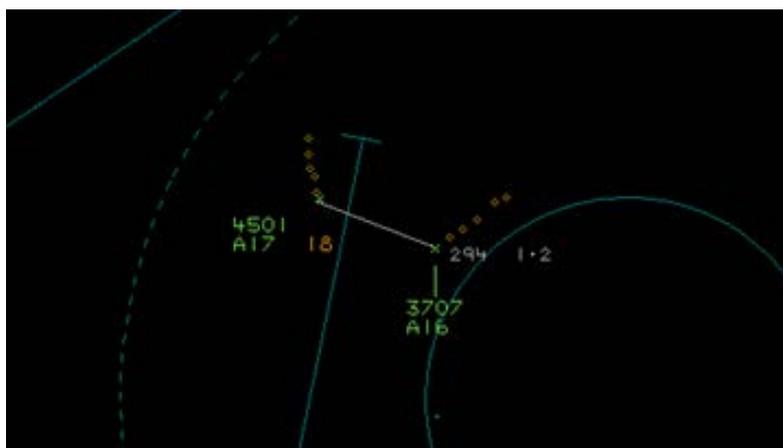
Figure 8: Geometry at 15:41:21 (PA34 4501; Chinook 3707).

At 15:41:21 (Figure 8), the Brize Zone controller passed Traffic Information to the Chinook pilot on traffic right, 2 o'clock, 1nm, converging, indicating 200ft above. The incorrect call sign was used; however, the pilot reported that he was visual with the traffic.

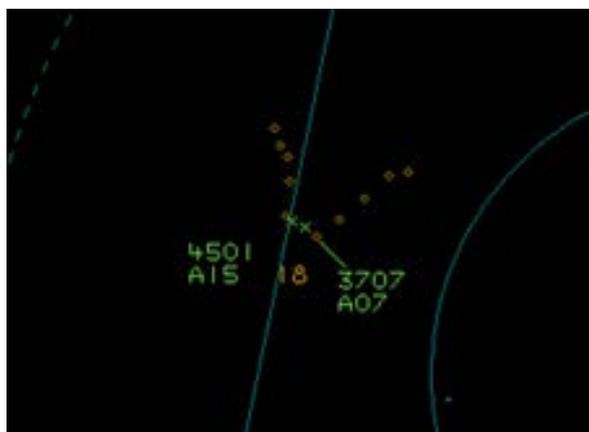
Figure 9: Geometry at 15:41:53 (PA34 4501; Chinook 3707).

At 15:41:53 (Figure 9), the 2 aircraft were at CPA of 0.1nm horizontally and 800ft vertically. It was another minute before the Brize Zone controller agreed a type of service with the Chinook pilot.

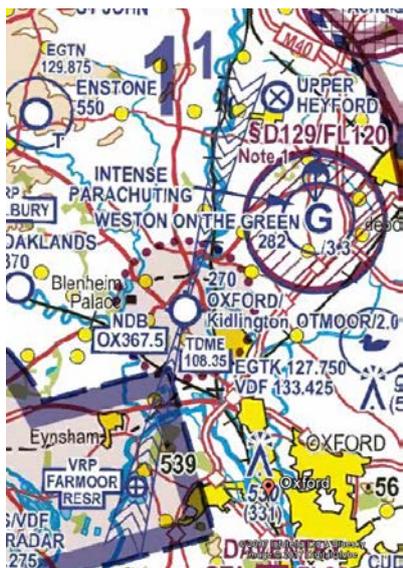
Figure 10 CAA 1:500,000 chart

Oxford is marked on the civil aeronautical charts with these symbols for both runways as shown in Figure 10 below.

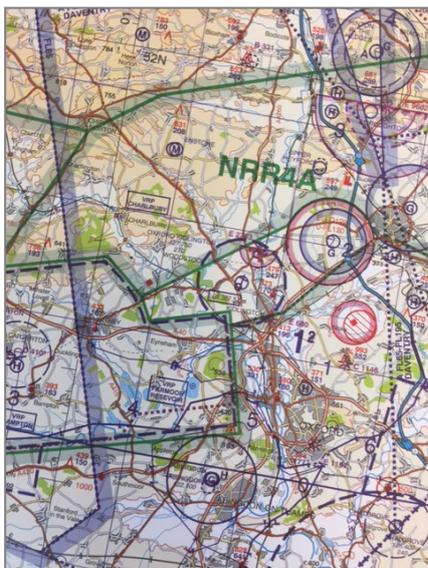
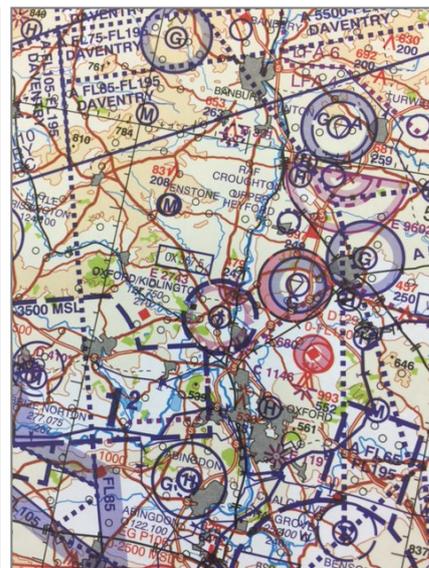
The Board noted the comments made by the PA34's operating company about the difference between military and civil charts in depicting whether an instrument approach existed at civil airfields outside CAS. The HQ JHC member commented that the Chinook crew were based at Benson and would have been well aware of the Instrument Approach paths at Oxford. As a result, on this occasion, the Board felt that the absence of a feathered display on the military chart was not directly pertinent. However, prompted by this incident, the HQ Air Training member undertook to contact the military Aeronautical Information Documents Unit (AIDU) to seek their opinion as to whether the addition of such annotations to the military map would be feasible.

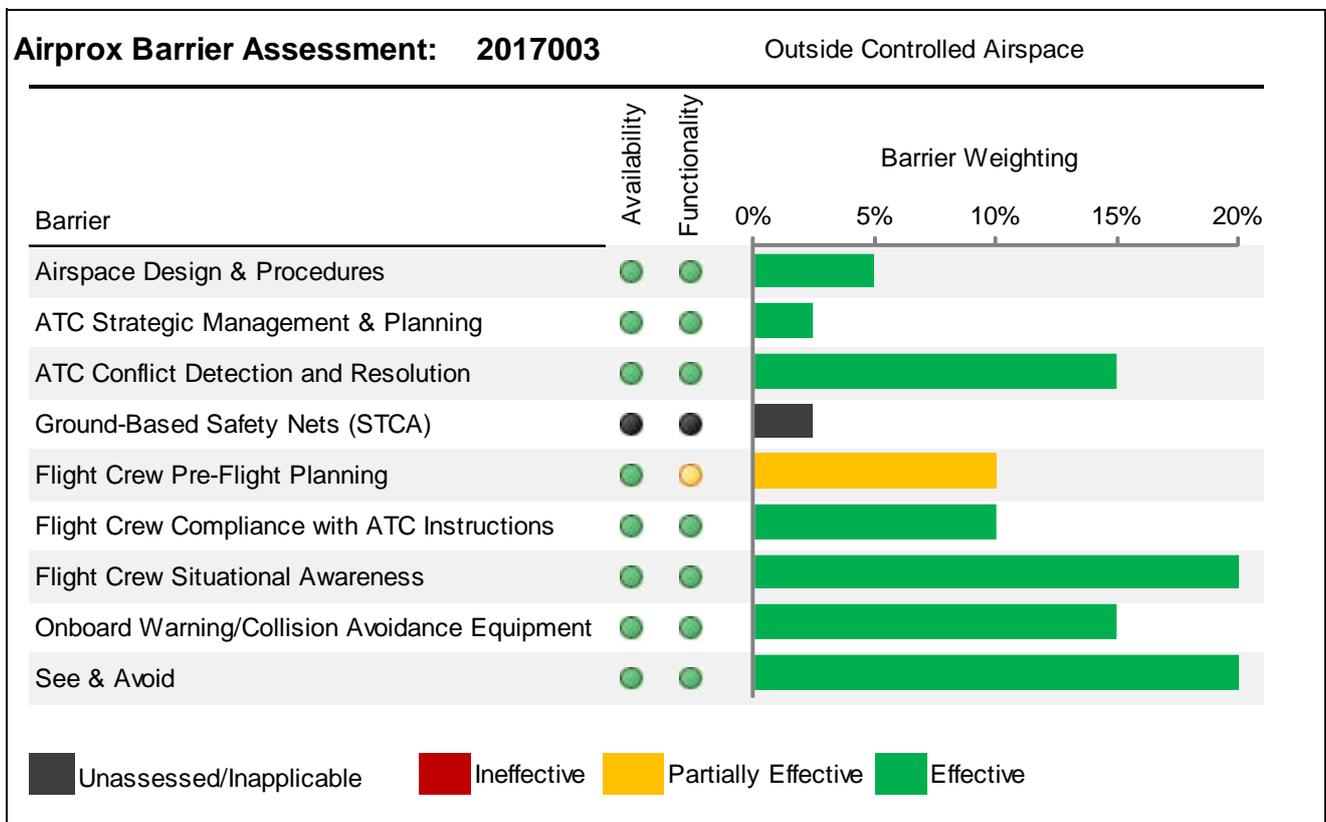
Flight Crew Pre-Flight Planning was only **partially effective** because the Chinook pilot's pre-brief for the flight should have addressed the fact that he was routeing close to Oxford and potentially towards an Instrument Approach. Consequently, it would have been prudent for him to have contacted Oxford's frequency to advise them of his presence or ensure other mitigations were in place.
