AIRPROX REPORT No 2017040

Date: 16 Mar 2017 Time: 1259Z Position: 5325N 00018W Location: 9nm south Humberside

PART A: SUMMARY OF INFORMATION REPORTED TO UKAB

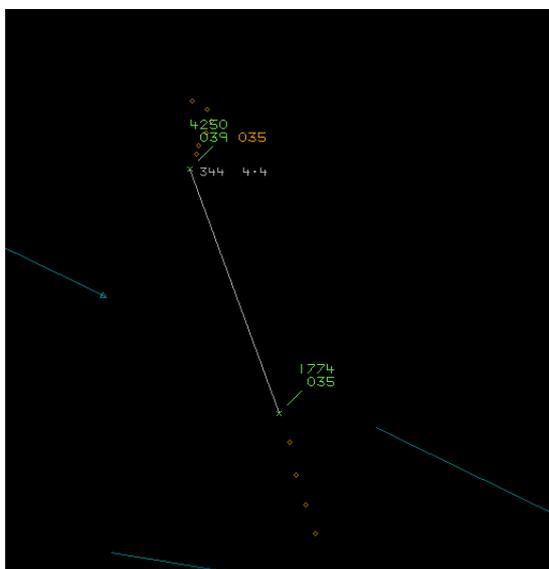
Figure 1 – Prestwick Radar at 1258:15

At approximately 1258:15 (Figure 1), Humberside radar provided Traffic Information to the DA42 pilot (squawk 4250) on the, then unknown, northbound aircraft, with the pilot indicating in his written report that he obtained visual contact with the CV22 (squawk 1774) at a reported range of '4 to 5 miles'. This Traffic Information was subsequently updated by Humberside, although the DA42 pilot remained visual with the CV22.

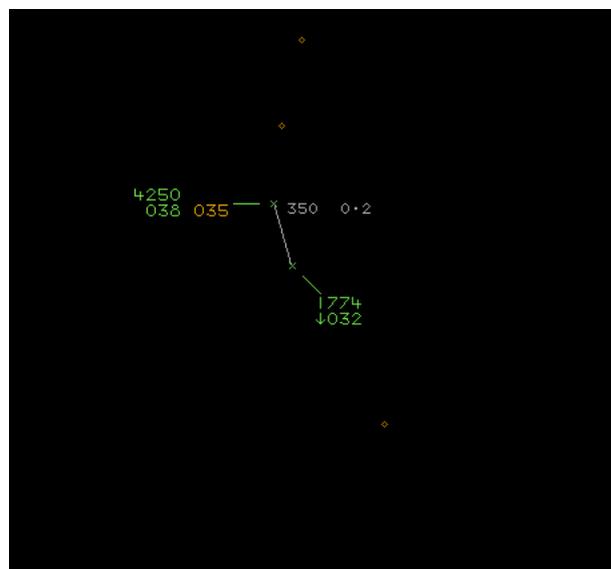
Figure 2 CPA - Prestwick Radar 1259:11

CPA occurred at 1259:11 (Figure 2), with an indicated 600ft and 0.2nm between the two aircraft. However, allowing for the update rate of the radar and the track and speed of both aircraft it is possible the lateral distance between the two aircraft occurred just after this radar screenshot and that it may have been less than 0.2nm.

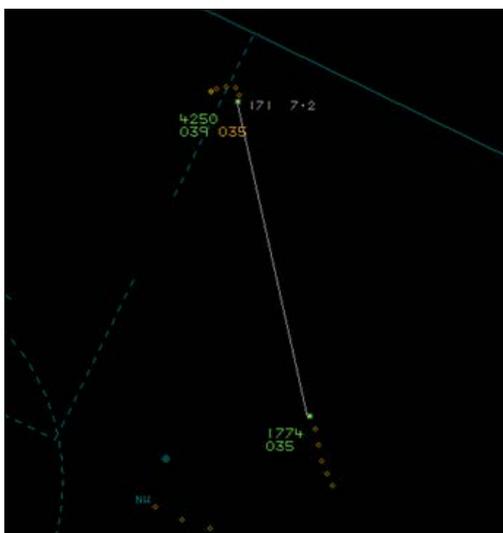
Figure 3

At 12:57:46 (Figure 3), the Coningsby LARS controller passed Traffic Information to the CV22 pilot on traffic 12 o'clock, 8nm, tracking south, indicating 400ft above. The CV22 pilot responded that he was searching but did not call visual with the traffic.

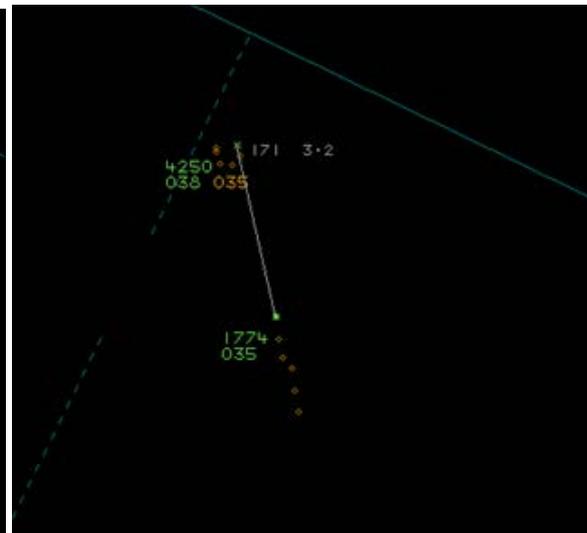
Figure 4

At 12:58:39 (Figure 4), the CV22 pilot told the Coningsby LARS controller that he was coming left 20 degrees due to the previously called traffic.

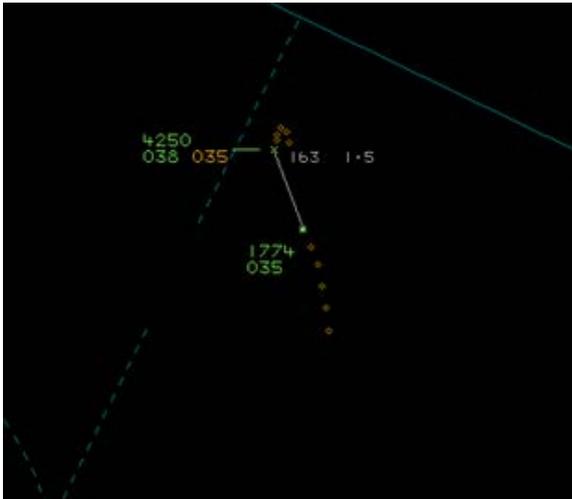
Figure 5

At 12:58:58 (Figure 5), the Coningsby LARS controller updated the Traffic Information to the CV22 pilot as 12 o'clock, 2nm, opposite direction, indicating 300ft above. The CV22 pilot responded that he was visual with the traffic and that it had turned towards him.

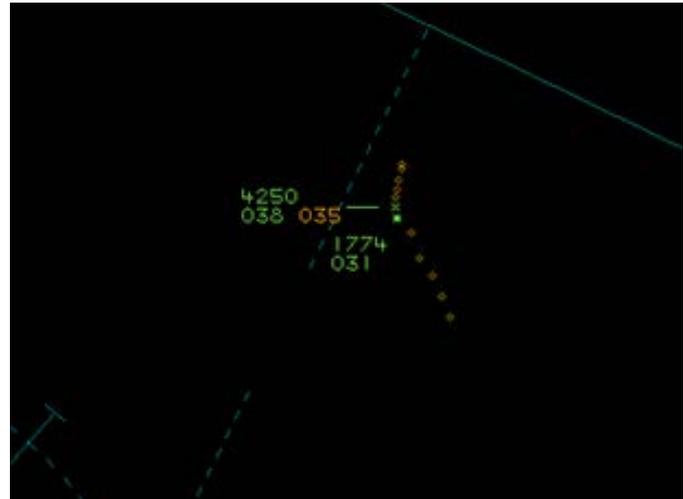
Figure 6

At 12:59:11 (Figure 6), the CV22 and the DA42 passed at their CPA of 0.2nm and 700ft.

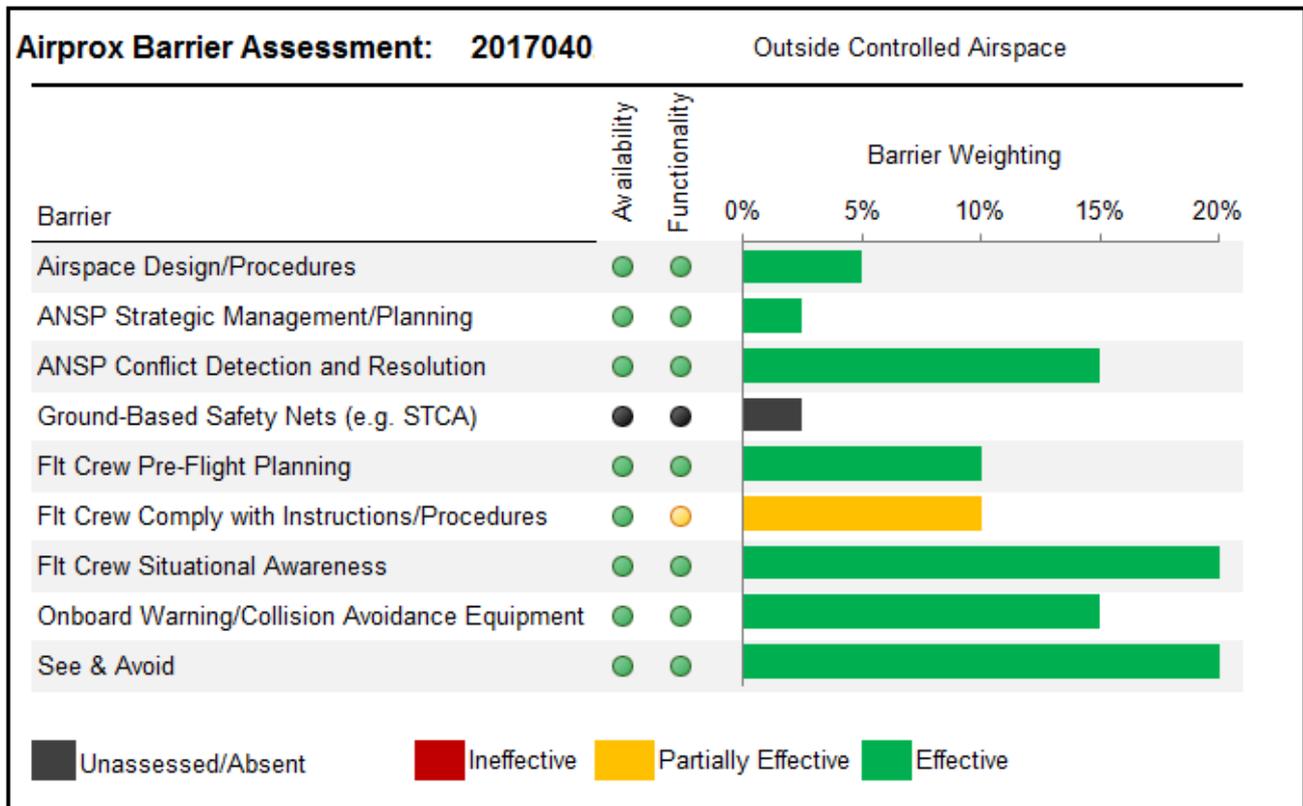
In assessing the effectiveness of the safety barriers associated with this incident, the Board concluded that the key factors had been that:

Flight Crew Compliance with Instructions & Procedures was assessed as **partially effective** because the CV22 and DA42 crews allowed their aircraft to come into proximity after having obtained Traffic Information and having made visual contact at 10nm and 4nm respectively.
