AIRPROX REPORT No 2017084

Date: 08 May 2017 Time: 1314Z Position: 5119N 00001E Location: Biggin Hill

PART A: SUMMARY OF INFORMATION REPORTED TO UKAB

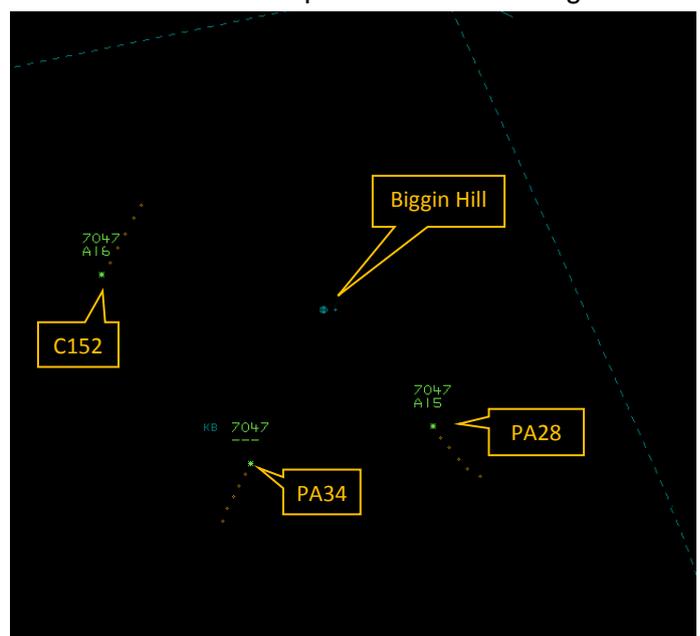
Figure 1 – 1310:56

At 1310:56 the C152 reported late downwind and was instructed to report on final approach, advising that they were No 2 to a "Seneca" (PA34) on short finals (Figure 1).

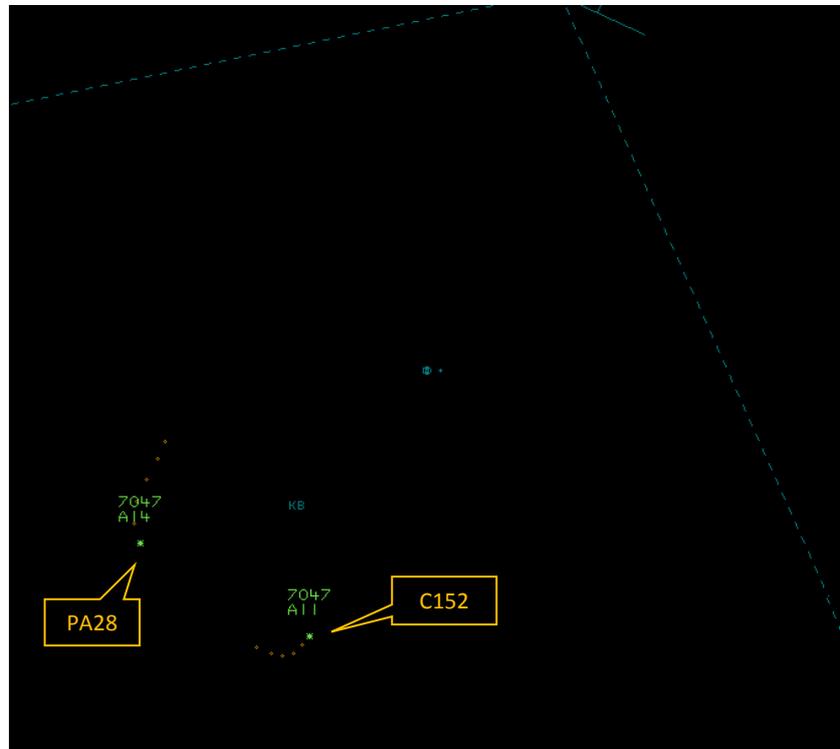
Figure 2 – 1313:10

At 1313:10 the PA28 pilot reported “*just turning downwind/, turning on base*”. The controller instructed the pilot to report final, advising that they were “*number two following a one five two on final*”. The PA28 pilot acknowledged their number in the sequence but not the aircraft that they were to follow. On the radar replay, the PA28 was observed already in the left-hand turn onto base leg when they made this call (Figure 2).

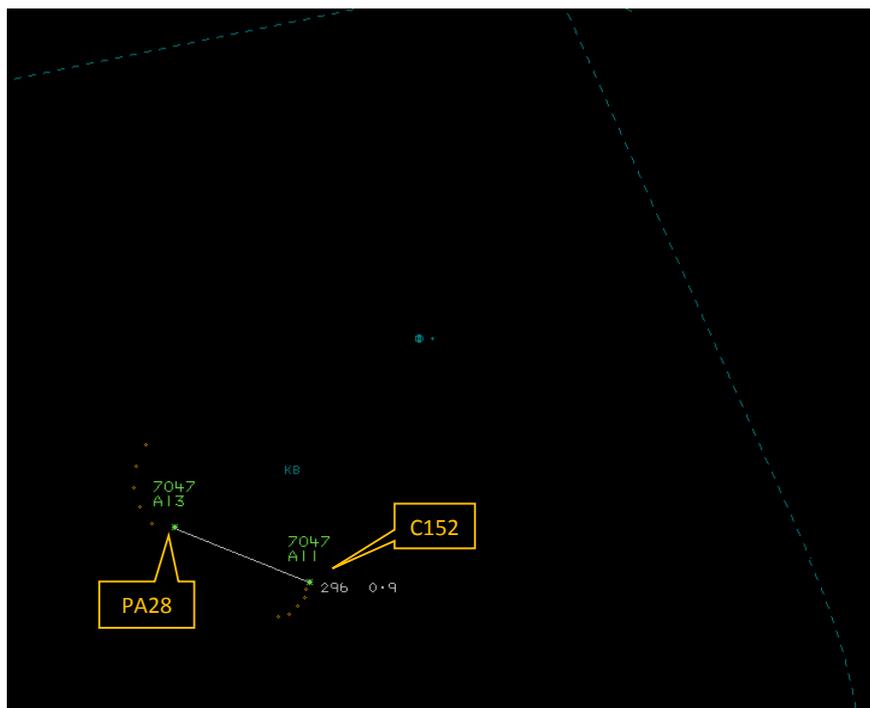
Figure 3 – 1313:20

At 1313:20 the C152 reported on final approach and was cleared for a touch and go. ATSI noted that at this time, according to the radar replay, the ground speed for the C152 was 42kts, and the PA28, 107kts (Figure 3).

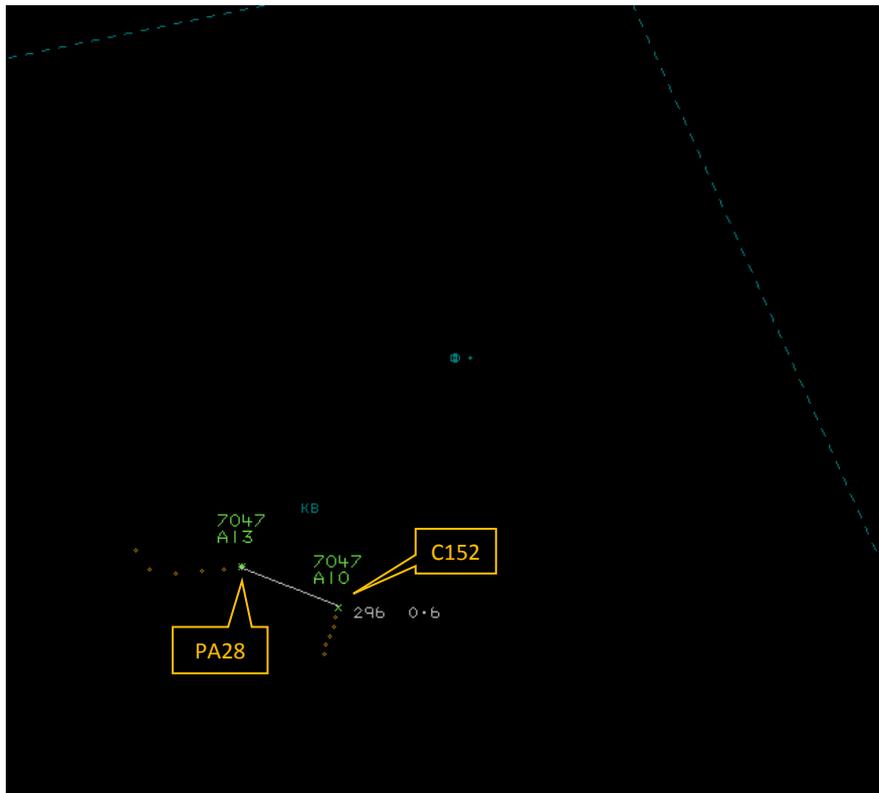
Figure 4 – 1313:32

At 1313:32 the PA28 was observed on a track towards and at an oblique angle to final approach, taking it to a point ahead of the C152 (Figure 4)

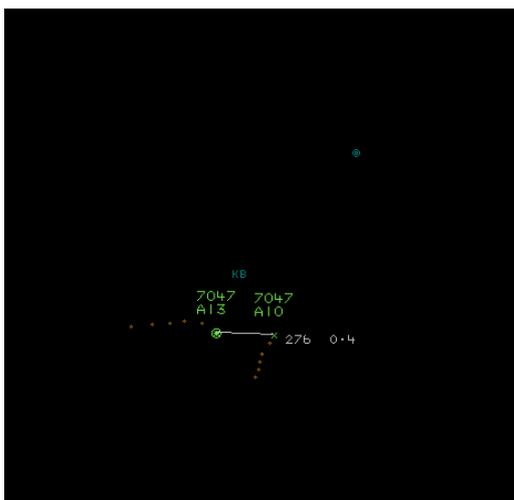
Figure 5 – 1313:39

At 1313:39 the PA28 was observed to make a turn to the right, onto a track which would take it behind the C152 (Figure 5).

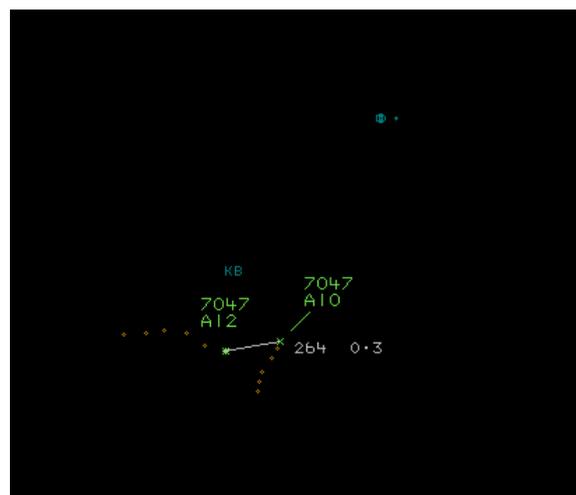
Figure 6 – 1313:44

At 1313:44 (Figure 6), the PA28 pilot reported *“traffic in sight”*. This was missed by the controller, possibly because the callsign was slightly clipped, and they asked the caller to repeat their call, which he did, in response to which the controller instructed them to continue their approach.

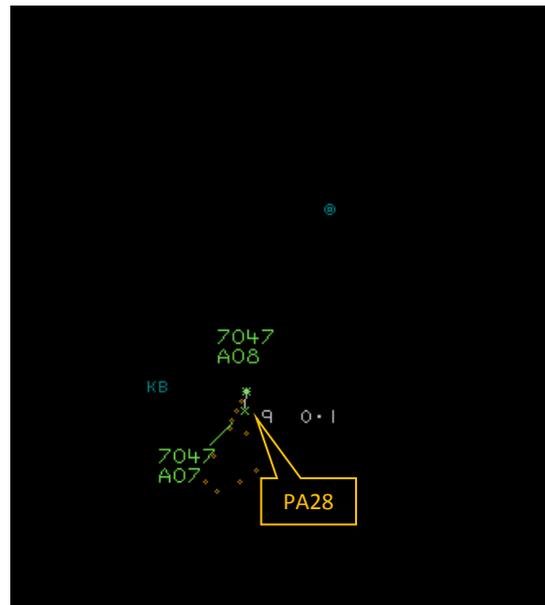
Figure 10 – 1314:10

At 1314:10 the PA28 pilot reported that the C152 was now above him (Figure 10).

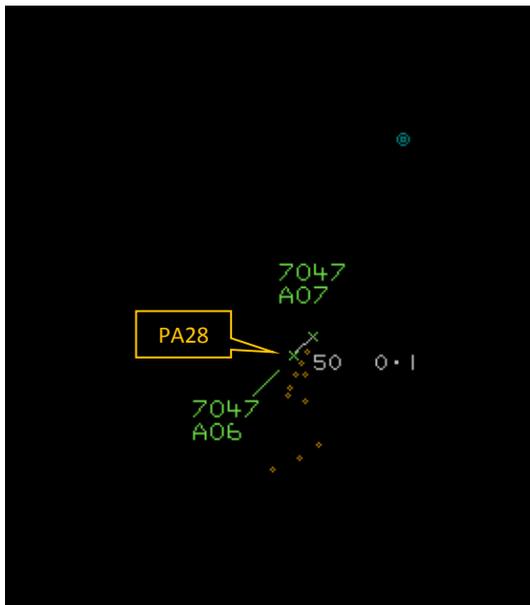
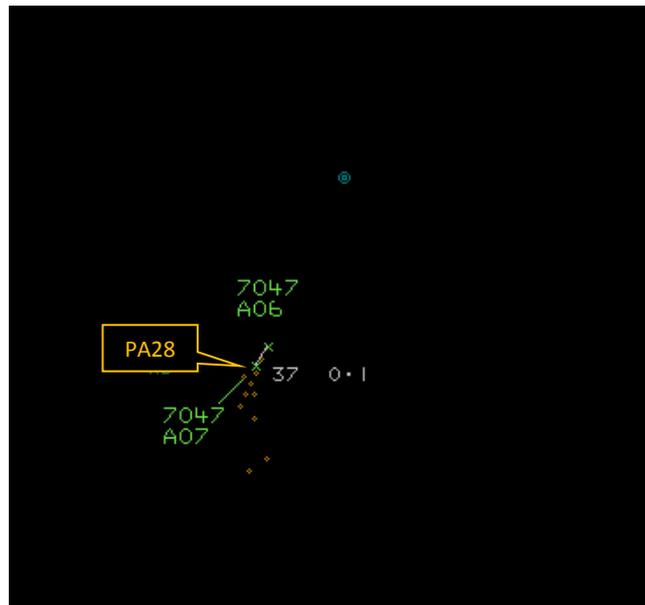
At 1314:14 the pilot of the PA28 reported going around which was acknowledged by the controller (Figure 11). At 1314:20 the controller passed Traffic Information to the C152 on the PA28 which was acknowledged by the pilot of the C152 (Figure 12).

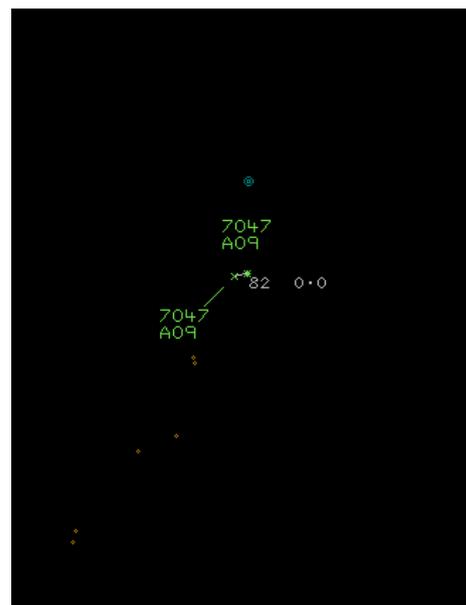
Figure 14 – 1314:48

Figures 13-14 illustrate the situation as it developed further. CPA took place at 1314:48 (Figure 14), with the radar replay showing both aircraft at the same altitude with <math><0.1\text{nm}</math> lateral separation.
