AIRPROX REPORT No 2017106

Date: 02 Jun 2017 Time: 1434Z Position: 5047N 00054W Location: ivo Thorney Island

PART A: SUMMARY OF INFORMATION REPORTED TO UKAB

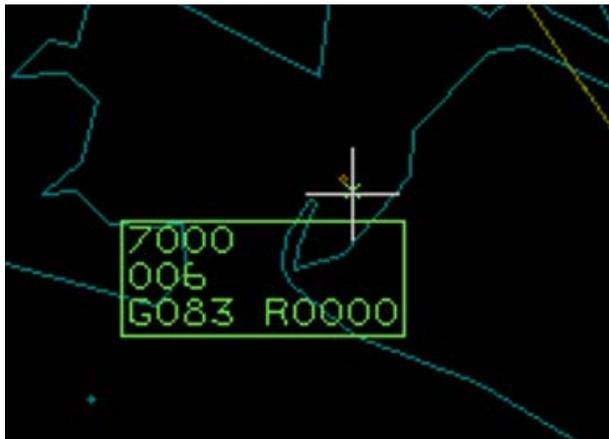
Figure 1 – 1433:20

An Airprox was reported by a Chinook pilot when it came into proximity with a WT9 in the vicinity of Thorney Island. The Chinook pilot was in receipt of a Basic Service from Goodwood Radio. The WT9 pilot was not in receipt of an ATC service but had reported attempting to call Solent Radar, without success. Approximately 2 minutes prior to the reported Airprox, the WT9 was observed on radar transiting at low-level along the coast in a north-westerly direction. However, due to the low level nature of the flight, radar contact was lost in the vicinity of The Witterings. Radar contact was regained shortly before CPA (code 7000) and, at 1433:20, the WT9 was observed in an apparent right-hand turn at 600ft. (Figure 1).

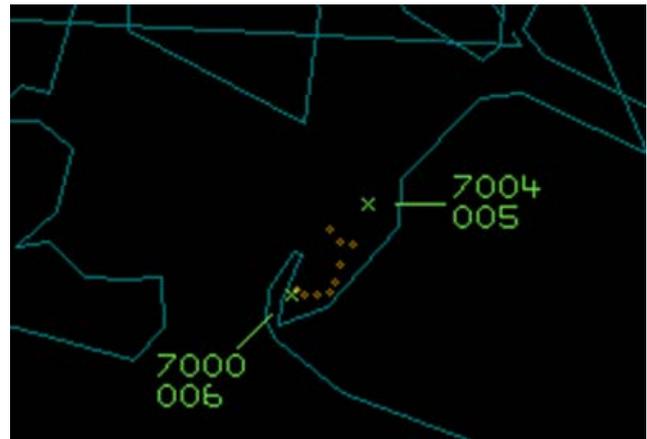
Figure 2 – 1433:50

At 1433:50 (Figure 2) the WT9 pilot had continued the right turn and the Chinook was observed north-east of the WT9 (code 7004). The Chinook radar return was also intermittent as it too was being operated at low level.

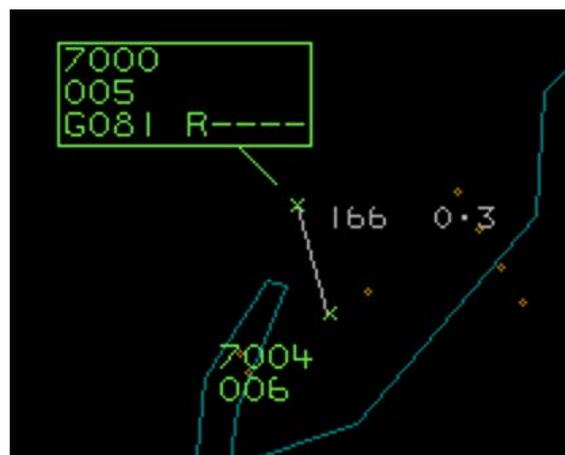
Figure 3 – 1434:15

The closest point of approach observed on radar occurred at 1434:15 (Figure 3), with the WT9 north of the Chinook by 0.3nm and 100ft below.

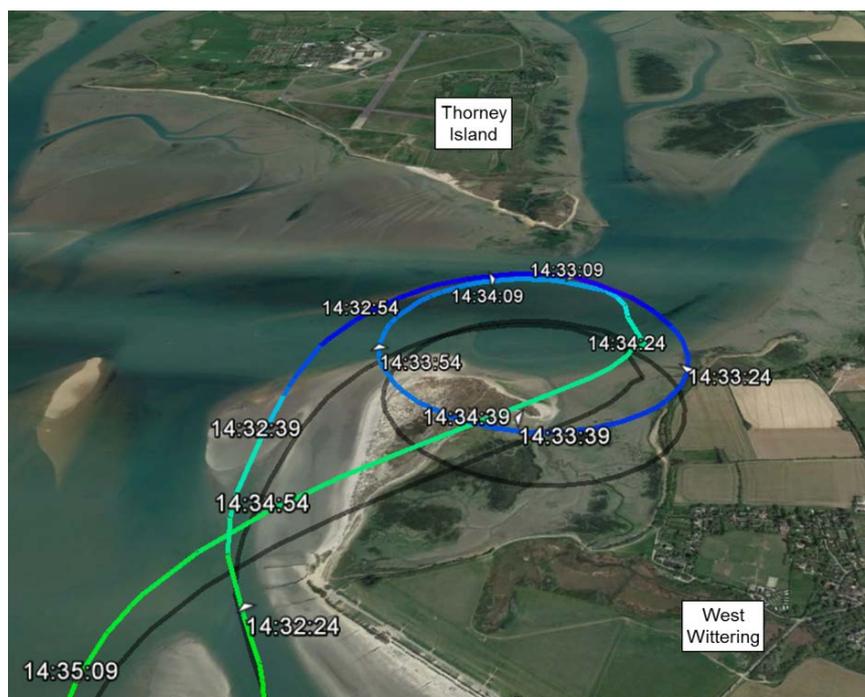
The Chinook and WT9 pilots shared an equal responsibility for collision avoidance and not to operate in such proximity to other aircraft as to create a collision hazard¹. Aircraft shall not be flown in formation except by pre-arrangement among the pilots-in-command of the aircraft taking part in the flight². In subsequent conversation with the WT9 pilot, it was established that he had a GPS track log of his route, which was forwarded to the UKAB. The relevant part of the GPS track is reproduced here:

Finally, members noted that whilst they could not comment on the WT9 pilot's alleged proximity to surface vessels, it was clear from his GPS track that he had not flown over houses at West Wittering, contrary to the Display Authoriser's perception of his track when viewed from Thorney Island. The Board agreed that, fundamentally, perception and mis-perception had played a major role in this Airprox; human perception was, by its nature, highly subjective and actual events could be very different from those perceived.

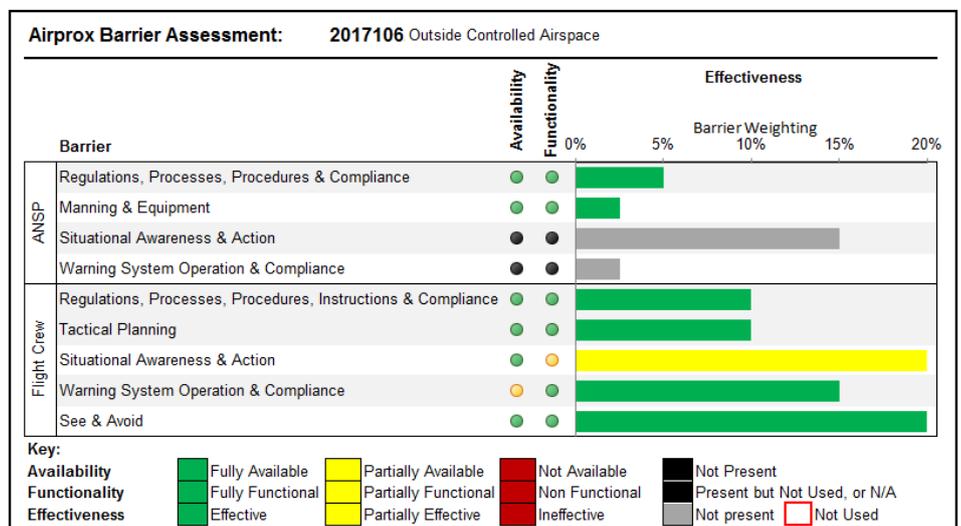
Situational Awareness and Action were assessed as **partially effective** because the WT9 pilot did not elect to hold in an area clear of the Chinook, which he had previously seen.
