**AIRPROX REPORT No 2017114**

Date: 07 Jun 2017 Time: 1551Z Position: 5317N 00432W Location: Valley

**PART A: SUMMARY OF INFORMATION REPORTED TO UKAB**

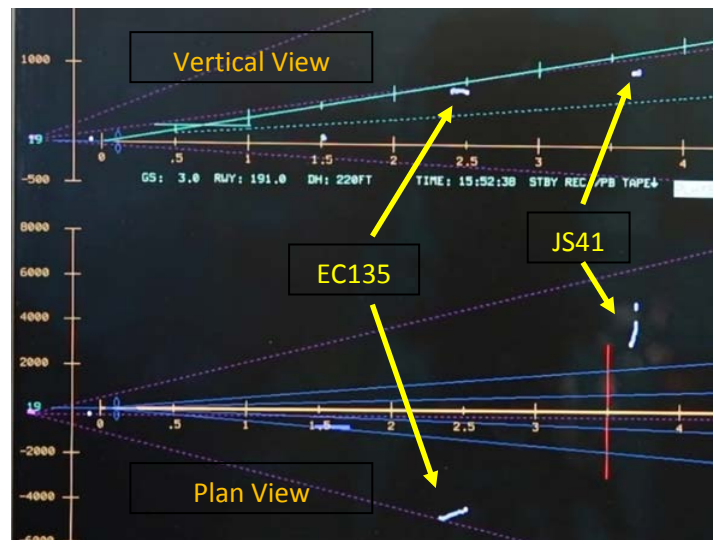
Figure 1

At Figure 1, the JS41 is shown turning final, at a range of approximately 3.5nm and 800ft, and the EC135 in transit on an opposite direction track at approximately 750ft, maintaining to the east of the extended centreline.

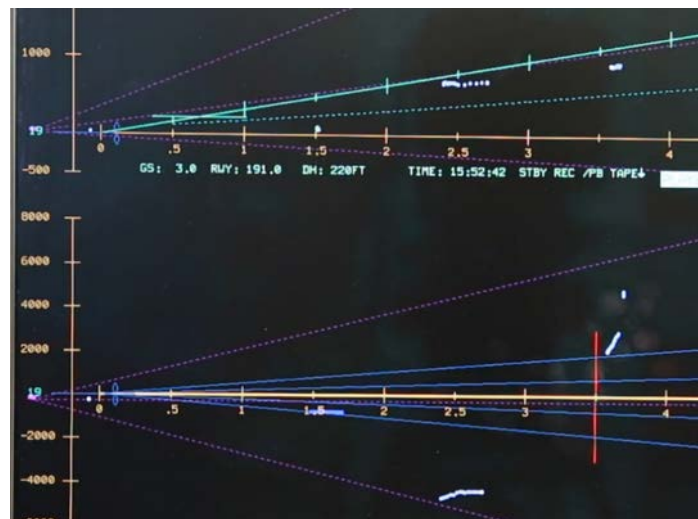
Figure 2

At Figure 2, the JS41 continues turning inbound while the EC135 appears to alter course to the right.

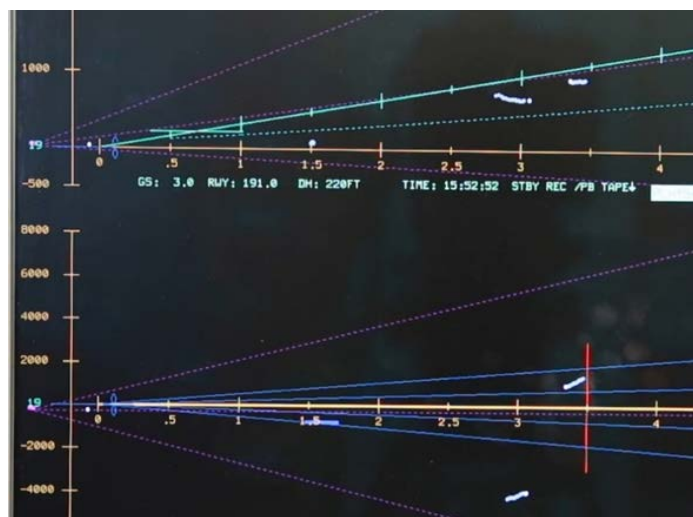
Figure 3

At Figure 3, the JS41 continues inbound while the EC135 appears to descend slightly. The 2 aircraft are offset by approximately 2nm.

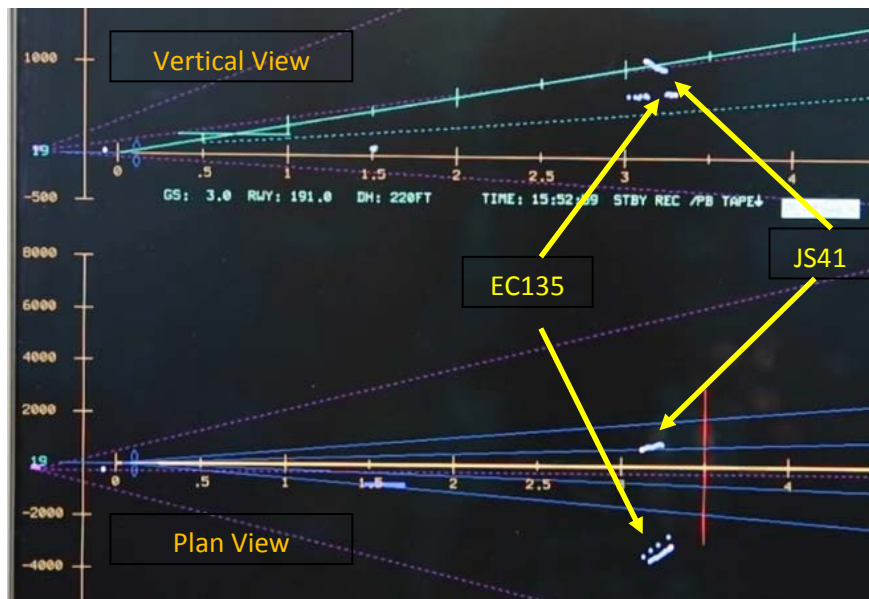
At Figure 4 the JS41 was instructed to go around at circuit height, at which stage the two aircraft had passed each other and had approximately 0.5nm lateral separation.

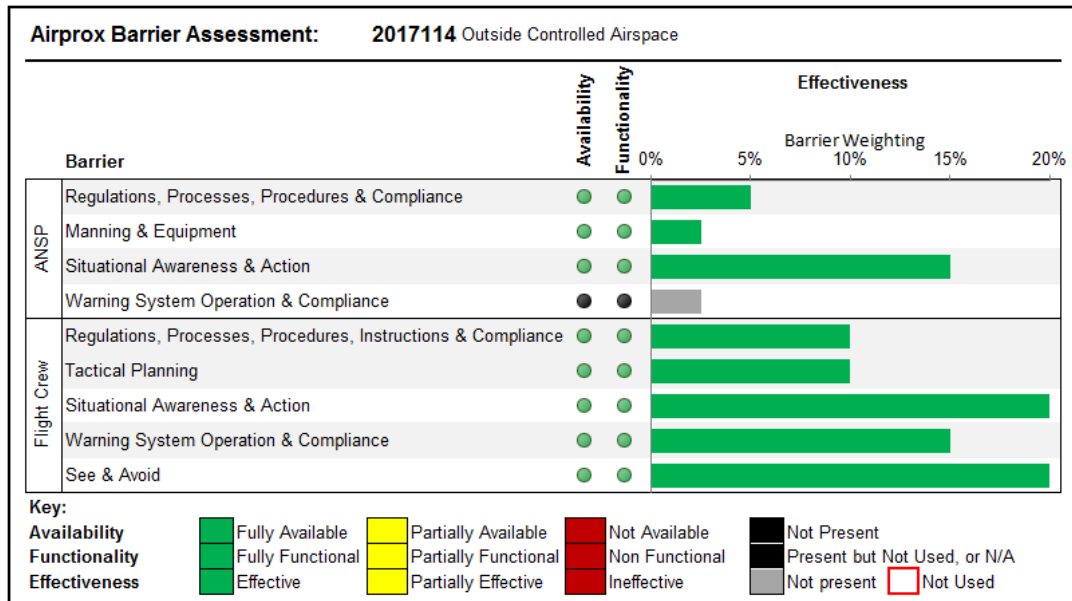
In assessing the effectiveness of the safety barriers associated with this incident, the Board concluded that all of the barriers had been fully effective.
