**AIRPROX REPORT No 2017117**

Date: 14 Jun 2017 Time: 0825Z Position: 5802N 00247W Location: 27nm SE Wick

**PART A: SUMMARY OF INFORMATION REPORTED TO UKAB**

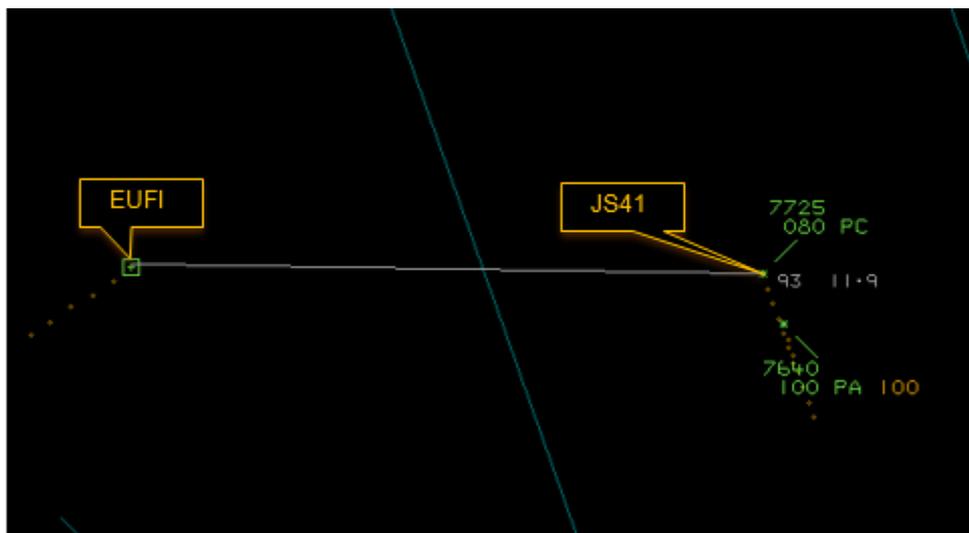
Figure 1 – 0823:12

At 0823:12 (Figure 1) the MOR-LO (Moray Low) controller issued a clearance to the JS41 pilot to descend when ready to FL60 (and therefore leave controlled airspace), and terminated the service. An instruction to contact Wick Approach was then given.

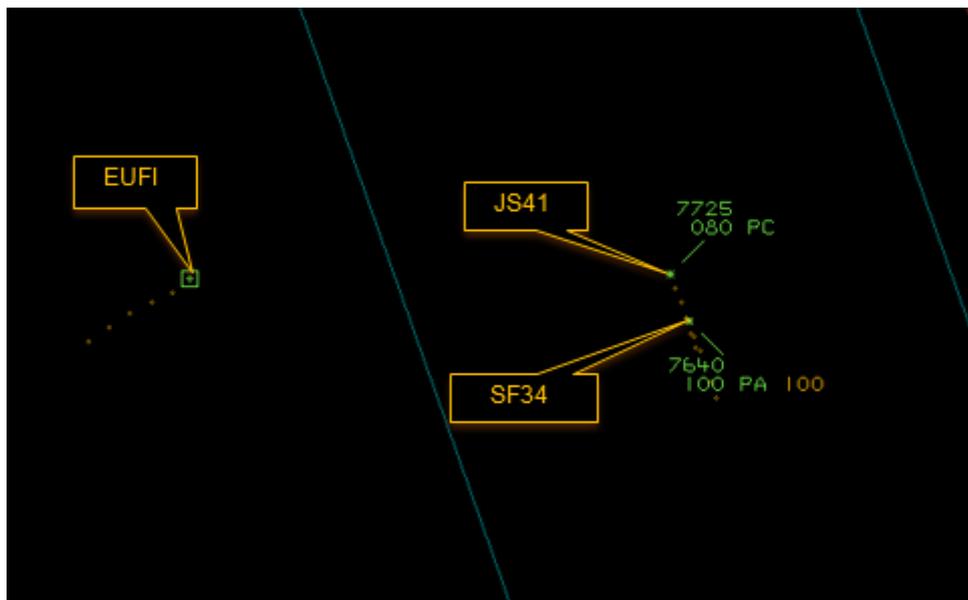
Figure 2 – 0823:37

At 0823:37 (Figure 2), the MOR-LO controller, (after receiving the read-back of the previous instruction), issued Traffic Information to the JS41 pilot about a fast-moving contact approaching from the west. There was no height information available on the primary-only Typhoon track (labelled as EUFI on the diagram but unknown to the MOR-LO controller at the time). The controller estimated that the track's trajectory would take the unknown aircraft behind the JS41 by one to two miles; he advised the JS41 pilot of this. The controller went on to issue the same Traffic Information to an SF340 not involved in the Airprox (SF34 - code 7640), which was on a similar track to the JS41 but 2000ft higher, commenting that it was not known whether the unknown traffic was above or below the airway.

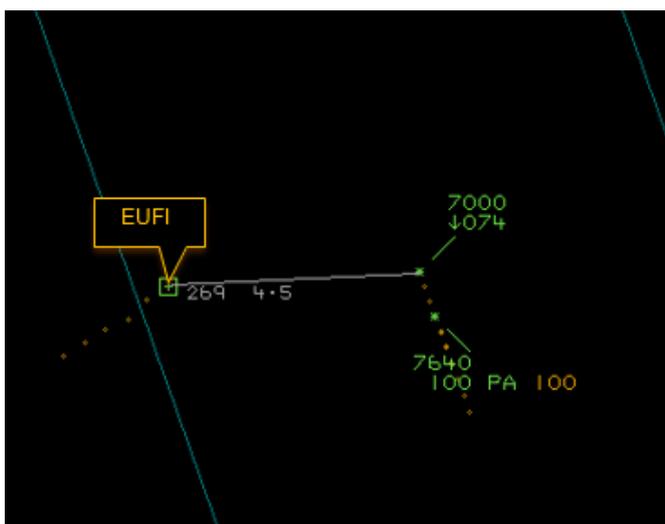
Figure 3 – 0824:16

At 0824:16 (Figure 3) the JS41 pilot called to confirm that they could still call Wick, and the MOR-LO controller queried if they had seen the traffic yet, advised them to keep looking out, and gave approval to contact Wick. The SSR code changed to 7000 as they began their descent to leave controlled airspace (the base of which was FL75).

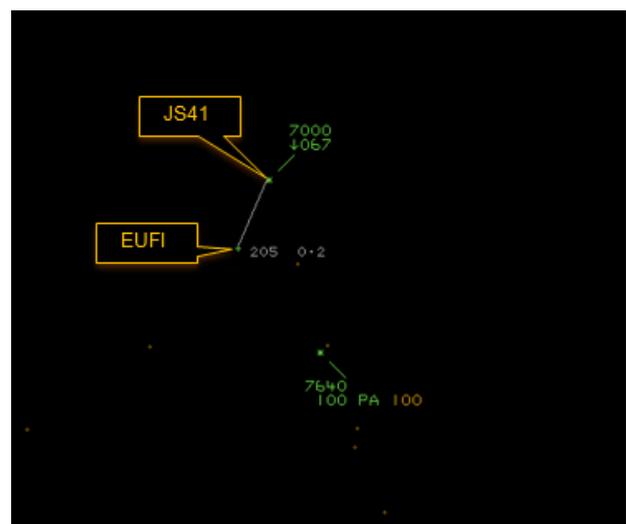
Figure 4 -0824:56

CPA occurred on the recording at 0824:56 (Figure 4) with an indicated lateral distance of 0.2nm.

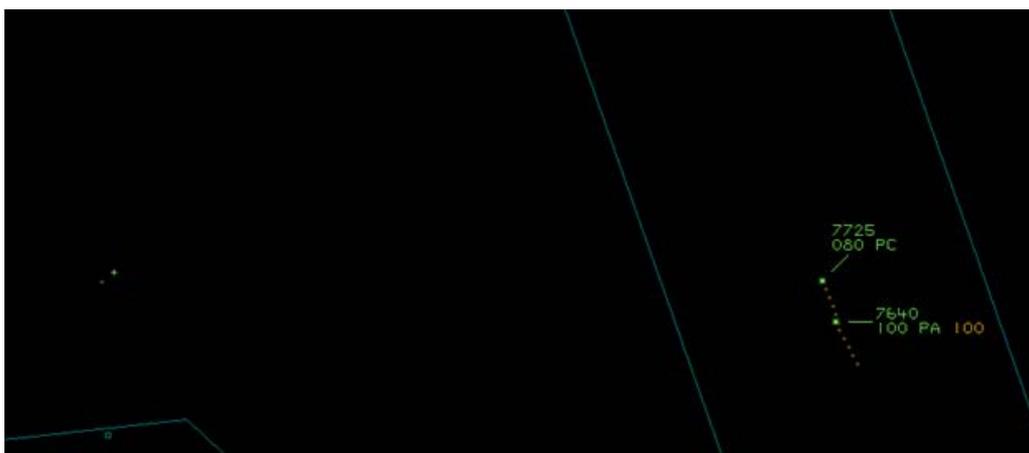
At 0821:31 (Figure 5), the primary contact of the Typhoon first began to paint on this radar picture.

Figure 5: Geometry at 0821:31 (Typhoon primary only; JS41 7725).

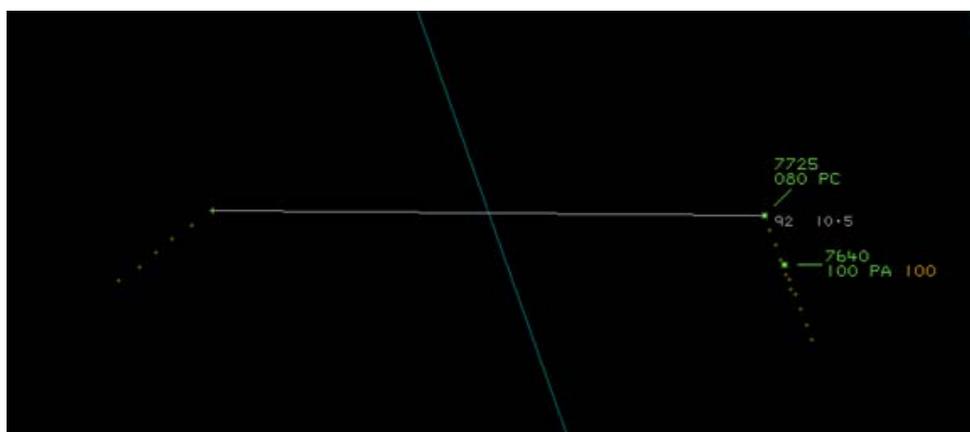
At 0823:25 (Figure 6), the Lossiemouth Approach controller began handing over the Typhoon to the Swanwick Mil North controller.

Figure 6: Geometry at 0823:25 (Typhoon primary only; JS41 7725).

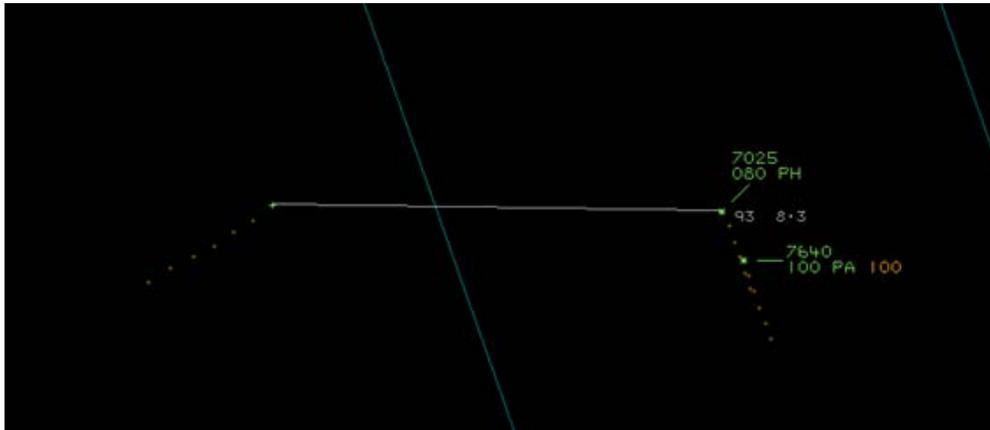
At 0823:43 (Figure 7), the handover of the Typhoon was completed without either the Lossiemouth or Swanwick Mil North controller mentioning the JS41 traffic 8.3nm away and 1000ft above, and inside Controlled Airspace. The JS41's SSR code had changed by one digit during this time.

Figure 7: Geometry at 0823:43 (Typhoon primary only; JS41 7025).

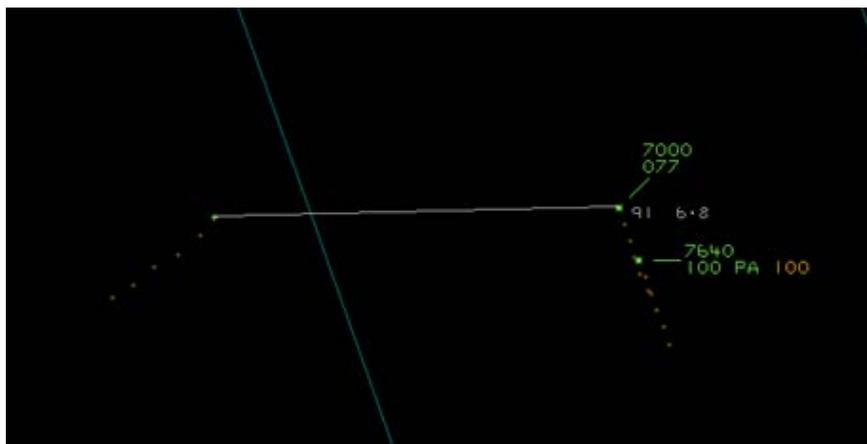
At 0823:57 (Figure 8), the Typhoon pilot checked in with the Swanwick Mil North controller. By this time, the JS41 had changed SSR code to 7000 and had commenced descent.

Figure 8: Geometry at 0823:57 (Typhoon primary only; JS41 7000).

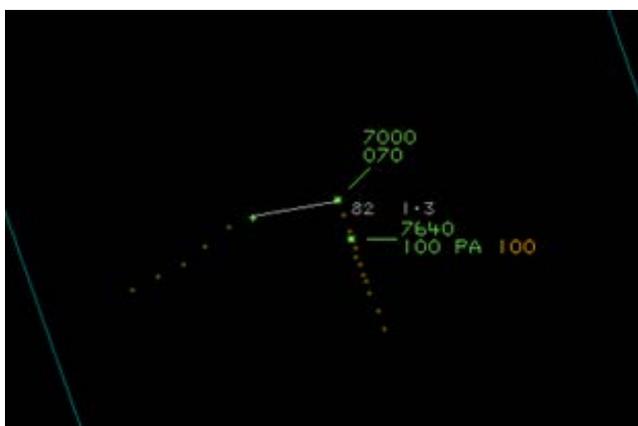
Figure 9: Geometry at 0824:47

At 0824:47 (Figure 9), the two aircraft were co-altitude [the Typhoon pilot had reported being level at FL70], with the JS41 now outside CAS.

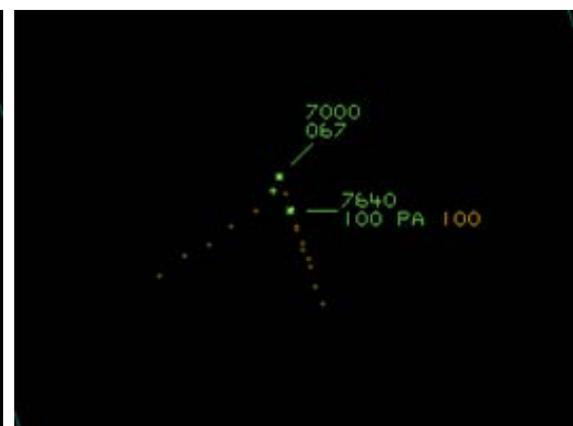
Figure 10: Geometry at 0824:56

At 0824:56 (Figure 10), the two aircraft were in proximity, with the JS41 300ft below the Typhoon [reported at FL70].
