## AIRPROX REPORT No 2017156

Date: 15 Jul 2017 Time: 1245Z Position: 5050N 00113W Location: Lee on Solent Airfield

### PART A: SUMMARY OF INFORMATION REPORTED TO UKAB

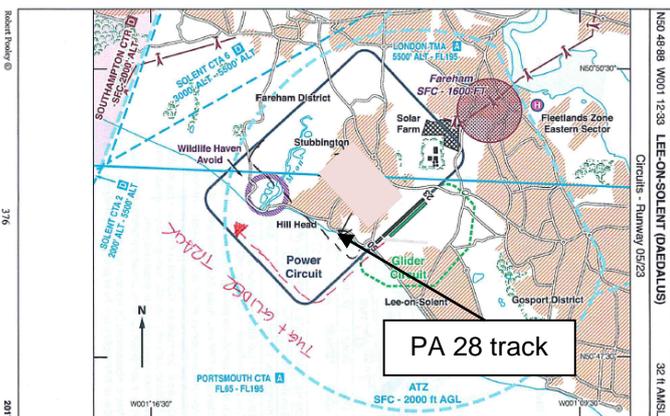
gliding circuit for release. Upon getting airborne from the touch-and-go, the tug/glider combination turned right towards the fixed-wing right-hand circuit. His options were limited due to the gliding circuit to his left and he did not want to maintain straight ahead in case the glider released and turned back to the glider circuit. He therefore made an early right turn at about 300ft, which he announced on the R/T, toward the mid-point downwind. On his final approach, he heard the Grob 109 pilot ask for his details as the Grob 109 pilot believed an Airprox had taken place. Neither he nor his student saw the Grob 109 in the circuit, or heard any calls from the Grob 109 pilot. He has talked to the AGCS operator about the incident, who said that they had never seen a tug/glider turn right and had expected it to turn left. He has tried to talk to the Grob 109 pilot but they have not returned his calls. In hindsight, he believes that he had no option but to turn right as he could not turn left or continue straight ahead as he was unaware of the speed of the Glider/Tug combination, but as it looked like a relatively slow chipmunk, he was concerned if he turned back to the left (Runway heading), he could catch up or become in conflict with the release cable.

Figure 2: Lee-on-Solent circuit diagram showing the PA28 and Tug/Glider combo tracks as reported by the PA28 pilot
