AIRPROX REPORT No 2017159

Date: 12 Jul 2017 Time: 1344Z Position: 5352N 00012W Location: Vale of York

PART A: SUMMARY OF INFORMATION REPORTED TO UKAB

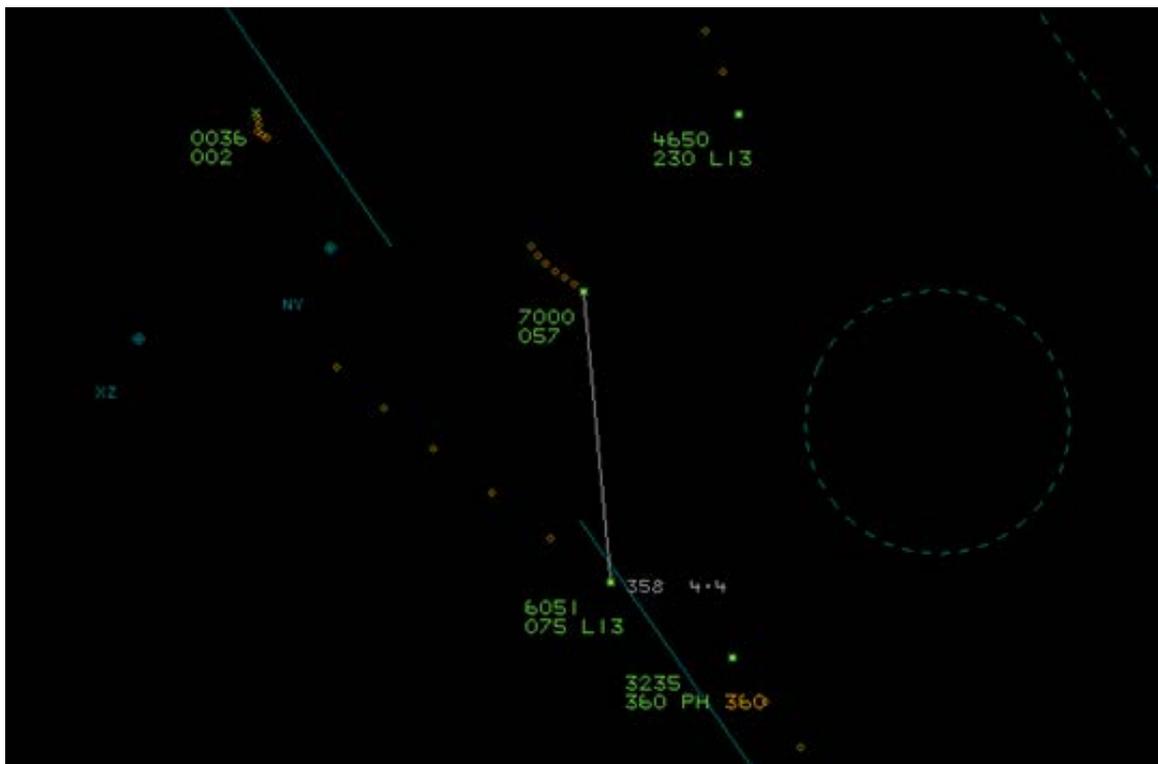
Figure 1: Geometry at 13:40:42 (Typhoon 6051; Microlight 7000)

At 13:40:42 (Figure 1), the Swanwick NE Tac Controller answered a landline call from Linton-on-Ouse ATC requesting information on an aircraft operating to the south west of the sector.

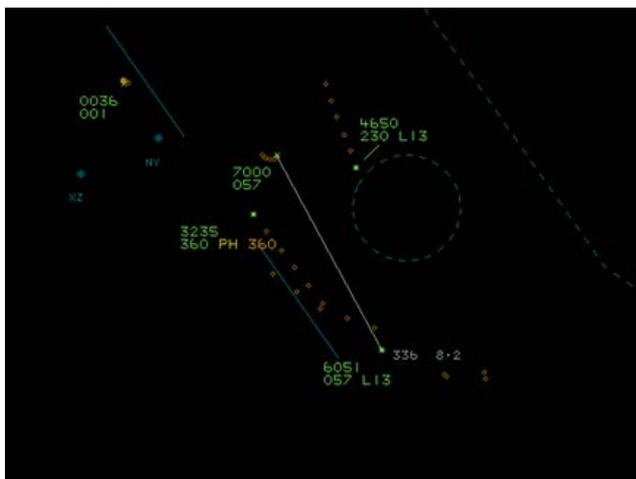
Figure 2: Geometry at 13:41:27
(Typhoon 6051; Microlight 7000)

At 13:41:27 (Figure 2), the Swanwick NE Tac Controller instructed the other aircraft on frequency (SSR 4650) to descend from FL230 to FL170.

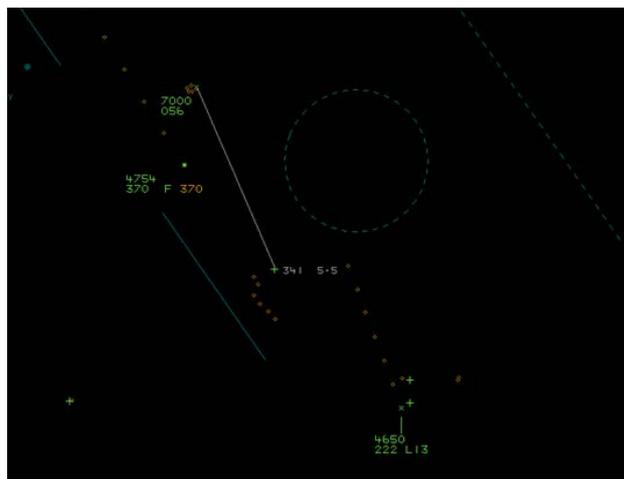
Figure 3: Geometry at 13:43:04

At 13:43:04 (Figure 3), the Typhoon and Microlight were both general handling approximately 5-6nm apart.

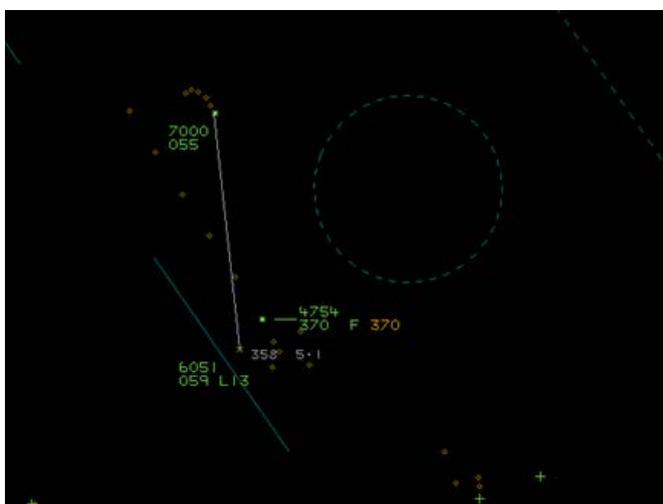
Figure 4: Geometry at 13:43:29
(Typhoon 6051; Microlight 7000)

At 13:43:29 (Figure 4), the Typhoon and Microlight both turned towards each other and began closing distance. At 13:44:07 (Figure 5), the Typhoon and Microlight were at their closest point, with separation of approximately 0.5nm and 300ft.

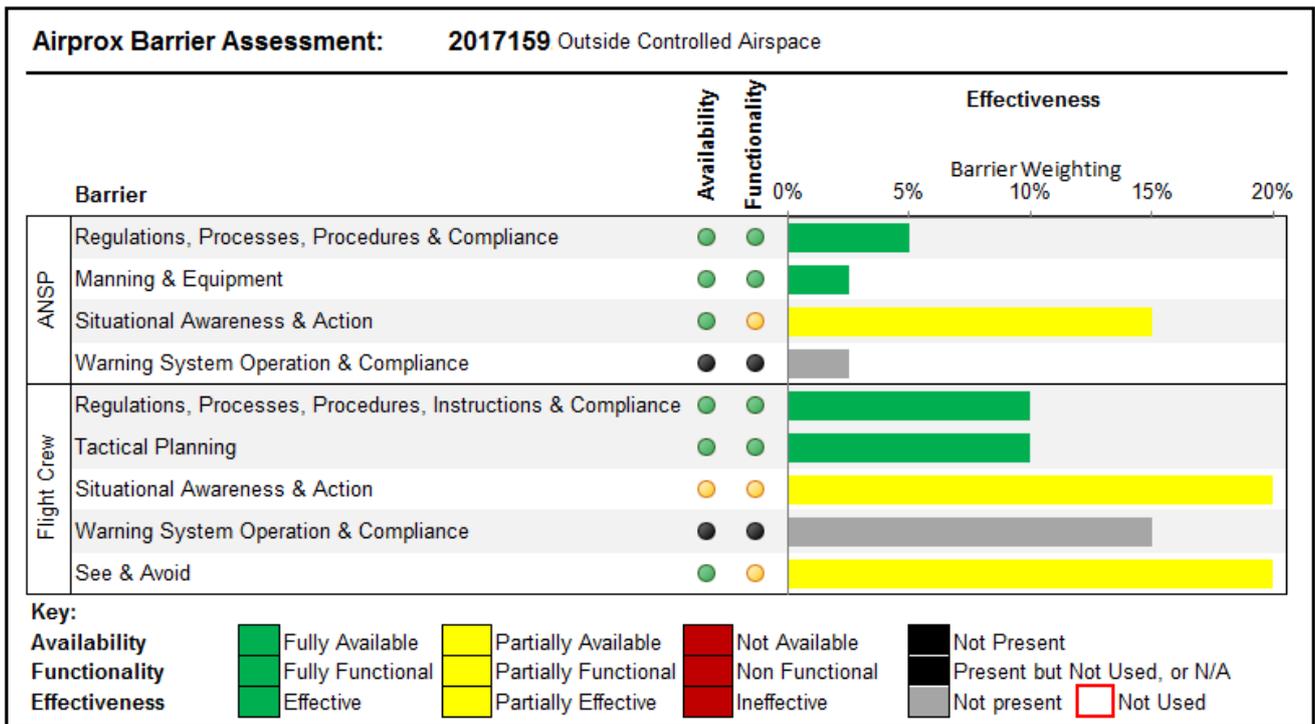
Safety barrier assessment overleaf.

Situational Awareness and Action were assessed as **partially effective** because the controller's workload precluded updated Traffic Information when the Typhoon turned north.

Situational Awareness and Action were assessed as **partially effective** because neither pilot had SA on the other aircraft until visual contact.

See and Avoid were assessed as **partially effective** because the Typhoon pilot saw the microlight at a late stage.
