AIRPROX REPORT No 2017198

Date: 04 Aug 2017 Time: 1412Z Position: 5106N 00148W Location: Overhead Old Sarum aerodrome

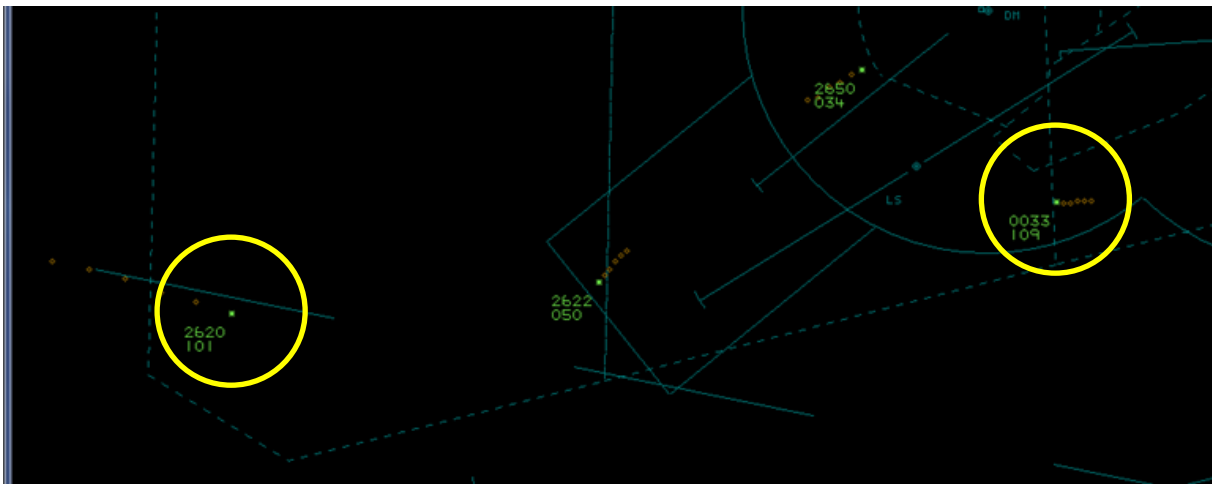
Figure 1: Geometry at 1409:17 (C208 0033; Hawk 2620)

At 1409:17 (Figure 1), the Boscombe Radar controller passed Traffic Information to the Hawk pilot on traffic 5nm east, indicating FL50. At the same time, the C208 pilot reported 2 mins to drop at Old Sarum.

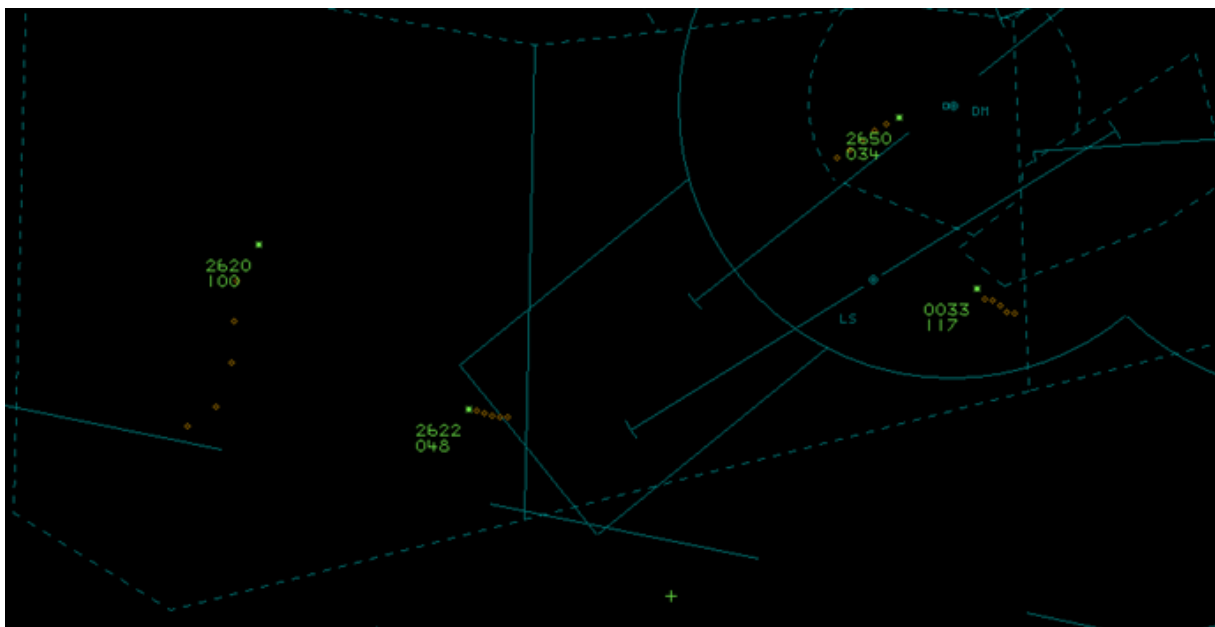
Figure 2: Geometry at 1409:59 (C208 0033; Hawk 2620)

At 1409:59 (Figure 2), the Hawk pilot stated that he would be ready for recovery in one minute, having been told that Netheravon traffic was holding on the ground to facilitate his TACAN approach.

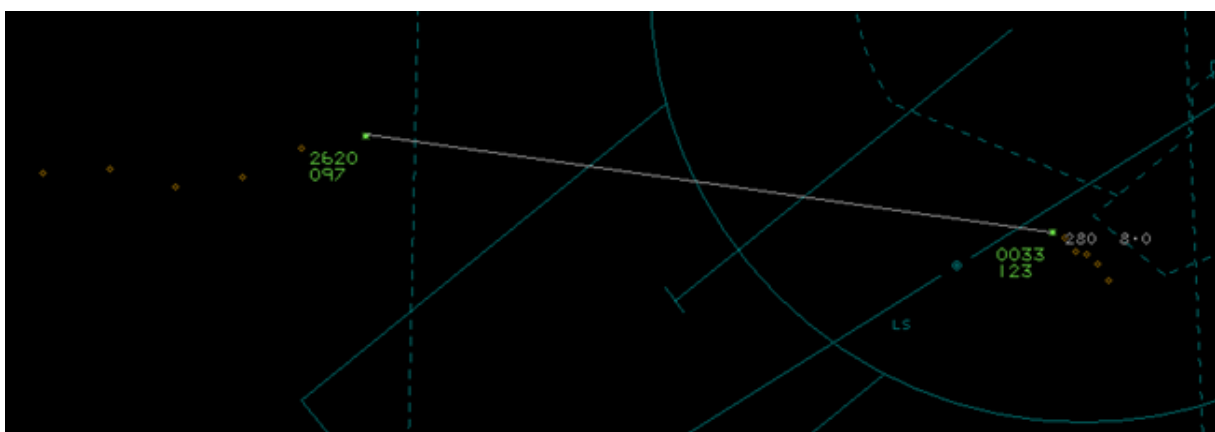
Figure 3: Geometry at 1410:39 (C208 0033; Hawk 2620)

At 1410:39 (Figure 3), the Hawk pilot stated that he was still one minute to recovery.

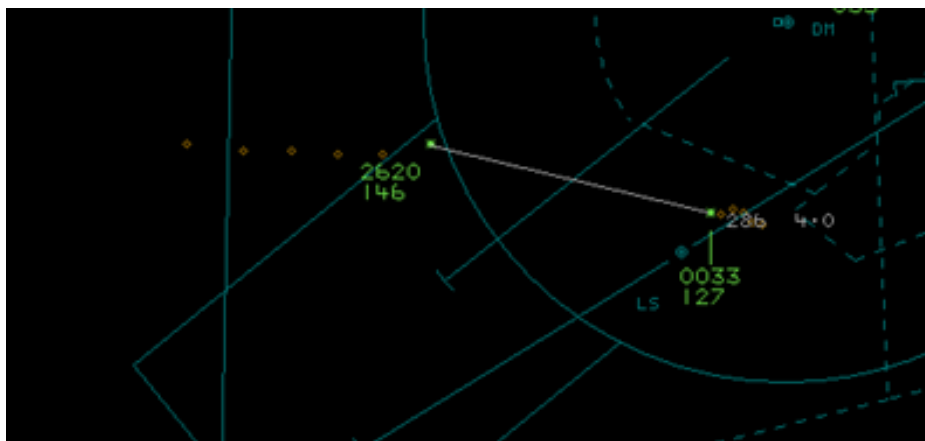
Figure 4: Geometry at 1411:09 (C208 0033; Hawk 2620)

At 1411:09 (Figure 4), the Boscombe Radar Controller passed Traffic Information to the Hawk pilot on the C208 as “traffic southeast, 3nm, manoeuvring, FL130 climbing, para-dropper Old Sarum”. The Hawk pilot acknowledged but did not say whether he was visual with the traffic.

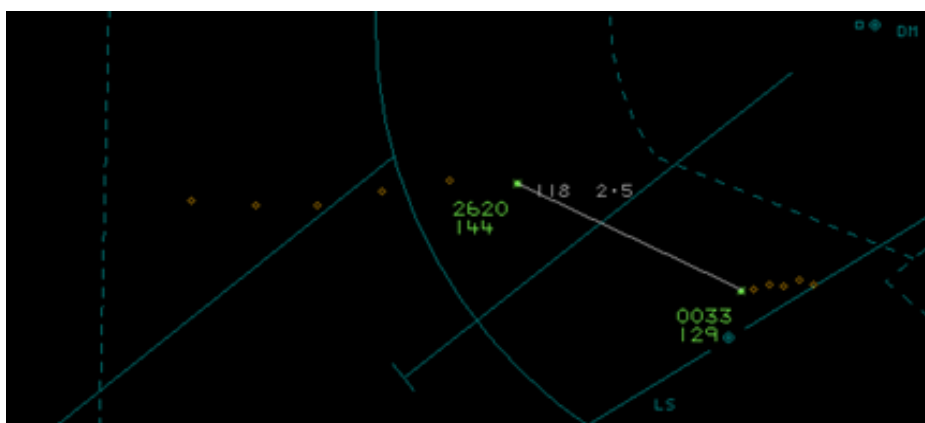
Figure 5: Geometry at 1411:23 (C208 0033; Hawk 2620)

At 1411:23 (Figure 5), the Boscombe Zone/LARS Controller passed Traffic Information to the C208 pilot as “traffic north, half a mile, manoeuvring, indicating FL140, Hawk”. The C208 pilot reported visual with the Hawk. At the same time, the Boscombe Radar Controller passed Traffic Information to the Hawk pilot as “para now south east, err 1nm, FL130 Climbing”. The Hawk pilot responded that they were complete in that area and would head west for a TACAN recovery, but did not call visual with the C208.

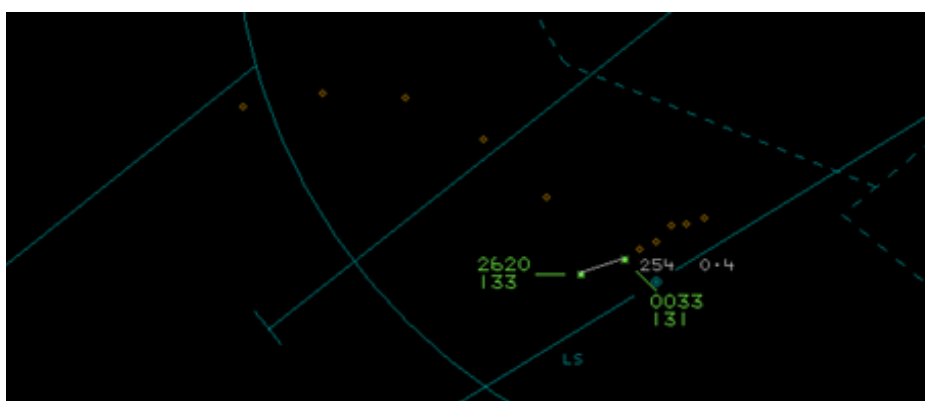
Figure 6: Geometry at 1411:37 (C208 0033; Hawk 2620)

At 1411:37 (Figure 6), the two aircraft were at CPA, with 0.4nm lateral separation and 200ft vertical separation. One sweep later, the Hawk was at FL130 and the C208 at FL132 with a lateral separation of 0.8nm
