**AIRPROX REPORT No 2017221**

Date: 08 Sep 2017 Time: 1822Z Position: 5303N 00137W Location: Carsington Water

**PART A: SUMMARY OF INFORMATION REPORTED TO UKAB**

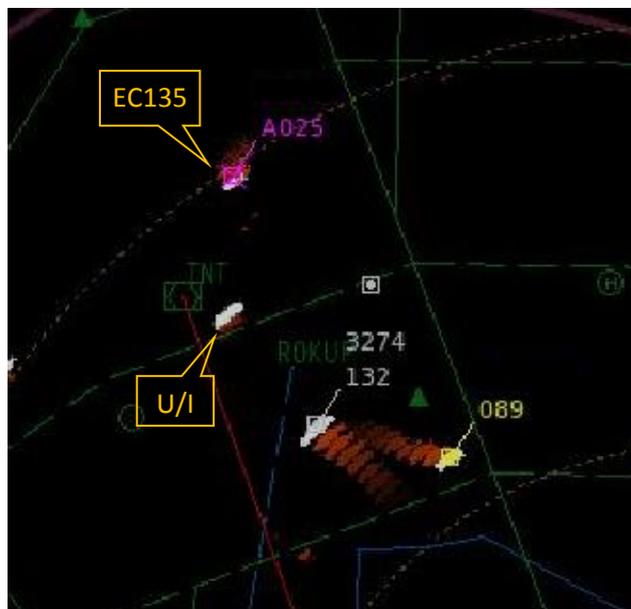
Figure 1 – 1820:00

Figure 1 shows the situation at 1820:00 when the EC135 first contacted the East Midlands radar controller.

The primary contact believed to be the microlight had been a strong but intermittent contact, and had generally been maintaining a north-northwesterly track south of Carsington Water. After their initial call at 1820:00, the EC135 pilot confirmed that they were en-route for Birmingham at 2500ft, and requested a Basic Service. The controller confirmed the Basic Service, and, although they then requested the pilot to squawk ident, they did not advise the pilot that they were identified.

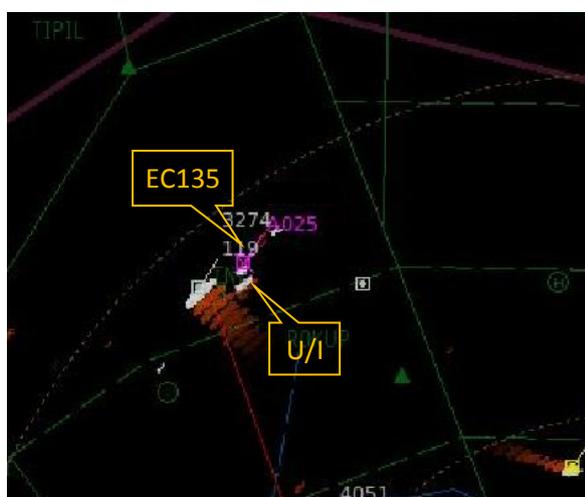
Figure 2 – 1820:57

Figures 2 and 3 illustrate the situation as it continued to develop, with Figure 3 showing the situation just prior to both radar contacts merging. CPA could not be illustrated using the East Midlands radar replay because both primary radar contacts disappeared when they merged fully at approximately 1821:11. Figure 4 shows the situation shortly after CPA.

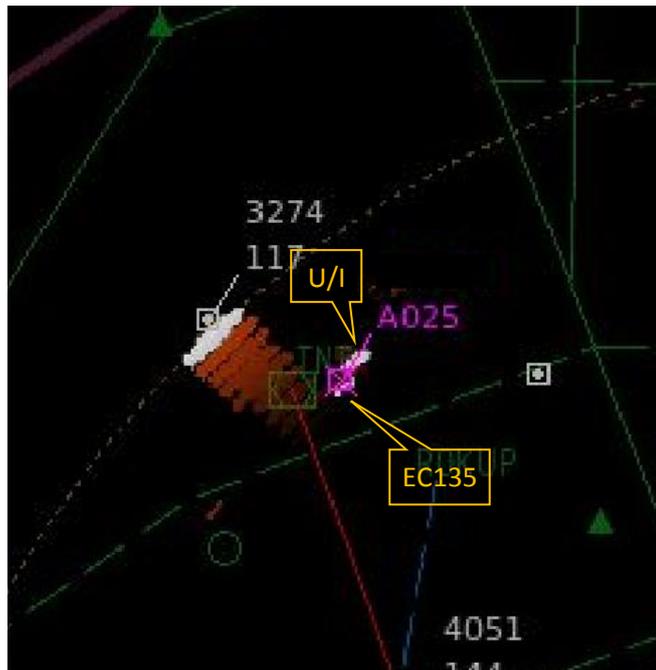
Figure 4 – 1821:18

The EC135 pilot reported seeing the microlight already in a turn, which they assumed was to avoid them, and therefore did not deem it necessary to take any avoiding action of their own. No report was received from the second aircraft, which was not in communication with East Midlands Radar.

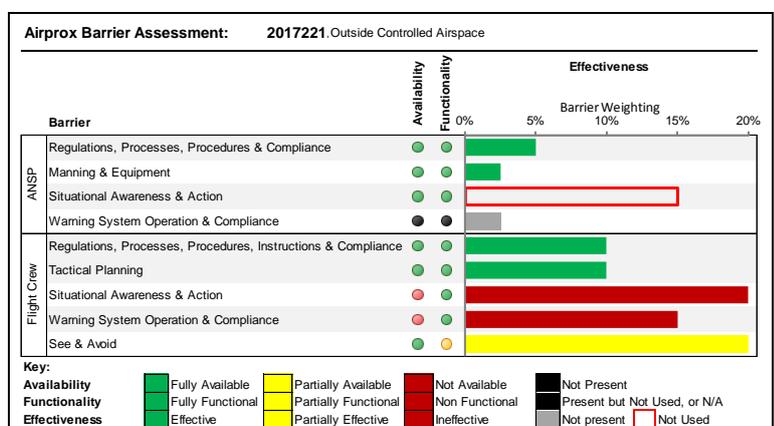
**Situational Awareness and Action** were assessed as **ineffective** because the EC135 pilot did not receive any information, either from ATC or from his CWS, about the microlight before he saw it.

**Warning System Operation and Compliance** were assessed as **ineffective** because the EC135's TCAS could not detect the non-transponding microlight.

**See and Avoid** were assessed as **partially effective** because the EC135 pilot saw the microlight later than desirable.
