AIRPROX REPORT No 2017237

Date: 03 Oct 2017 Time: 1143Z Position: 5142N 00034W Location: 1.5nm SW Bovingdon VOR

PART A: SUMMARY OF INFORMATION REPORTED TO UKAB

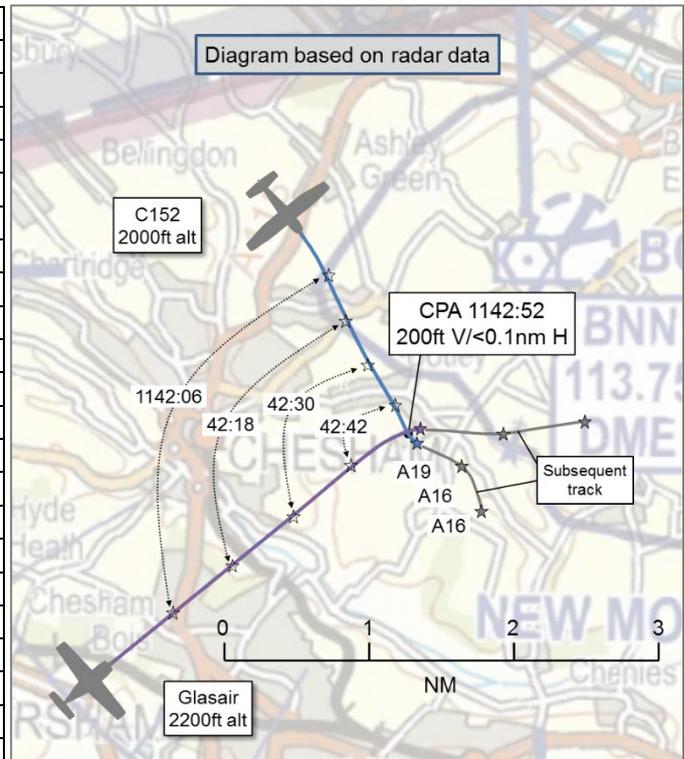
THE C152 PILOT reports instructing a navigation sortie, on recovery to Denham, when he saw a white, low-wing, single-engine aircraft on the right, in a shallow descent, at a range of 20-30ft. He immediately took control and made a steep descending left turn.

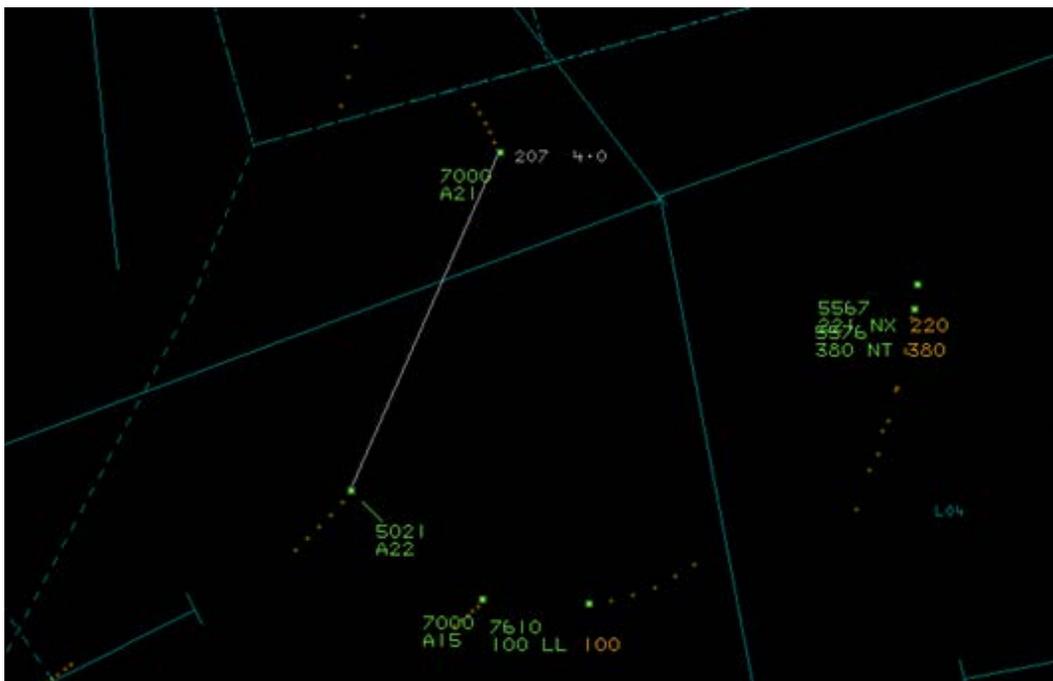
Figure 1: Geometry at 11:41:44

was under control of Farnborough LARS. Radar replays using NATS radars showed the C152 change from a Brize Norton SSR code to 7000 at 11:41:44 (Figure 1).

Although the exact time that the C152 pilot left the Brize LARS frequency is not known, the C152 pilot changed from a Brize LARS SSR code to 7000 with 4nm separation from the Glasair. Under a BS, there was no requirement for the Brize LARS Controller to pass Traffic Information to the C152 pilot in this situation and, due to the combination of the aircraft's range from Brize and its altitude, it is unlikely to have been visible on the Controller's radar screen at the time.

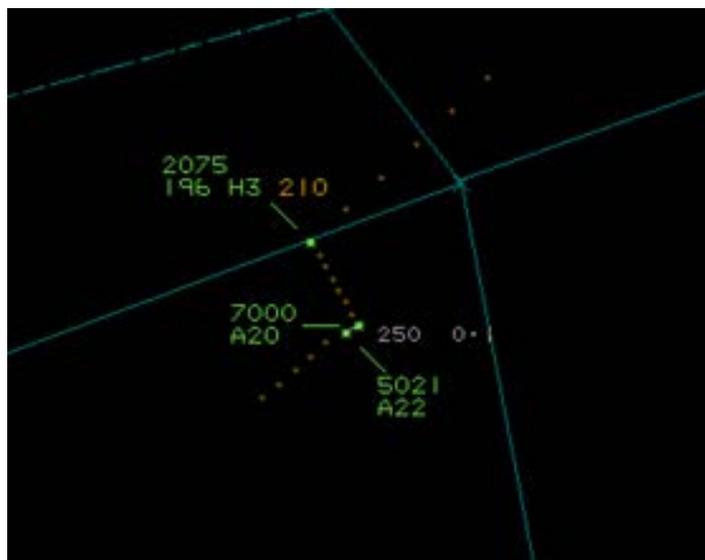
Figure 2: Geometry at 11:42:52

At 11:42:51 (Figure 2), the C152 and Glasair passed at their closest point.

The incident geometry was converging and the C152 pilot was required to give way to the Glasair¹, although *both* pilots shared an *equal* responsibility for collision avoidance and not to operate in such proximity to other aircraft as to create a collision hazard². It was established from radar replay that the Glasair pilot turned right at CPA and then left on to a heading of about 080°.

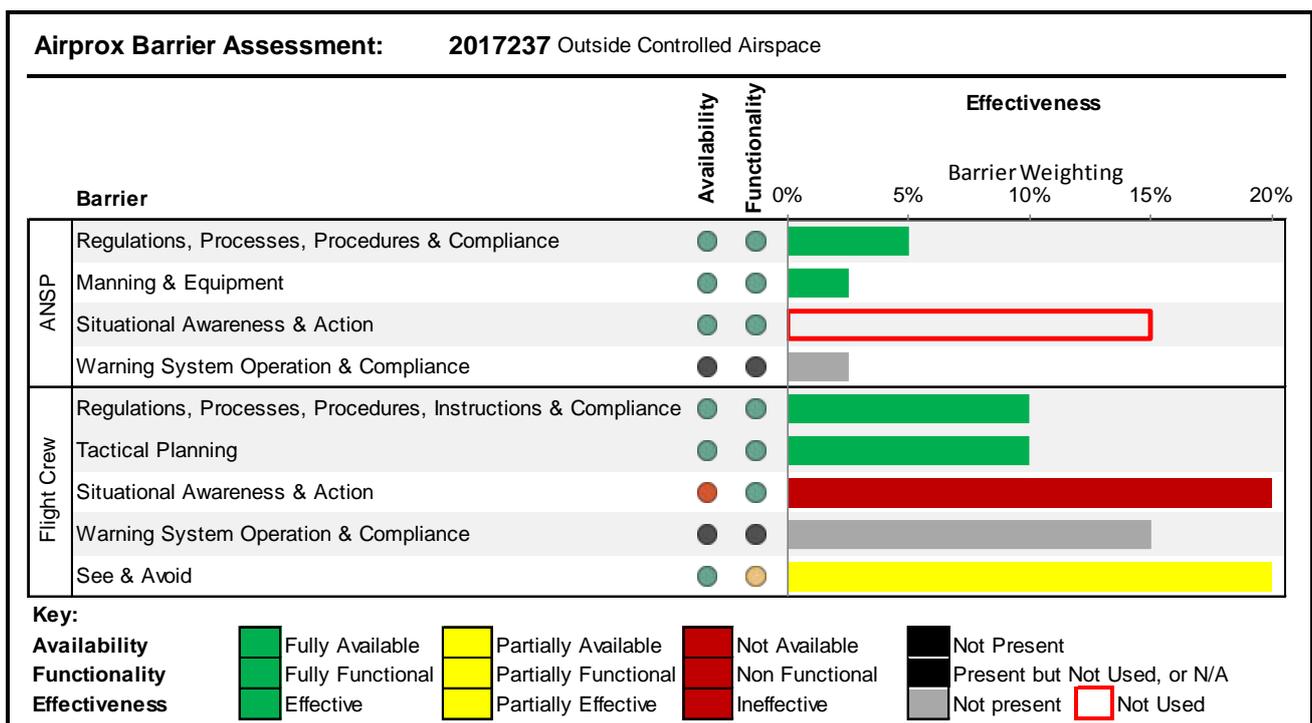
Situational Awareness and Action were assessed as **not used** because the Farnborough LARS(N) controller was not required to monitor the Glasair under a Basic Service.

Situational Awareness and Action were assessed as **ineffective** because at least one pilot (and probably both it seemed) was not aware of the presence of the other aircraft, which resulted in a low degree of separation at CPA.

See and Avoid were assessed as **partially effective** because the C152 pilot was able to take emergency avoiding action.
