AIRPROX REPORT No 2017253

Date: 24 Oct 2017 Time: 1349Z Position: 5703N 00248W Location: ivo Aboyne

PART A: SUMMARY OF INFORMATION REPORTED TO UKAB

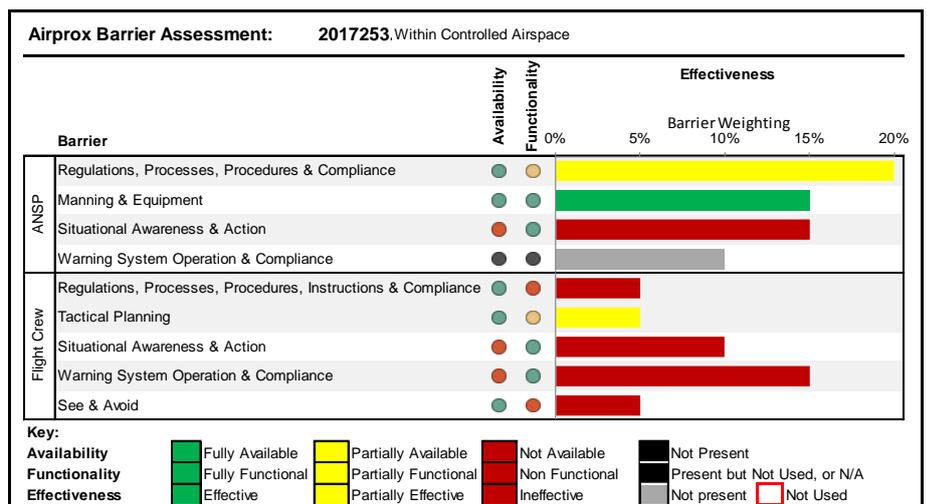
In assessing the effectiveness of the safety barriers associated with this incident, the Board concluded that the key factors had been that:

Regulations, Processes, Procedures and Compliance were assessed as **partially effective** because the DHC8 was routed closer to the western edge of the Aberdeen CTA than recommended in CAP493.

Situational Awareness and Action were assessed as **ineffective** because the Aberdeen surveillance system did not detect the glider within the Aberdeen CTA and hence the controllers were unaware of its presence.

Regulations, Processes, Procedures and Compliance were assessed as **ineffective** because the available information suggests the ASK13 pilot inadvertently flew into CAS.

Tactical Planning was assessed as **partially effective** because the ASK13 pilot’s navigation plan did not ensure that he remained outside of controlled airspace.

Situational Awareness and Action were assessed as **ineffective** because neither pilot was aware of the other aircraft prior to CPA.

Warning System Operation and Compliance were assessed as **ineffective** because the ASK13 was not fitted with any systems compatible with the DHC8’s TCAS II.

See and Avoid were assessed as **ineffective** because the DHC8 crew did not see the ASK13 until CPA, and the ASK13 pilot did not see the DHC8 at all.
