AIRPROX REPORT No 2017261

Date: 01 Nov 2017 Time: 1608Z Position: 5101N 00115W Location: Southampton CTA/CTR

PART A: SUMMARY OF INFORMATION REPORTED TO UKAB

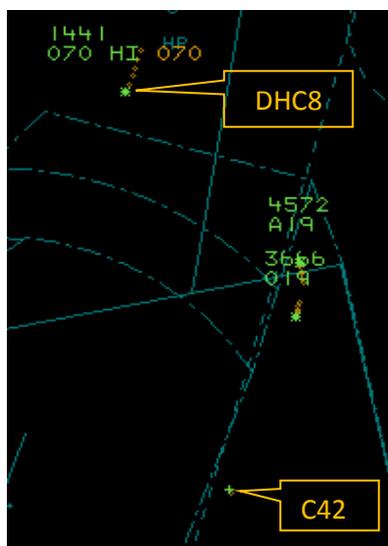
Figure 1 - 1605:39

The DHC8 pilot made initial R/T contact with Solent Radar at 1601:30 and was advised to expect vectors for the ILS RW20, left-hand. The pilot was then given heading and descent instructions to position for the ILS. The primary-only radar contact was not visible at this time. At 1605:39, the primary radar contact re-appeared on the eastern edge of the CTR (Figure 1).

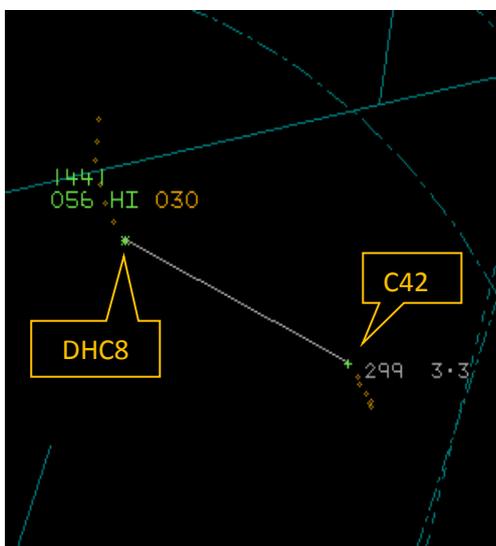
Figure 2 - 1607:43

At 1607:43, the controller instructed the DHC8 pilot to turn left heading 090° and descend to altitude 3000ft (Figure 2). The controller then turned his attention to other inbound, transiting and free-calling pilots.

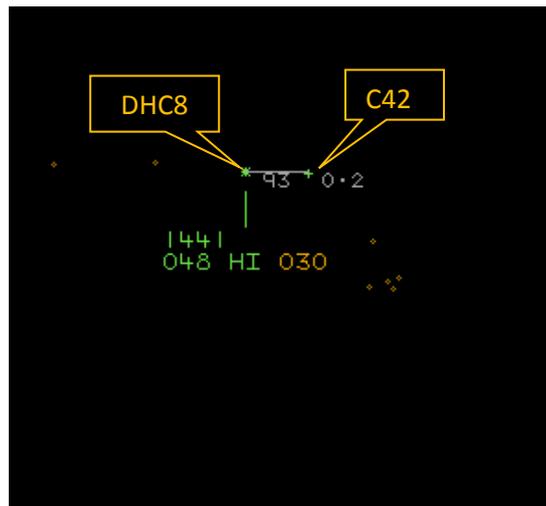
Figure 3 – 1608:28

CPA occurred at 1608:28 with the aircraft separated laterally by 0.2nm (Figure 3).

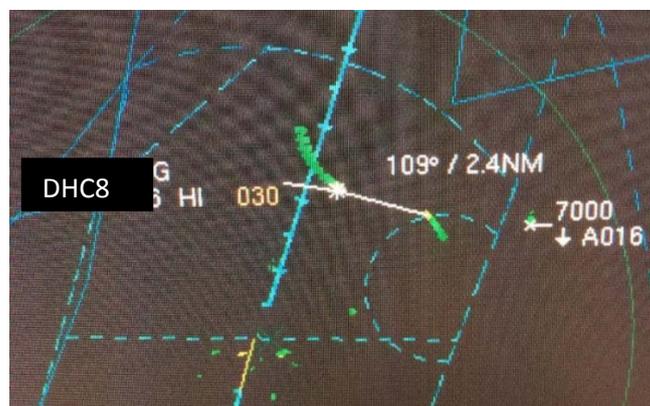
Figure 4 - 1607:54

16:07:54 (Figure 4): Primary contact leaves the confines of the Bishops Waltham flying area tracking North West bearing 052 degrees at 5.3NM from SAM and 2.4NM from [DHC8 C/S] on converging tracks. On the ATCO's screen the [DHC8 C/S] label obscures the view of the primary contact.

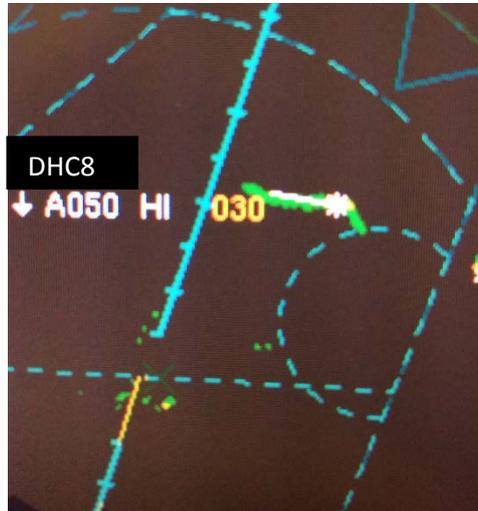
Figure 5 - 1608:24

16:08:24 (Figure 5): Radar contacts of [DHC8 C/S] and infringing aircraft merge at this point.
