**AIRPROX REPORT No 2017263**

Date: 06 Nov 2017 Time: 1109Z Position: 5234N 00027E Location: 5nm W Marham

**PART A: SUMMARY OF INFORMATION REPORTED TO UKAB**

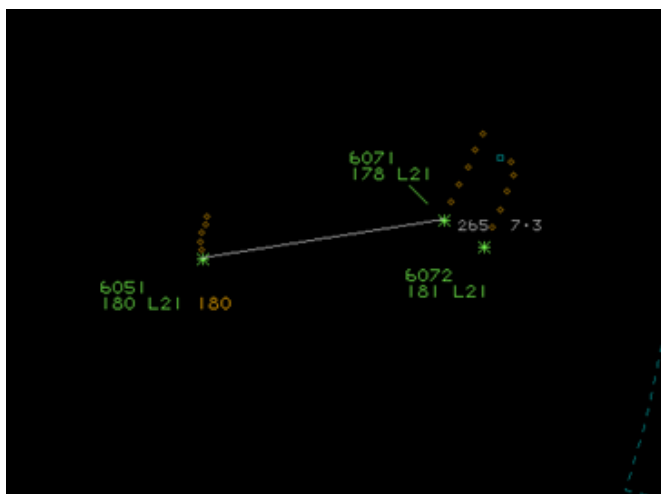
Figure 1: Geometry at 1106:48

At 1106:48 (Figure 1), having split the pair into separate elements for General Handling, the controller instructed the F15 pilots to operate in the block 6000-24000ft (RPS 29.97 inches = 1015hPa). The F15 pilots were operating on UHF and the B350 pilot was operating on VHF with the same controller.

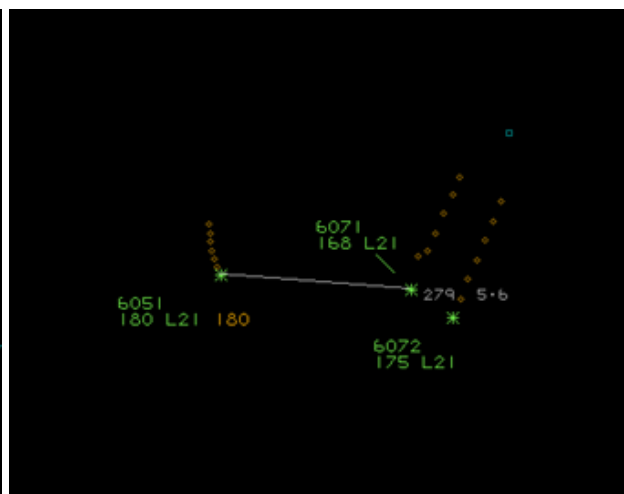
Figure 2: Geometry at 1107:07.

[6051-B350; 6071/6072-F15s.]

At 1107:07 (Figure 2), the controller first passed Traffic Information to the F15 pilots on the B350, describing its position as “west, 5nm, tracking south east, currently at FL180”. The lead F15 pilot acknowledged the Traffic Information but did not report visual with the traffic.

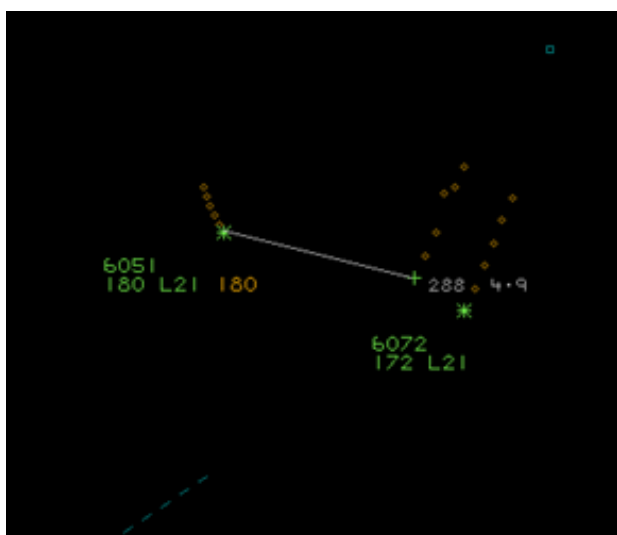
Figure 3: Geometry at 1107:17.

At 1107:17 (Figure 3), the controller passed Traffic Information to the B350 pilot on the F15s as “east, 5nm, tracking south west, currently at FL170, in the block 6000 to 24000ft, pair of F15s”. The B350 pilot acknowledged the Traffic Information but did not report visual with the traffic.

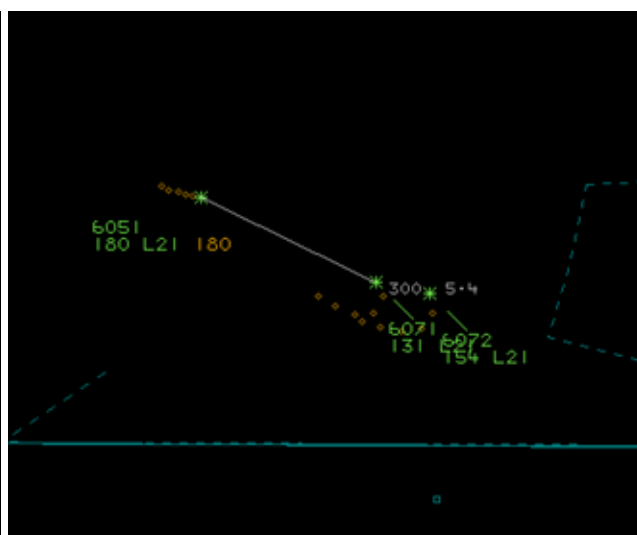
Figure 4: Geometry at 1108:01.

At 1108:01 (Figure 4), the controller asked the B350 pilot, who was still operating on VHF, if he could accept a UHF frequency. The pilot asked the controller to standby and then responded that he could accept UHF.

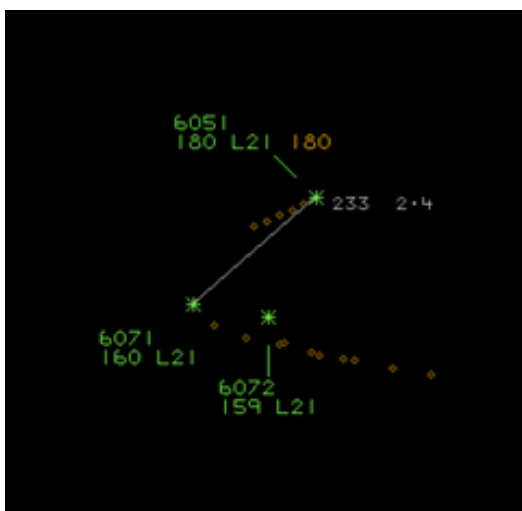
Figure 5: Geometry at 1108:40.

At 1108:40 (Figure 5), the controller instructed the B350 pilot to change frequency from VHF to UHF.

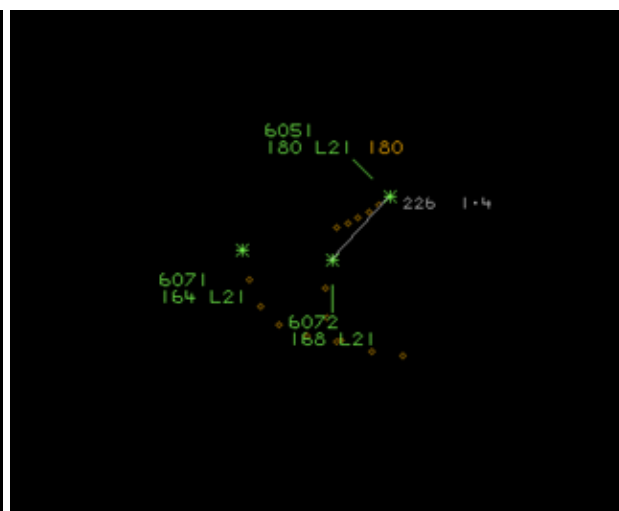
Figure 6: Geometry at 1108:50.

At 1108:50 (Figure 6), the controller passed Traffic Information to the F15 pilots as “west, 3nm, tracking north east at FL180, Beech 350”. The lead F15 pilot responded that he was searching. At the time, the B350 was actually to the north-east of the F15s, not west as described.

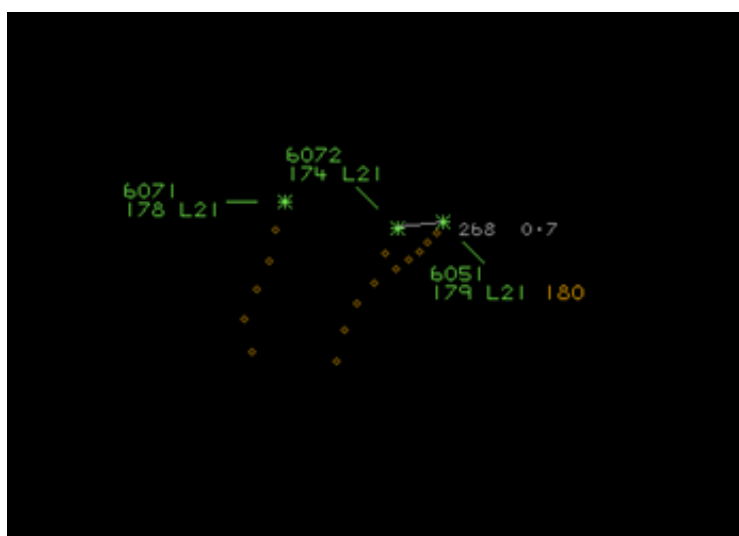
Figure 7: Geometry at 1109:06.

At 1109:06 (Figure 7), the B350 pilot transmitted on UHF that he had just had a TCAS RA. At that time there was approximately 0.7nm horizontal and 500ft vertical separation between the B350 and the second F15.

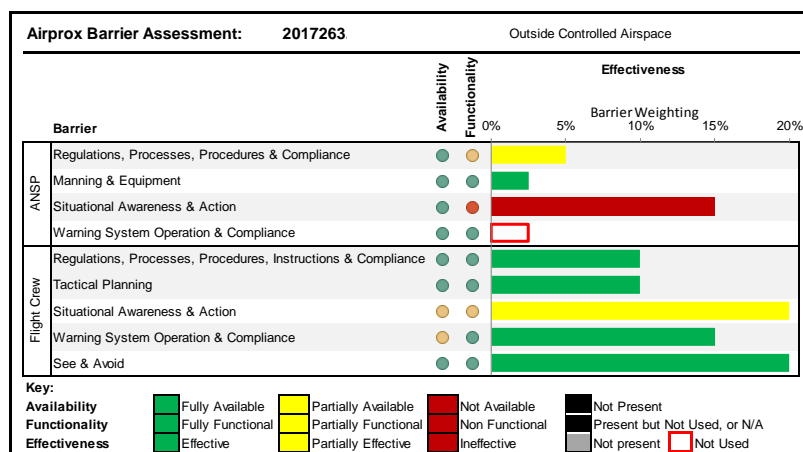
**Regulations, Processes, Procedures and Compliance** were assessed as **partially effective** because the Swanwick Tac Left controller inadvisably instructed the B350 pilot to change frequency when in close proximity to the F15s and before Traffic Information was updated.

**Situational Awareness and Action** were assessed as **ineffective** because the Tac Left controller passed erroneous Traffic Information to the F15 pilots.

**Situational Awareness and Action** were assessed as **partially effective** because of the incorrect azimuth Traffic Information issued to the F15 pilots.

**Warning System Operation and Compliance** were assessed as **partially available** because only the B350 was equipped with an electronic warning system.
