AIRPROX REPORT No 2018017

Date: 04 Feb 2018 Time: 1600Z Position: 5117N 00146W Location: Upavon Glider Site

PART A: SUMMARY OF INFORMATION REPORTED TO UKAB

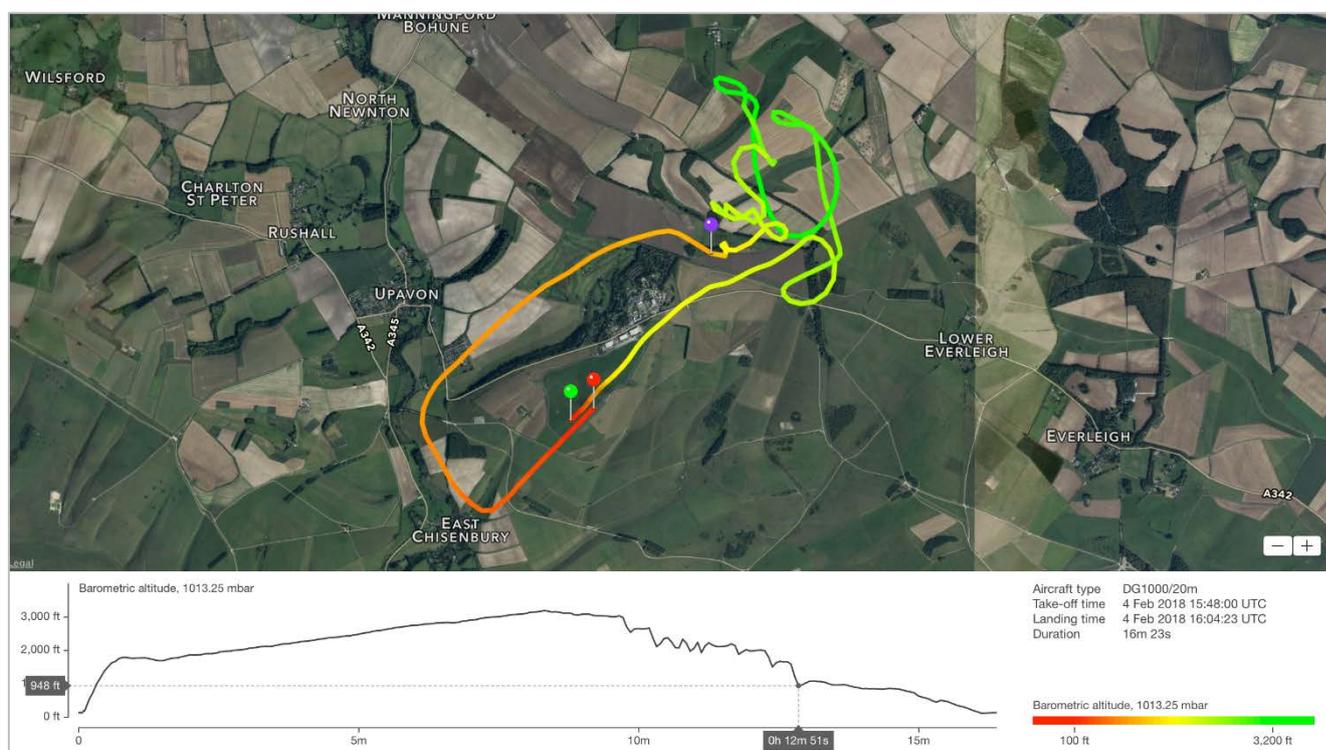
Figure 1: DG1000 IGC file

The DG1000 pilot provided a copy of his IGC FLARM logger file but there is no record of the Viking glider's flight. Neither glider appears on radar for a period close to the Airprox, therefore the time, position and altitude of the CPA cannot be verified.

1. The final spin exercise was conducted 1.1km upwind of the peritrack where the winches were located, the other exercises were further away up to 2.6km and not as stated in the DASOR 'at the top of the winch launch'. Also, the exercises were conducted well away from the Upavon FOB sterile area.
2. The low point of the exercise was 1327ft (1013mb) which is 813ft above airfield elevation, and above the circuit height.
3. The crew of the Viking indicates they identified the DG1000 manoeuvring when they completed the winch launch. For the 2 aircraft to have been in close proximity the Viking crew must have flown towards the previously identified manoeuvring aircraft for approximately 1km. The separation in the opinion of the DG1000 pilot was that he was well over the 50m stated in the DASOR.

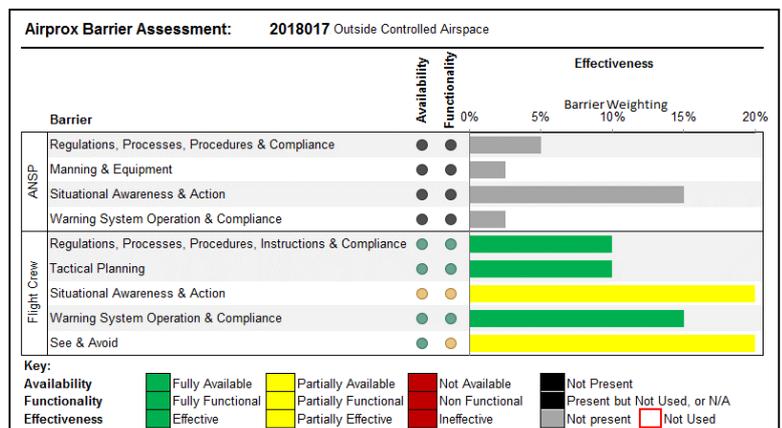
Situational Awareness and Action were assessed as **partially effective** because the Viking pilot saw the DG1000 spinning but did not ensure they were sufficiently separated in the event the DG1000 pilot carried out an unexpected manoeuvre.

See and Avoid were assessed as **partially effective** because the DG1000 pilot did not see the Viking.
