AIRPROX REPORT No 2018066

Date: 03 May 2018 Time: 1358Z Position: 5104N 00036W Location: 3.5nm SW Dunsfold

PART A: SUMMARY OF INFORMATION REPORTED TO UKAB

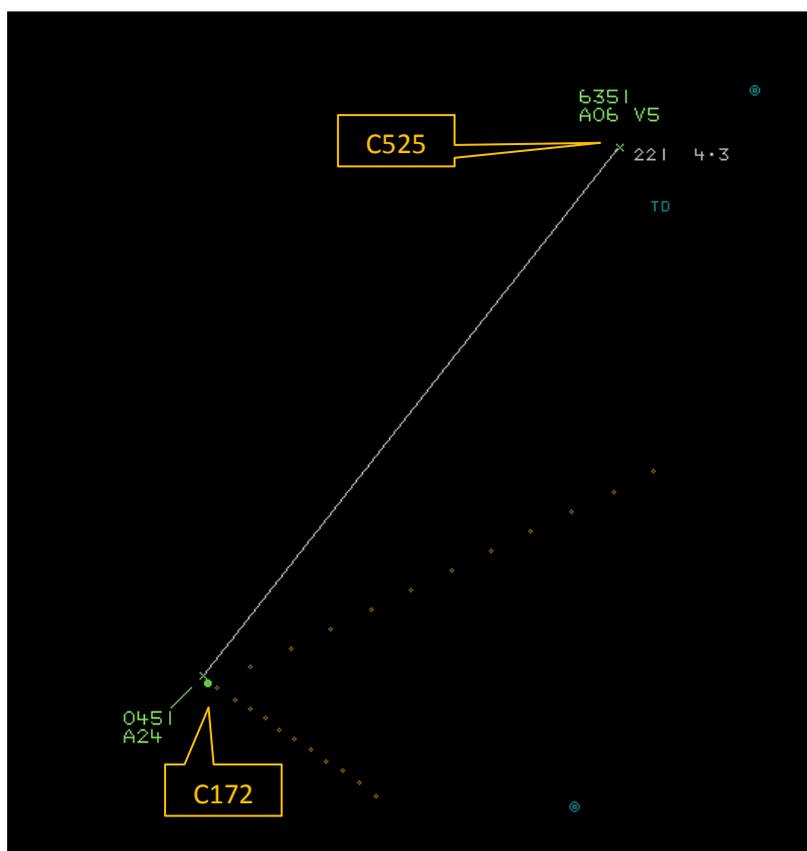
Figure 1 – 1357:34

The C525 was first visible on radar at 1357:34 (Figure 1), and the C525 pilot established communications with Farnborough Radar at 1357:45. The controller instructed the pilot to squawk code ident, passed the QNH 1019hPa, and asked what type of service was required outside of controlled airspace. The pilot read back the QNH correctly and requested a Basic Service.

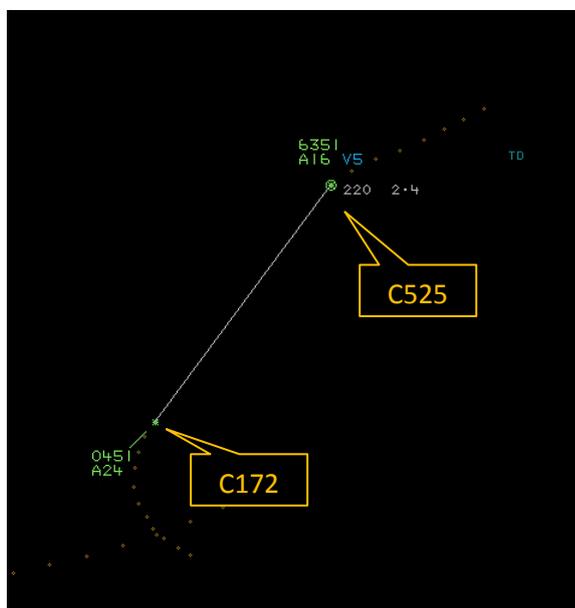
Figure 2 - 1358:05

At 1358:05, the Farnborough Radar controller identified the C525 and requested the aircraft's passing level. The controller then passed Traffic Information on the C172 advising it was manoeuvring to the south west, 700ft above (Figure 2). The pilot reported that they had the C172 on TCAS and they were passing 1900ft to level at 2300ft. The controller asked if they were routing to Goodwood.

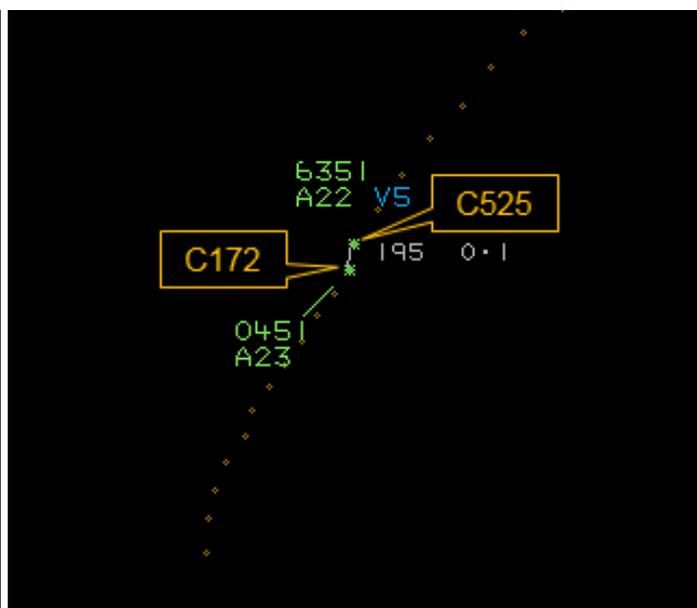
Figure 3 – 1358:30

CPA occurred at 1358:30 (Figure 3) and the radar indicated that the aircraft were separated by 0.1nm and 100ft.

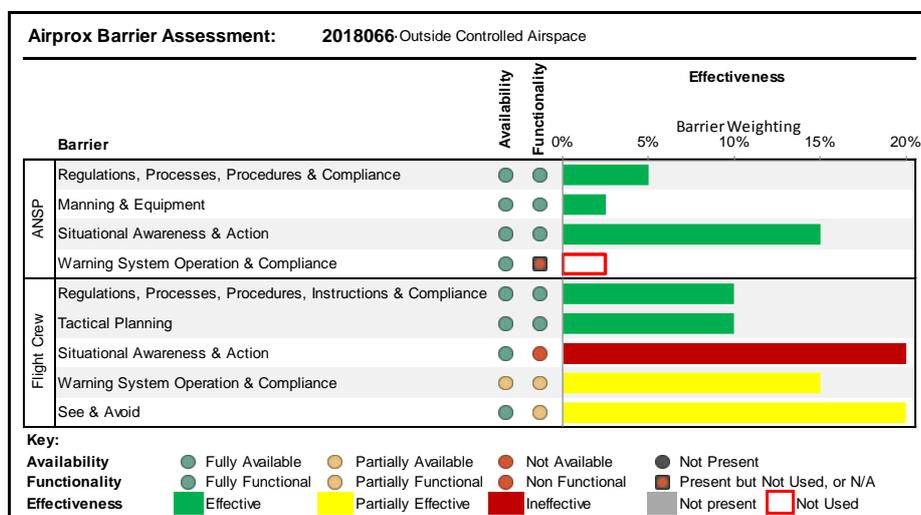
Warning System Operation and Compliance were assessed as **not used**, Farnborough were equipped with warning systems but they were not usable in the Class G environment due to numerous alarms and alerts being generated in normal operations.

Situational Awareness and Action were assessed as **ineffective** because the C525 pilot had Traffic Information but didn't act upon it, and the C172 did not have any information about the C525.

Warning System Operation and Compliance were assessed as **partially effective** because despite receiving a TA, the C525 pilot did not fully act upon it.

See and Avoid were assessed as **partially effective** because both pilots took last-minute avoiding action.
