AIRPROX REPORT No 2018103

Date: 01 Jun 2018 Time: 0959Z Position: 5121N 00048W Location: 6nm N Farnborough

PART A: SUMMARY OF INFORMATION REPORTED TO UKAB

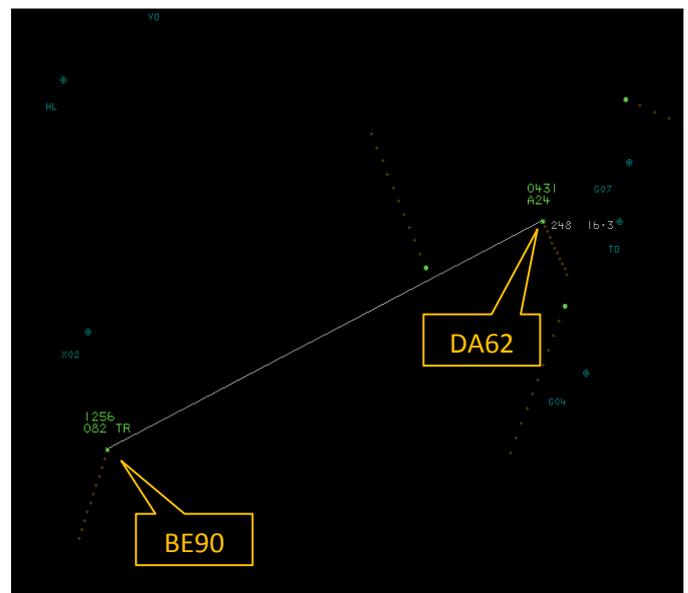
Figure 1 – 0946:43.

The BE90 pilot established communication with the controller at 0946:43 (Figure 1), descending to 4000ft routing direct to ROVUS. The controller issued the QNH and instructed the pilot to descend to 3400ft. The pilot read back the instruction and QNH correctly.

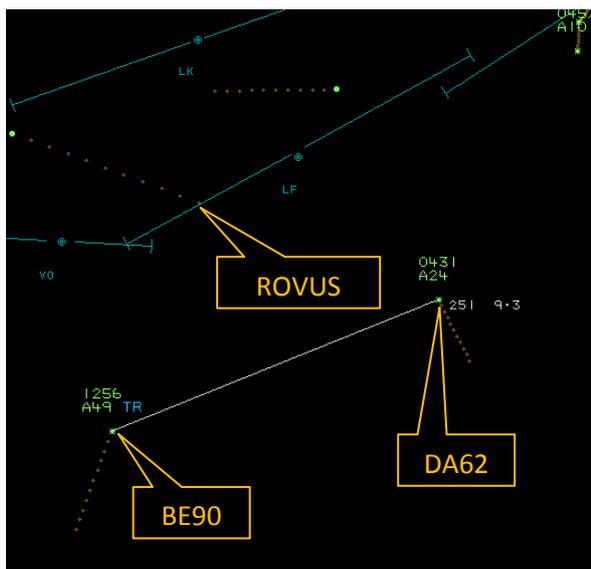
Figure 2 – 0955:01

At 0955:01 (Figure 2), the controller asked the BE90 pilot if there were happy to route from ROVUS to Elstree under their own navigation which the pilot stated that they were.

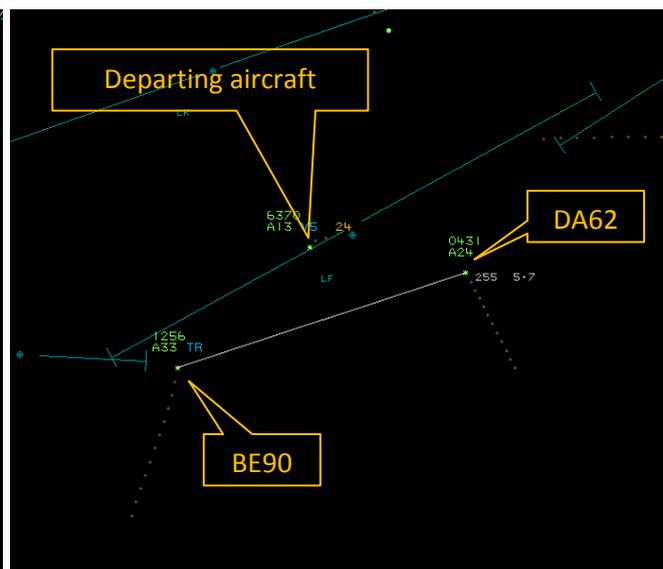
Figure 3 – 0956:15

At 0956:15 (Figure 3), the BE90 pilot informed the controller that they were continuing their descent to 2400ft. The controller instructed the pilot to maintain 3400ft and passed Traffic Information on the aircraft departing from Farnborough climbing to 2400ft.

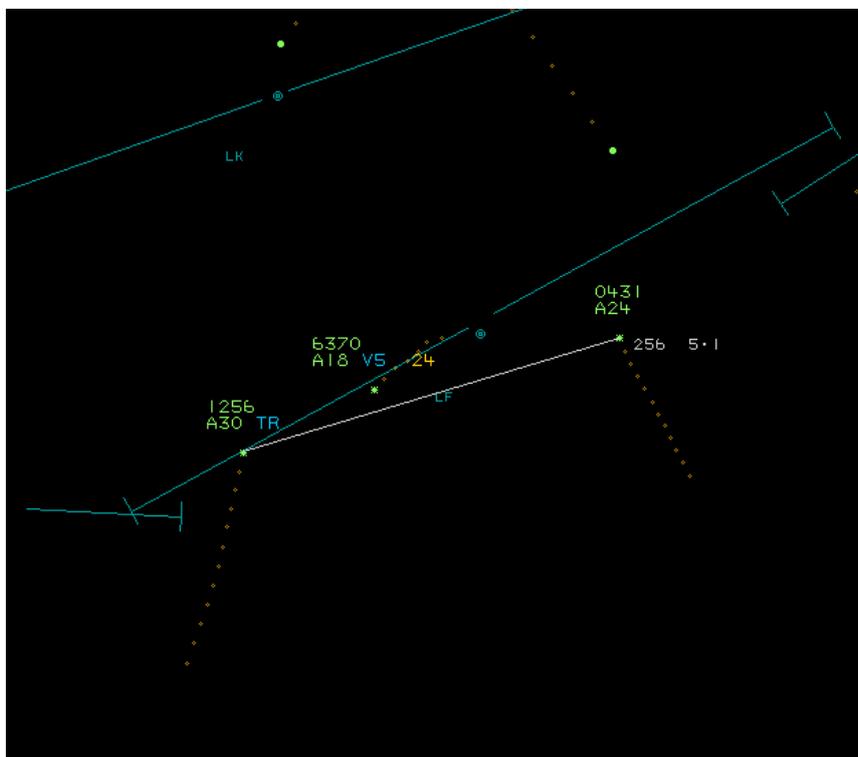
Figure 4 – 0956:30.

At 0956:30 (Figure 4), the pilot of the departing aircraft, displaying SSR code 6370, established communication with the controller, climbing to 2400ft, heading 220°. The BE90 had already descended below 3400ft and the controller issued the departing traffic with avoiding action to turn left heading 160° and passed Traffic Information on the BE90. Once the conflict was resolved, a Deconfliction Service was agreed between the controller and the aircraft displaying 6370.

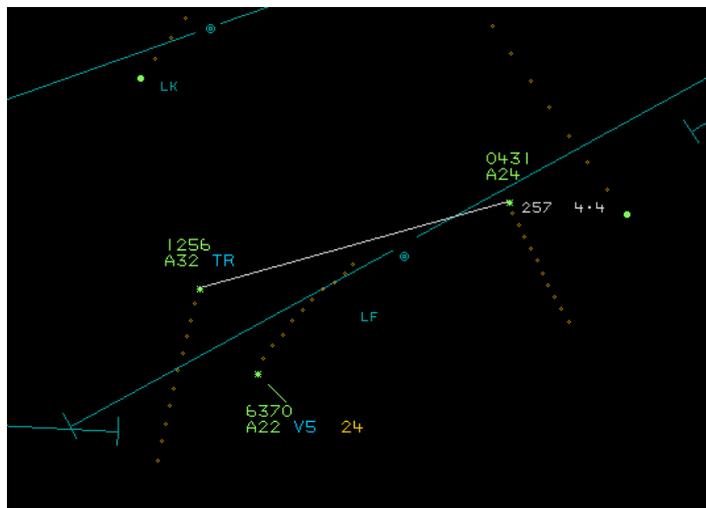
Figure 5 - 0956:53.

At 0956:53 (Figure 5), the controller passed Traffic Information to the DA62 pilot on the BE90. The controller then informed the BE90 pilot that they were now clear of the departing aircraft and passed Traffic Information on the DA62. The controller instructed the BE90 pilot to descend at their discretion. The DA62 pilot stated that they had the BE90 on 'TCAS' and the BE90 pilot copied the traffic and read back the instruction to descend at their discretion.

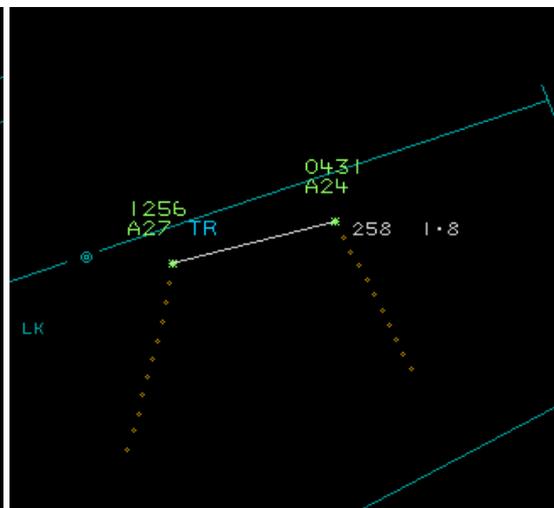
Figure 6 - 0958:01.

At 0958:01 (Figure 6), the DA62 pilot asked what the BE90 was doing because it was heading straight at them. The controller passed further Traffic Information and the DA62 pilot asked if the BE90 was turning. The controller informed the DA62 that the BE90 was tracking north.

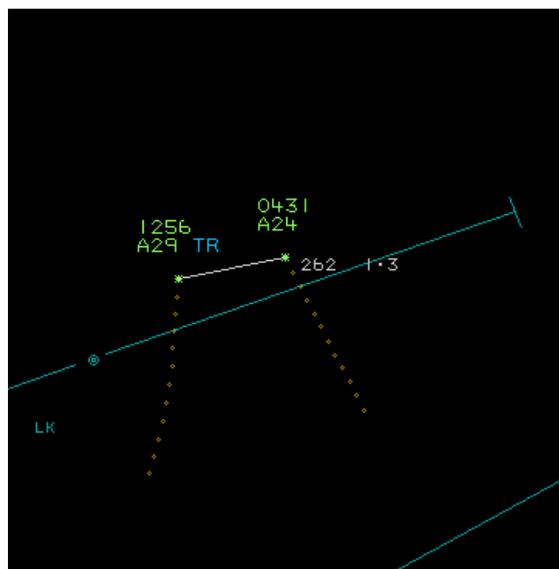
Figure 7 - 0958:18.

At 0958:18 (Figure 7), the controller asked the BE90 pilot if they were visual with the aircraft on their right-hand side. The pilot reported that they were not visual but had the aircraft on TCAS. The controller then warned the BE90 pilot that they were about to infringe the CAS ahead of them by 1.5nm which had a base of 2500ft. The pilot reported that they were descending.

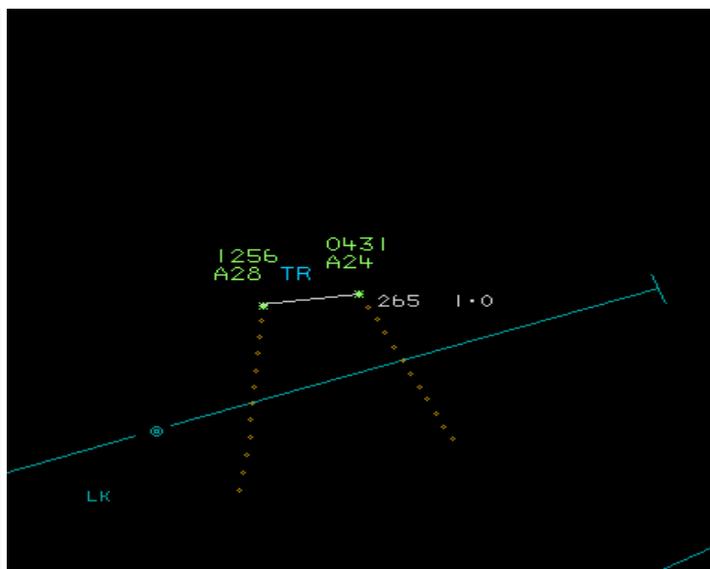
Figure 8 - 0958:30.

At 0958:30 (Figure 8), the DA62 pilot requested an avoiding action turn to the right onto 090° from the controller. The controller approved the turn but reminded the pilot to remain outside CAS. The pilot stated that they were turning right to avoid the other aircraft.

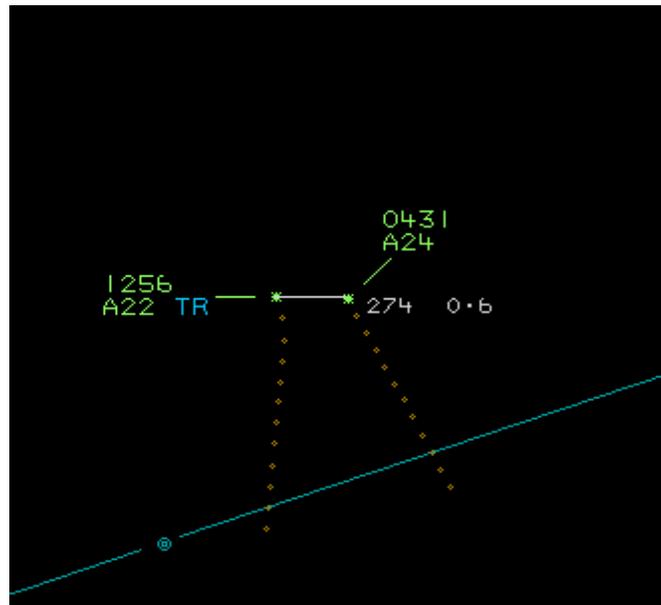
Figure 9 – 0958:46.

CPA occurred at 0958:46 (Figure 9), with the radar indicating 0.6nm horizontally and 200ft vertically between the aircraft. At this point the radar showed the BE90 pilot had initiated a turn to the left.

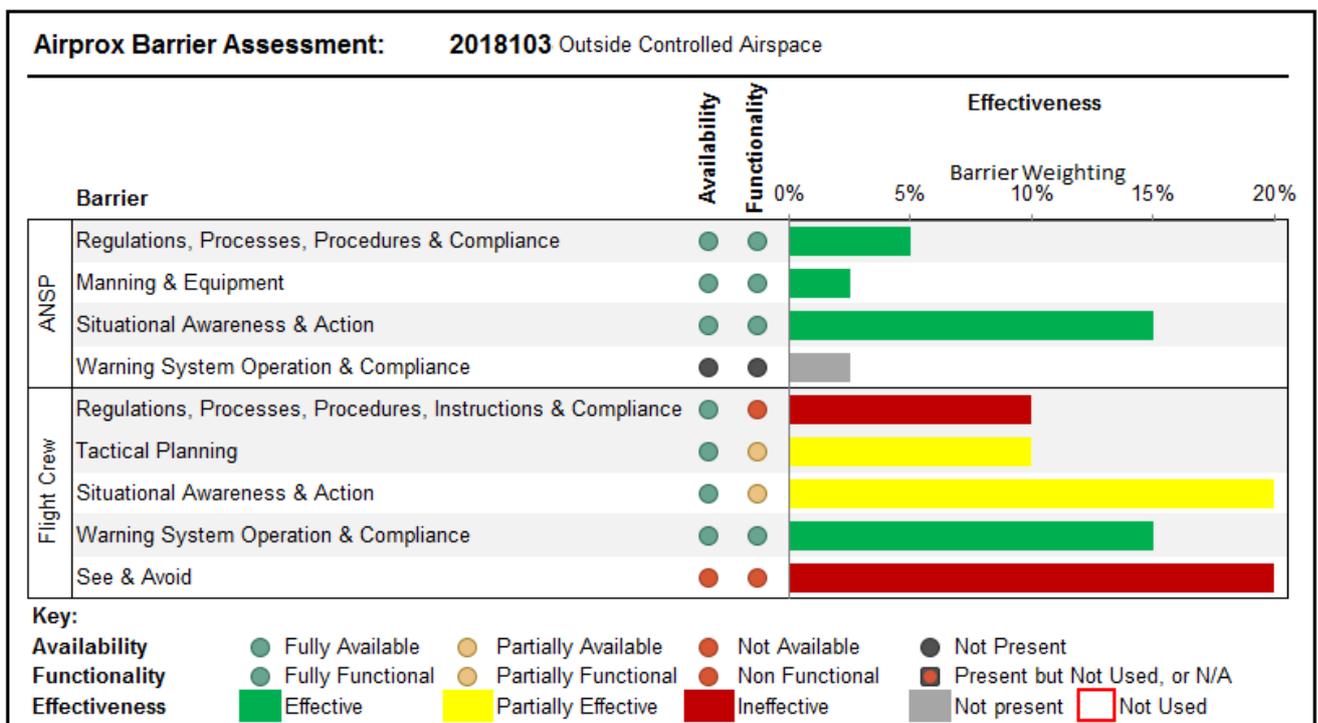
Regulations, Processes, Procedures, Instructions and Compliance were assessed as **ineffective** because the BE90 pilot did not give way to the DA42 sufficiently early.

Tactical Planning was assessed as **partially effective** because the BE90 pilot did not alter his plan in a timely manner to account for the DA42.

Situational Awareness and Action were assessed as **partially effective** because the BE90 pilot did not fully employ the available situational awareness provided by his TCAS and Traffic Information.

See and Avoid were assessed as **ineffective** because both pilots were unable to see the other aircraft because of the weather conditions.
