AIRPROX REPORT No 2018136

Date: 21 Jun 2018 Time: 1502Z Position: 5146N 00116W Location: 6nm N Benson

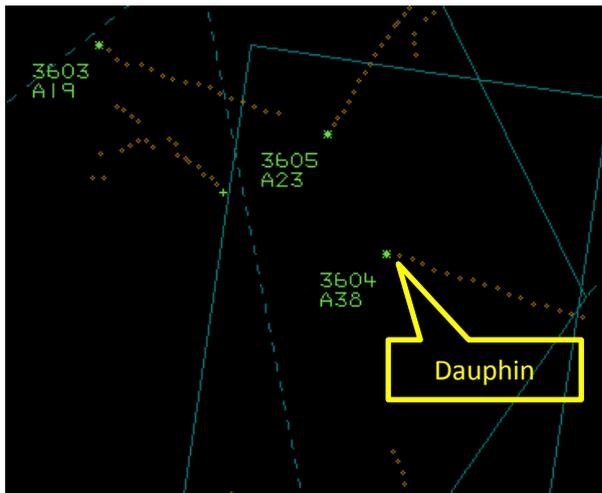
Figure 1: 1502:09
(Dauphin squawking 3604)

The following screen shots were taken using NATS radars, not the radar available to the Benson controller, so not necessarily indicative of what he could see. The Benson controller gave Traffic Information at 1502:09 (Figure 1). Further traffic can be seen in the 1 o'clock, 1.5nm away, which may have been the fixed wing traffic indicting on the Dauphin's TAS. At 1502:24 the Benson controller passed Traffic Information on the fixed wing aircraft. Two primary-only contacts can be seen 1.2nm and 1.7nm to the north-west of the Dauphin. By 1502:47 the closest primary contact had faded from radar, 0.3nm to the south of the Dauphin.

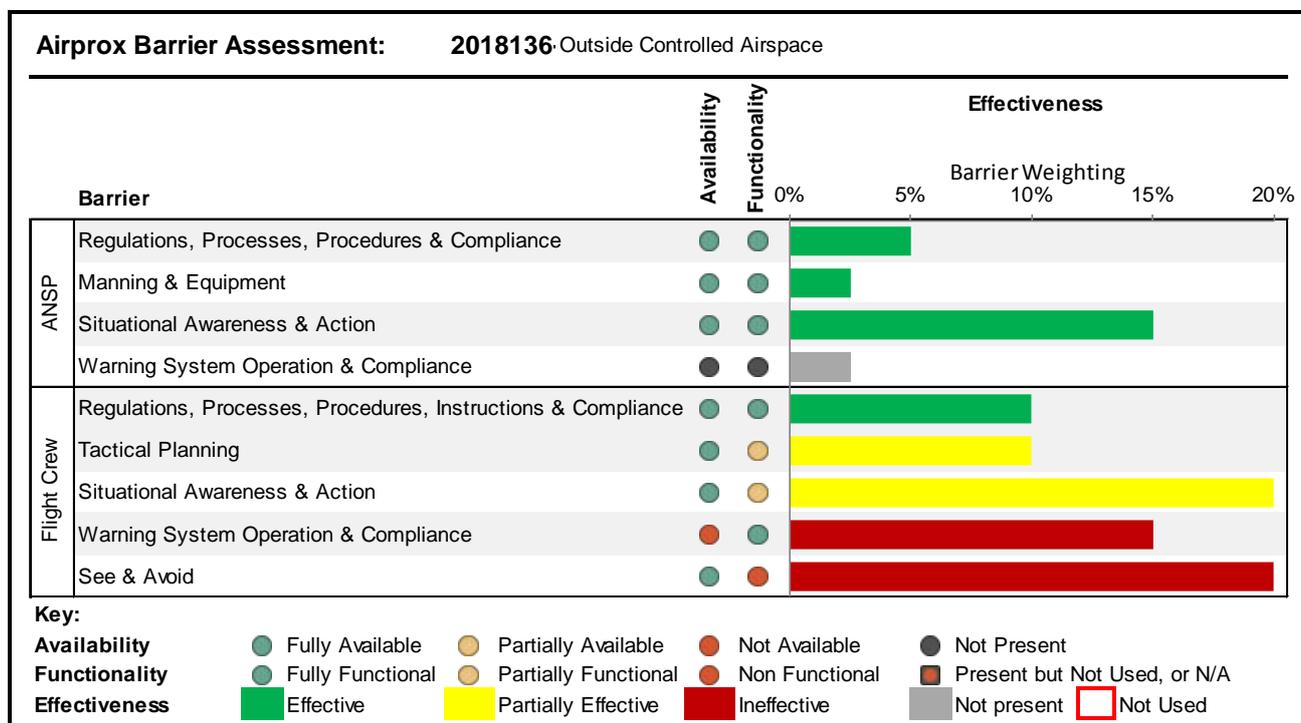
Tactical Planning was assessed as **partially effective** because the Dauphin pilot was not aware of the gliding competition NOTAM.

Situational Awareness and Action were assessed as **partially effective** because although the Dauphin pilot was given Traffic Information by the controller, he did not fully assimilate that there were two aircraft being called and focused on the fixed-wing contact showing on his TAS.

Warning System Operation and Compliance were assessed as **ineffective** because the Dauphin TAS could not detect the glider.

See and Avoid were assessed as **ineffective** because no avoiding action was taken by the Dauphin due to the very late sighting. It may have been that the glider pilot saw the Dauphin and avoided but this could not be formally assessed.
