## AIRPROX REPORT No 2018142

Date: 22 Jun 2018 Time: 1135Z Position: 5132N 00303W Location: Thirlmere

### PART A: SUMMARY OF INFORMATION REPORTED TO UKAB

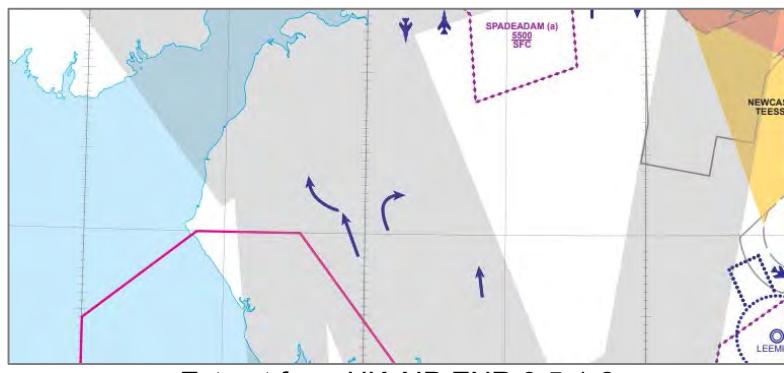
Extract from UK AIP ENR 6-5-1-2

The flow-arrows depicted on military low-flying charts are not depicted on CAA VFR charts and there is no requirement for civilian pilots to observe the associated military regulations.

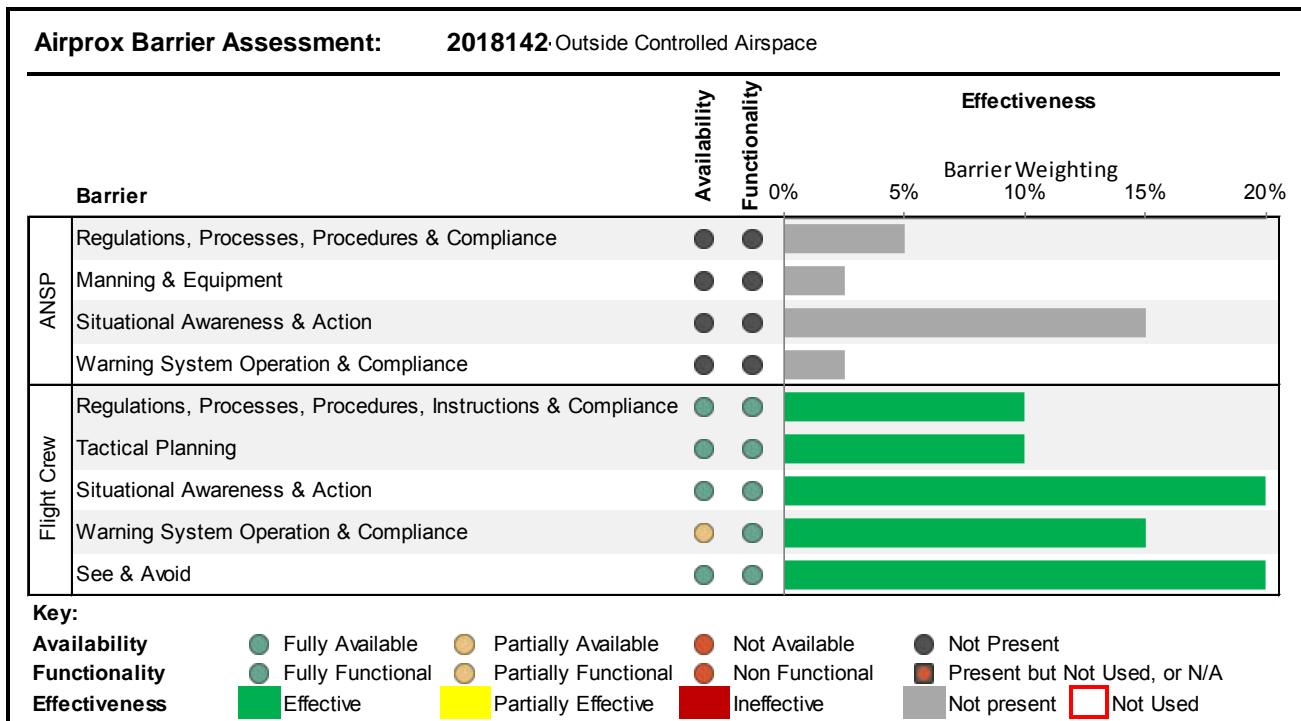
The Board considered that all relevant safety barriers had been fully effective, albeit the availability of collision warning systems in the unknown light-aircraft could not be determined and so could not be graded as ‘fully available’ for that reason.
