## AIRPROX REPORT No 2018147

Date: 23 Jun 2018 Time: 1146Z Position: 5147N 00107E Location: Clacton airfield

### PART A: SUMMARY OF INFORMATION REPORTED TO UKAB

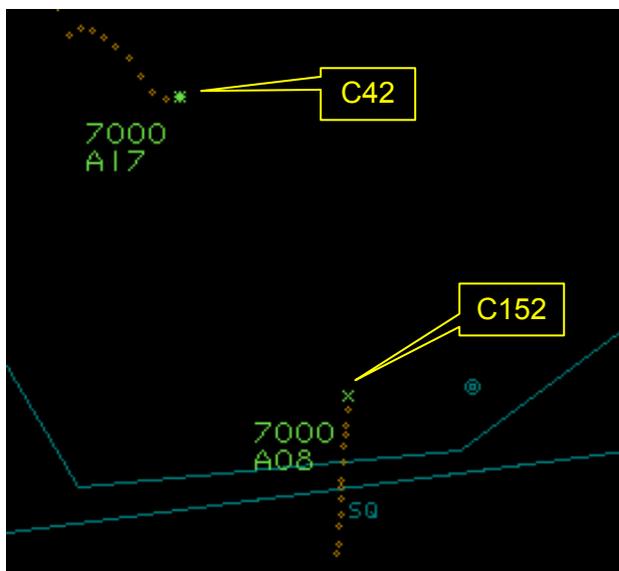
Figure 1: 1144:26

The following radar screen shots were taken from the NATS radars. At Figure 1, the C152 is established in the circuit and the C42 is approaching from the north-west. Figure 2 shows the C152 northbound, as reported by the C42 pilot; the C42 joins the circuit and can be seen making a tight circuit (Figure 3). The closest that the two aircraft appear on the radar is at 1146:33 when they are 400ft and 0.2nm apart, after which the C42 fades from radar followed shortly afterwards by the C152. It is likely that actual separation is much closer than this as the two aircraft continue on finals, but the minimum separation is not known.

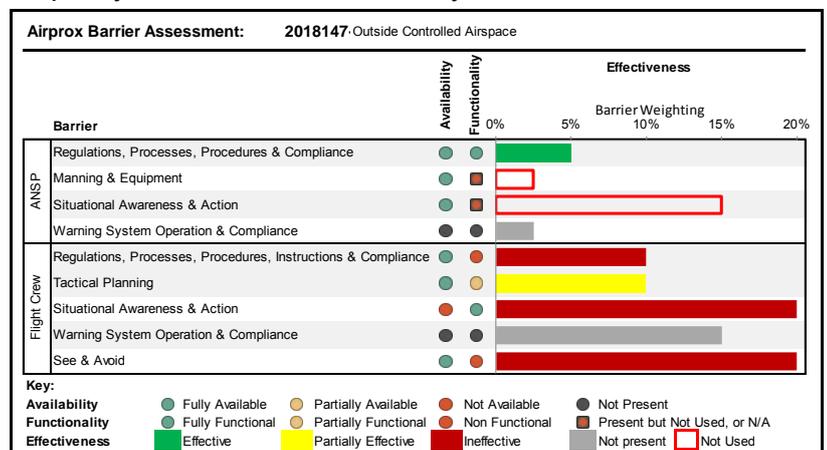
**Manning and Equipment** were assessed as **not used** because although Clacton sometimes provides AGCS, at the time of the Airprox the radio was not being manned.

**Situational Awareness and Action** were assessed as **not used** because there was no-one available to provide situational awareness to the pilots.

**Regulations, Processes, Procedures, Instructions and Compliance** were assessed as **ineffective** because the C42 pilot did not integrate with the C152 in the visual circuit.

**Tactical Planning** was assessed as **partially effective** because the C42 pilot flew a non-standard, tight visual circuit which likely sapped his capacity to also lookout effectively.

**Situational Awareness and Action** were assessed as **ineffective** because neither pilot was aware of the presence of the other in the circuit.

**See and Avoid** were assessed as **ineffective** because neither pilot was able to take any avoiding action, it was fortuitous that the C42 went around due to his height and speed.
