**AIRPROX REPORT No 2018158**

Date: 29 Jun 2018 Time: 1502Z Position: 5325N 00312W Location: 5nm NW Liverpool Airport

**PART A: SUMMARY OF INFORMATION REPORTED TO UKAB**

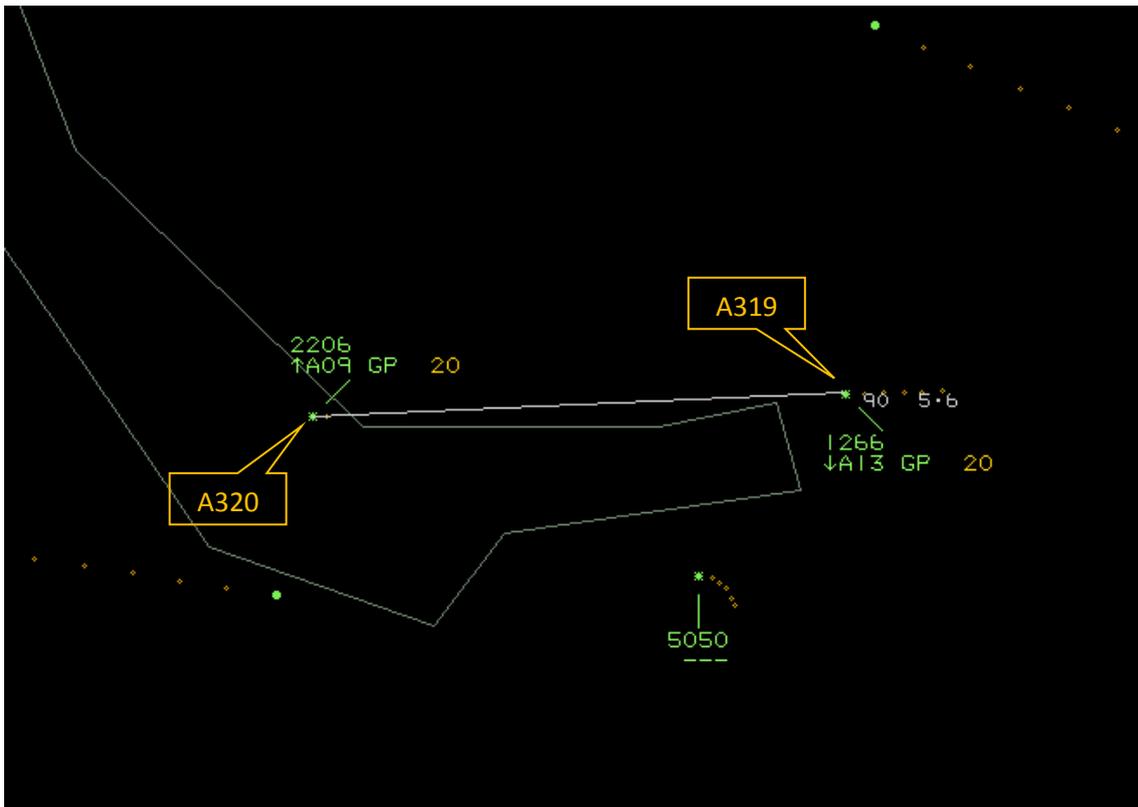
Figure 1 – 1458:20.

At 1458:02 the A320 pilot reported to the Liverpool Aerodrome controller that they were conducting a missed approach after attempting to land on RW27. At 1458:20 (Figure 1), the Aerodrome controller instructed the A320 pilot to fly a heading of 270° and to climb to an altitude of 2500ft.

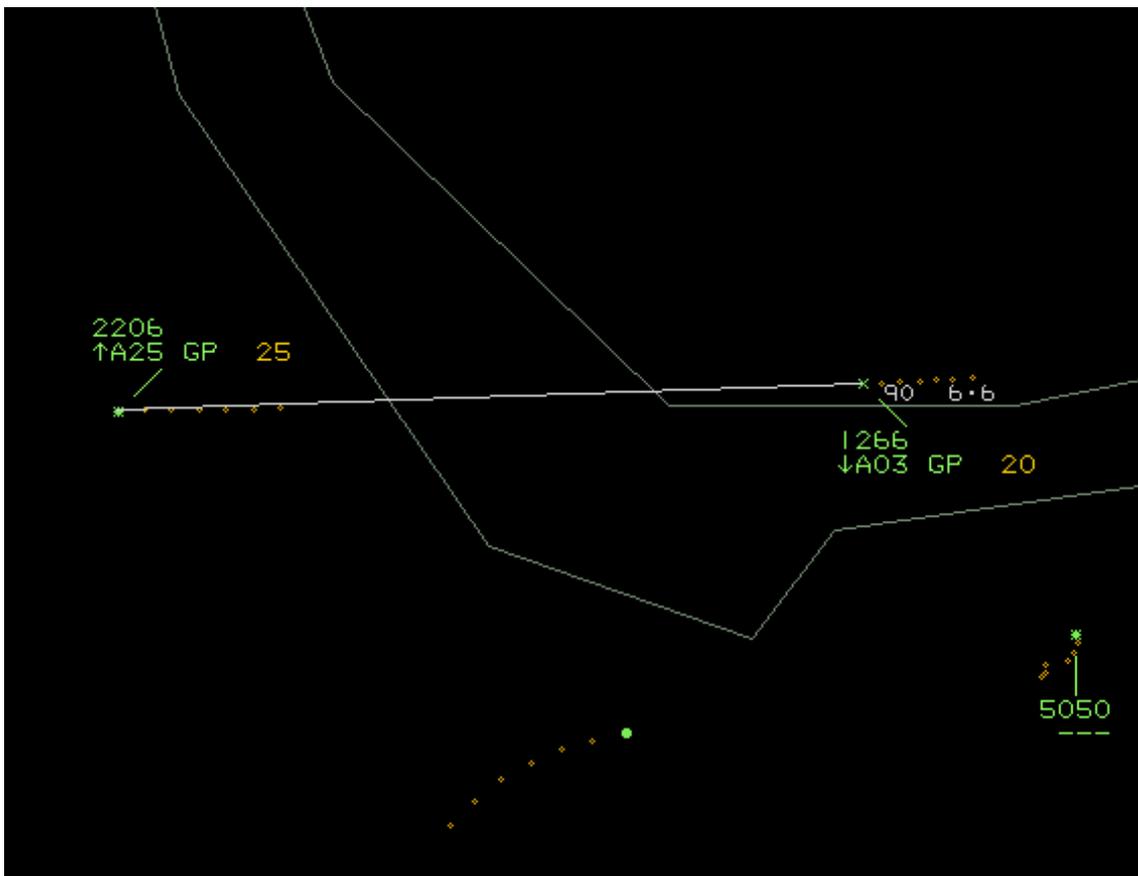
Figure 2 – 1459:38.

At 1459:16, the Aerodrome controller instructed the A320 pilot to contact the Liverpool Radar controller. At 1459:38 (Figure 2), the A320 pilot established communication with the Liverpool Radar controller and was instructed to fly heading 360°, this was read back correctly. The controller established the reason for the go-around and discussed the suitability of RW27 for the subsequent approach to land.

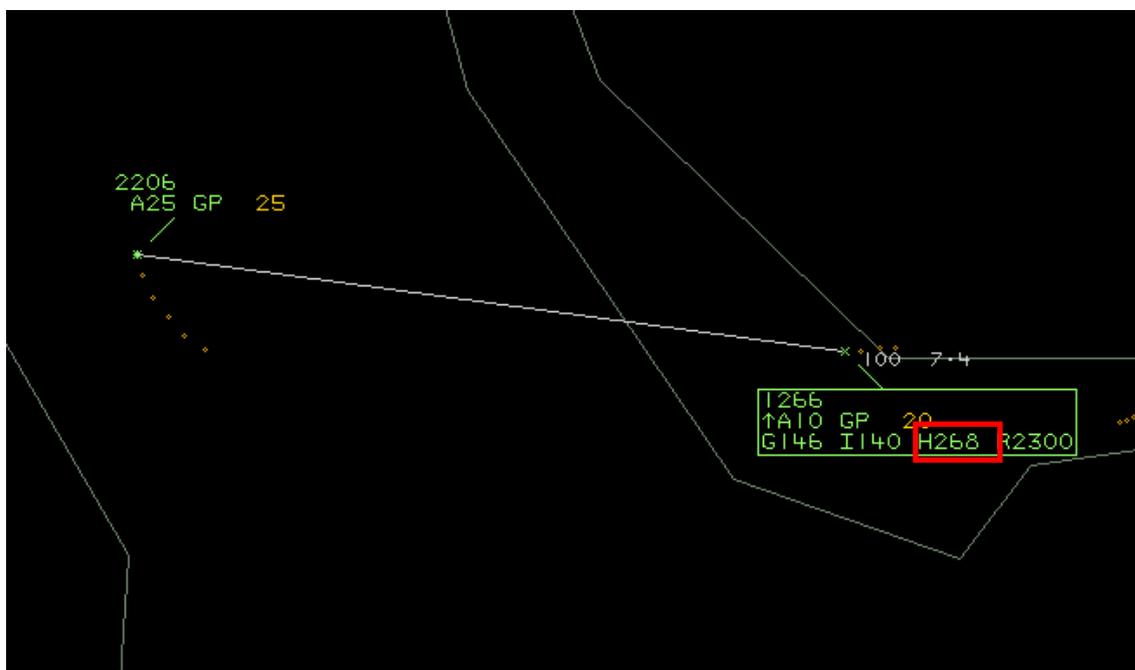
Figure 3 – 1500:36.

At 1500:20, the A319 pilot reported to the Aerodrome controller that they were conducting a missed approach, which was acknowledged by the controller. At 1500:36 (Figure 3), the Aerodrome controller instructed the A319 pilot to fly heading 270° and to climb to altitude 2500ft. The heading was questioned by the pilot but then read back correctly. The radar indicated that the A319 was flying a heading of 268° at 1500:36.

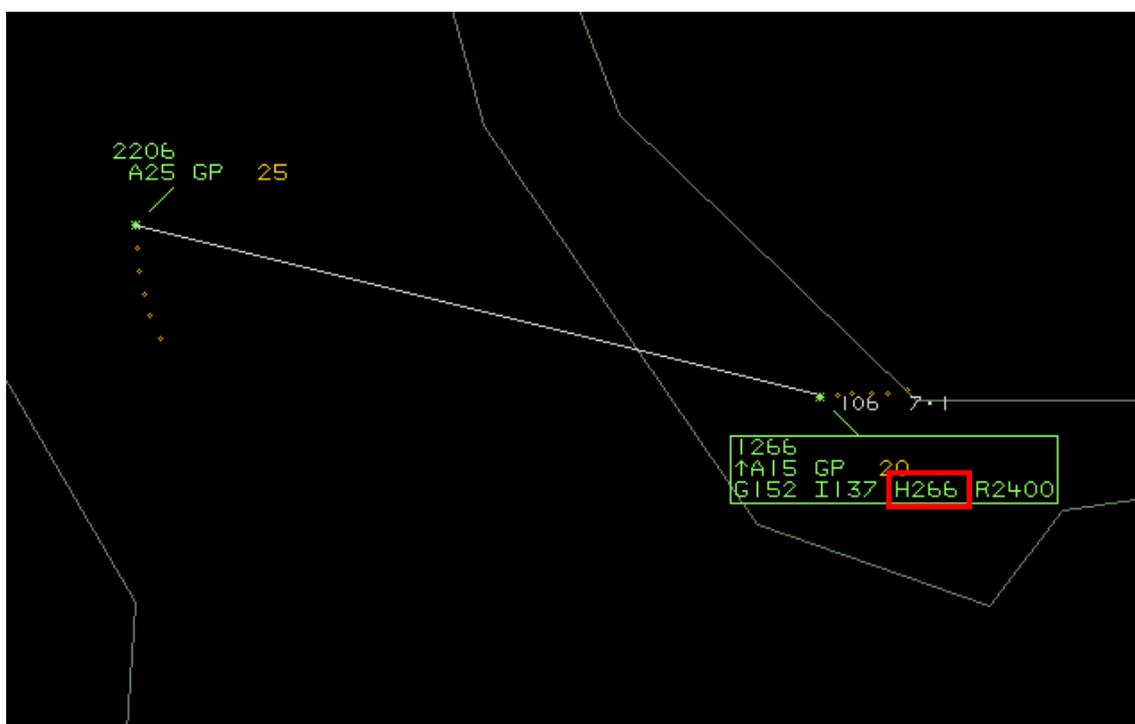
Figure 4 – 1500:48.

At 1500:48 (Figure 4), the A320 pilot stated to the Radar controller that they would like to land on RW27, the controller instructed the pilot to fly heading 085°.

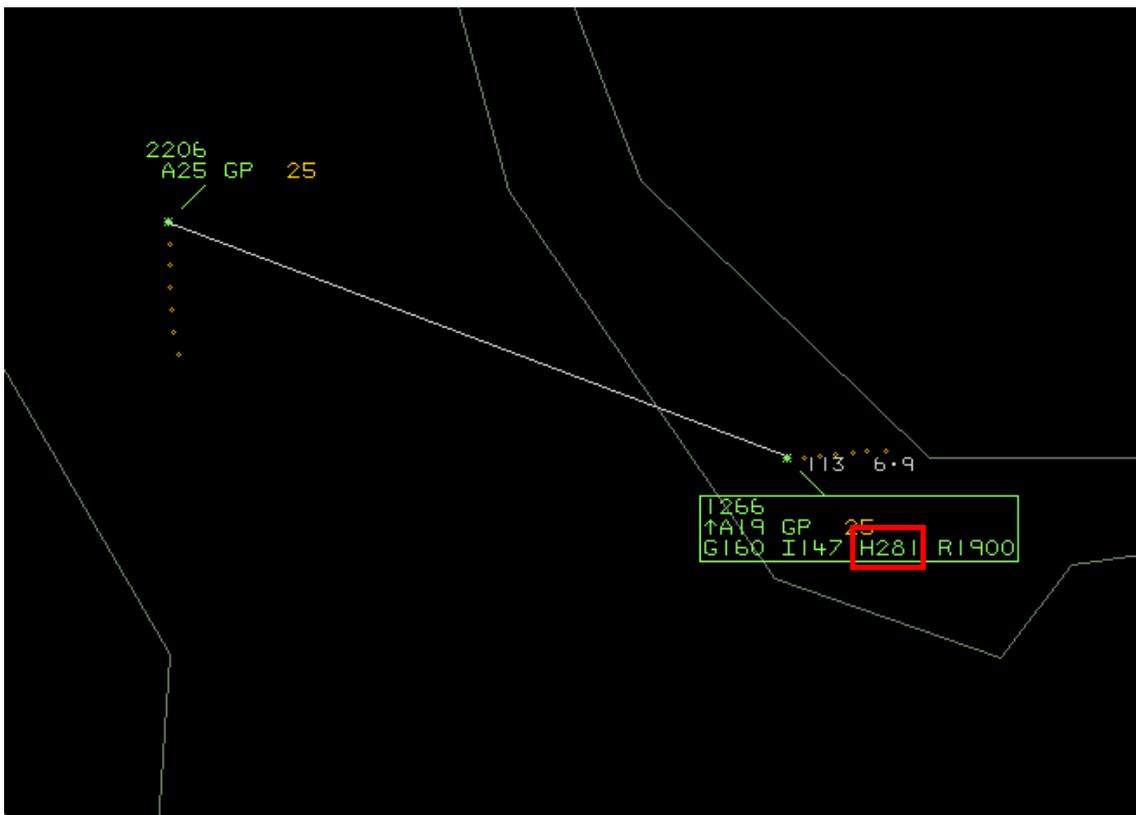
Figure 5 – 1500:58.

At 1500:58 (Figure 5), the A319 pilot requested the Aerodrome controller to confirm that they were to make a right turn.

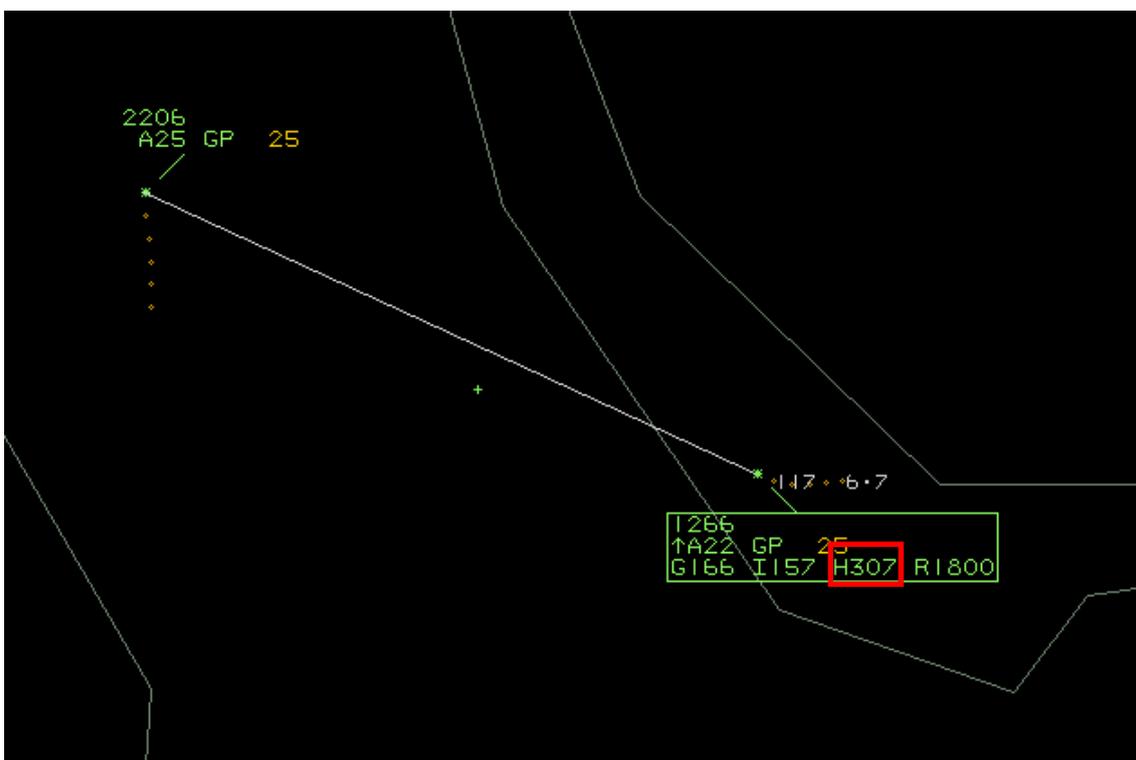
Figure 6 – 1501:08.

At 1501:08 (Figure 6), the Aerodrome controller asked the A319 pilot to repeat the request, which they did. The Aerodrome controller then informed the pilot it was a left turn.

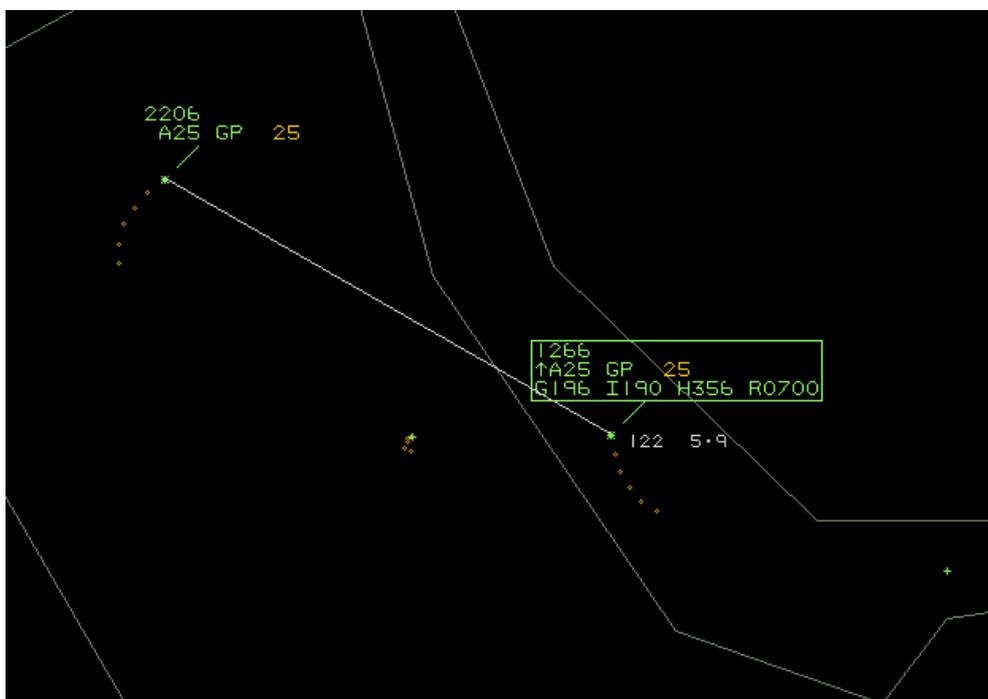
Figure 7 – 1501:28.

At 1501:28 (Figure 7), the Aerodrome controller instructed the A319 pilot to fly a heading of 270° and instructed them to contact radar which was read back correctly. At the same time the Radar controller instructed the A320 pilot to stop the right turn as soon as possible which was acknowledged by the pilot.

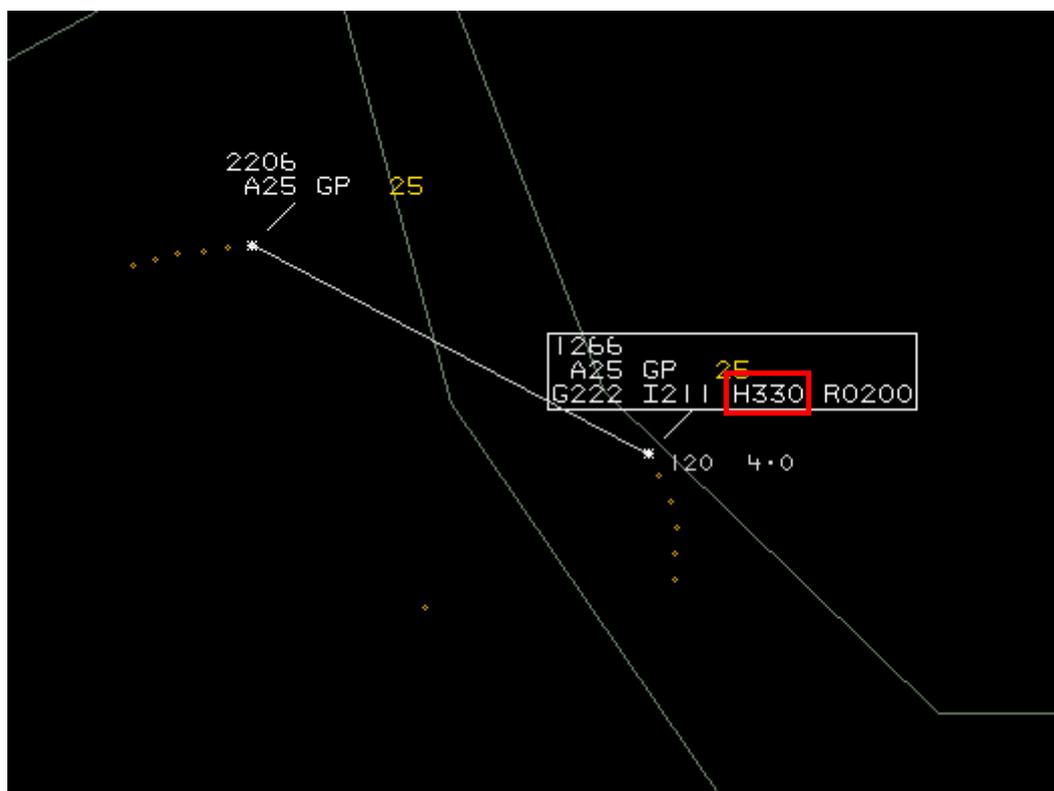
Figure 8 – 1501:50.

At 1501:50 (Figure 8) the Radar controller instructed the A320 pilot to turn left onto 360° and passed Traffic Information on the A319. The pilot reported visual with the A319.

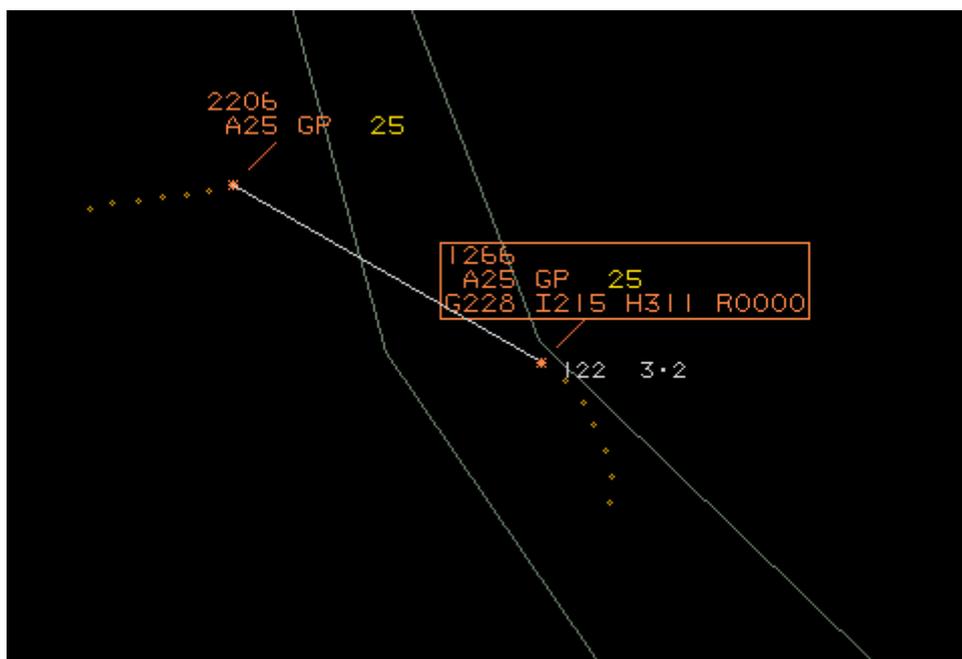
Figure 9 – 1501:58.

At 1501:58 (Figure 9), the Aerodrome controller instructed the A319 pilot to fly heading 250° which was read back correctly.

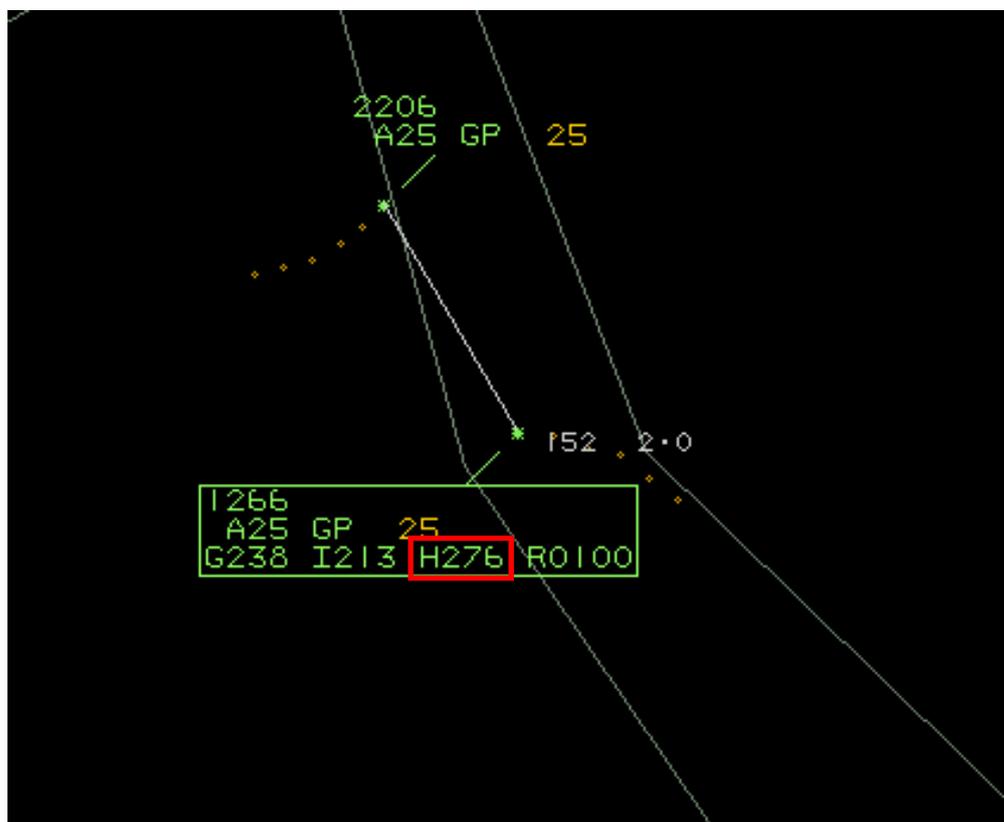
Figure 10 – 1502:15.

CPA occurred at 1502:15 (Figure 10), when the aircraft were separated by 2.0nm, same altitude.

The pilot of the A319 reported that there was confusion in the cockpit as to whether the go-around instruction was to fly heading 270° or 070° which resulted in the track deviation.
