AIRPROX REPORT No 2018159

Date: 06 Jul 2018 Time: 1204Z Position: 5108N 00058W Location: Lasham

PART A: SUMMARY OF INFORMATION REPORTED TO UKAB

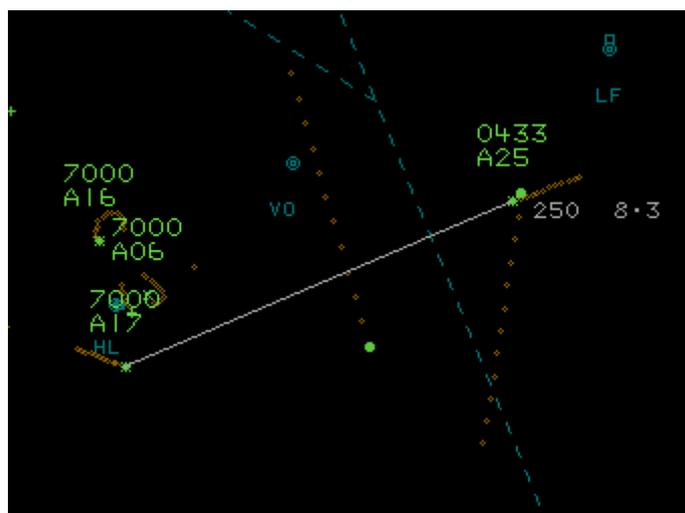
Figure 1 - 1200.59

At 1200.59 (Figure 1), the Farnborough controller issued the MI8 pilot with approval to transit the Odiham MATZ but instructed them to remain clear of Odiham ATZ and warned them of intense aerial activity at Lasham, which was 9nm ahead and active with multiple glider contacts. The MI8 pilot acknowledged this information.

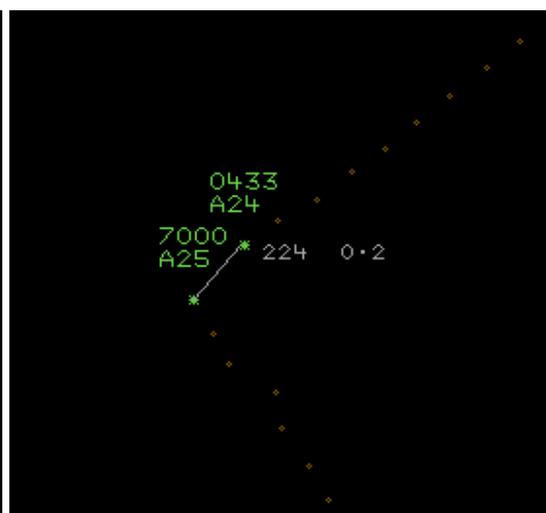
Figure 2 - 1204.32

CPA occurred at 1204.32 (Figure 2), with the aircraft separated by 0.2nm laterally and 100ft vertically.

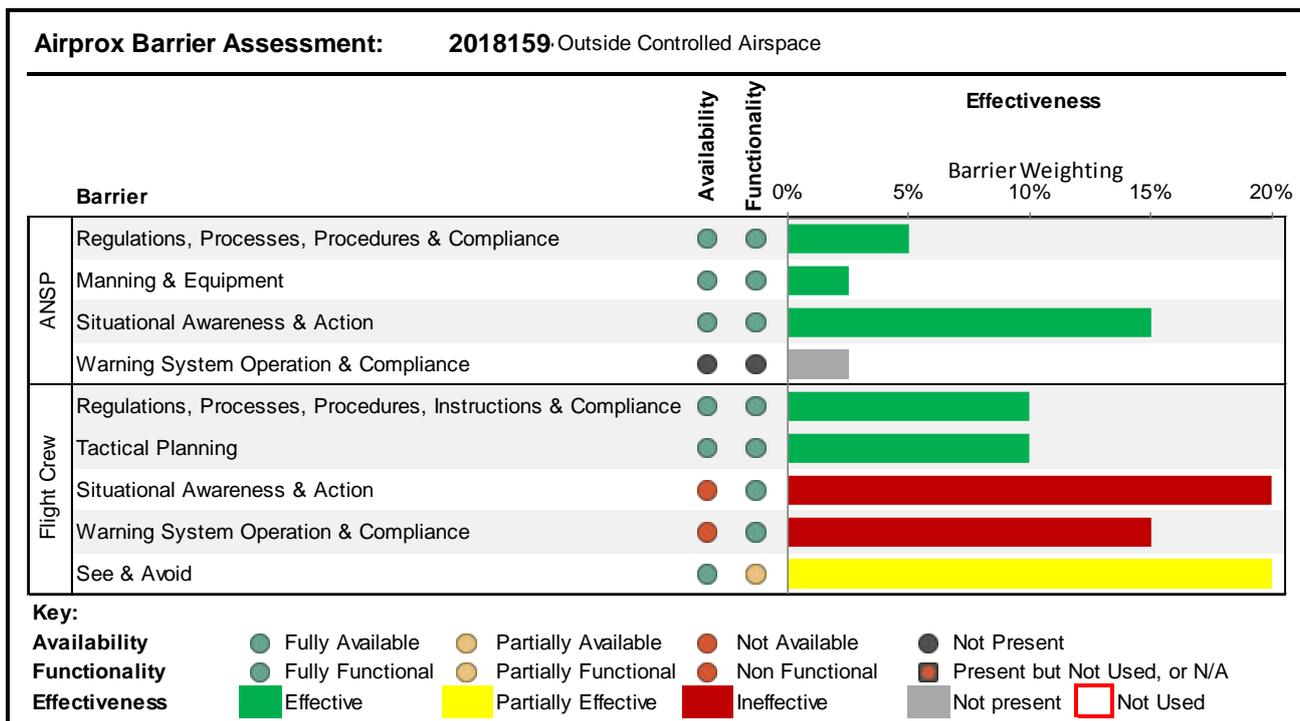
Situational Awareness and Action were assessed as **ineffective** because although the MI8 pilot had generic information about gliding at Lasham, neither pilot had any specific information about the other aircraft prior to the Airprox.

Warning System Operation and Compliance were assessed as **ineffective** because the DR400's FLARM could not detect the MI8.

See and Avoid were assessed as **partially effective** because the DR400 pilot managed to take avoiding action, albeit later than desirable.
