AIRPROX REPORT No 2018174

Date: 12 Jul 2018 Time: 1315Z Position: 5209N 00005E Location: 5nm SW Cambridge Airport

PART A: SUMMARY OF INFORMATION REPORTED TO UKAB

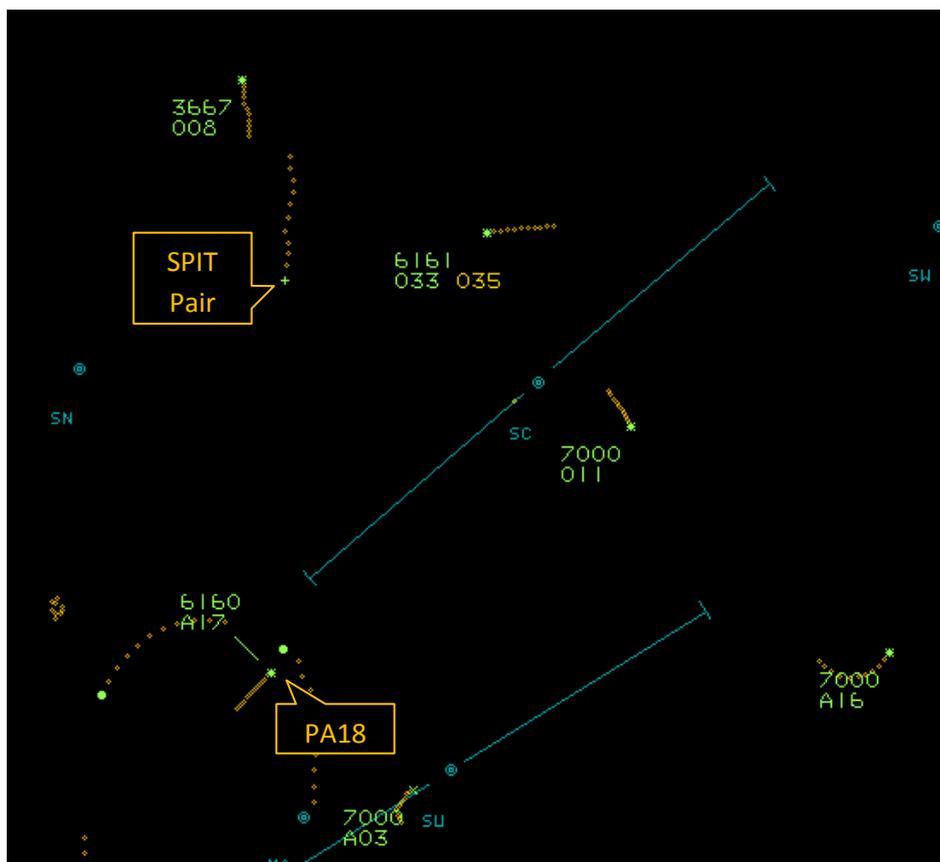
Figure 2 – 1313:04

At 1313:10, the Spitfire pilot advised the Duxford AFISO that they were '2 minutes out'.

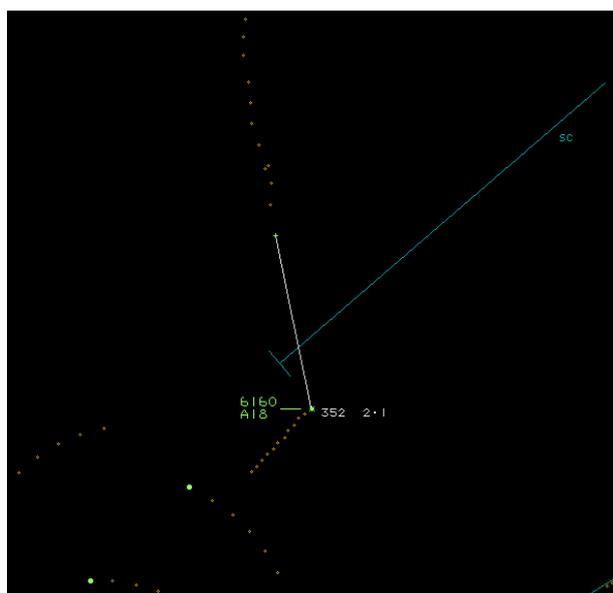
Figure 3 – 1314:10

At 1314:10, the Cambridge controller passed Traffic Information to the PA18 pilot on the primary-only contact, believed to be the Spitfire formation, advising that the traffic was north of the PA18 by 2 miles, that it was fast moving, but that there was no level information (Figure 3).

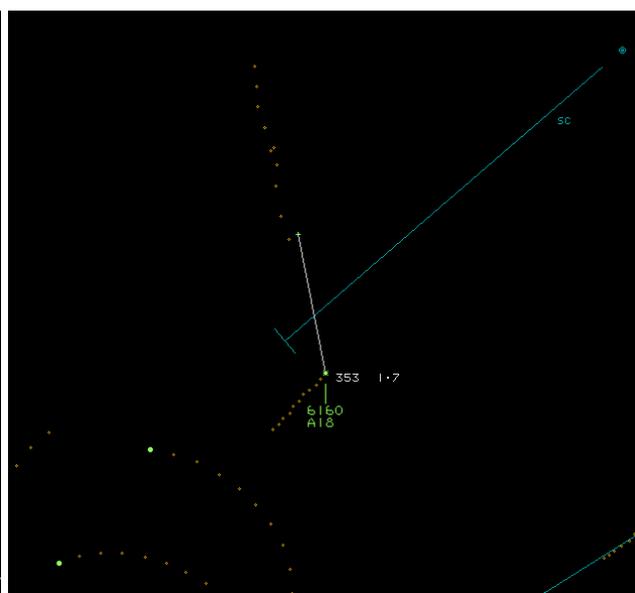
Figure 4 – 1314:20

At 1314:20 (Figure 4), the Cambridge controller updated the PA18 pilot on the position of the Spitfire formation, referencing its position using the clock-code method. The PA18 pilot advised that he was looking.

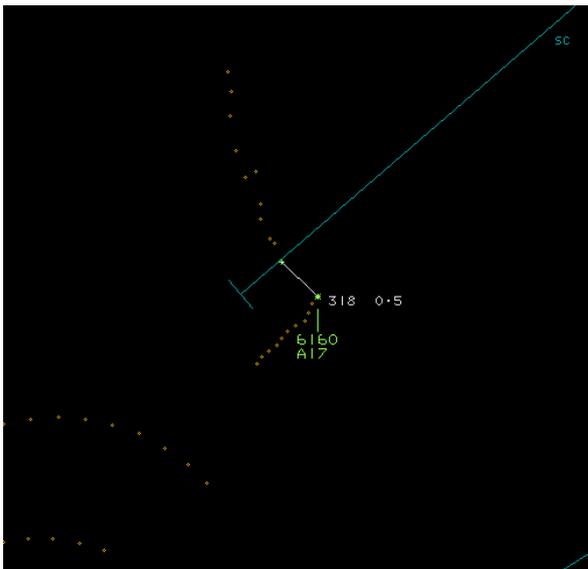
Figure 5 – 1314:40

At 1314:40 (Figure 5), the Cambridge controller advised that the traffic was passing/merging with the PA18.

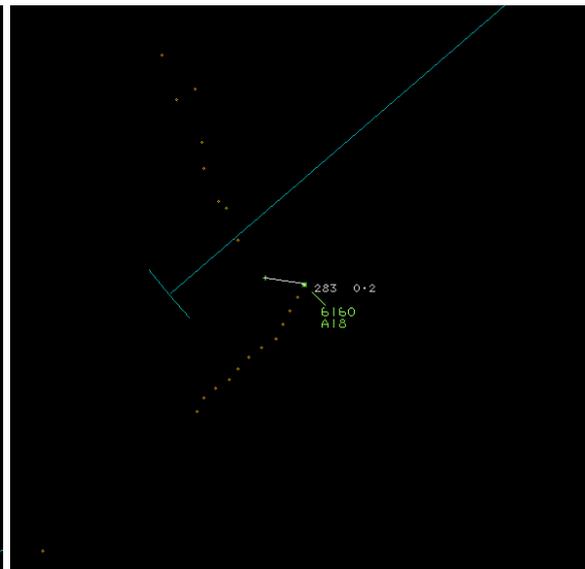
Figure 6 – 1314:42

CPA took place at 1314:42 (Figure 6). Only the lateral separation of 0.2nm could be determined from the radar replay. The Cambridge controller, who had earlier been busy vectoring two training aircraft for instrument approaches around primary contacts operating in the Cambridge final approach area, passed Traffic Information to the PA18 pilot on three occasions. However, the PA18 pilot ultimately did not acquire visual contact with the Spitfires. The Airprox took place in Class G airspace where both pilots were ultimately responsible for collision avoidance.

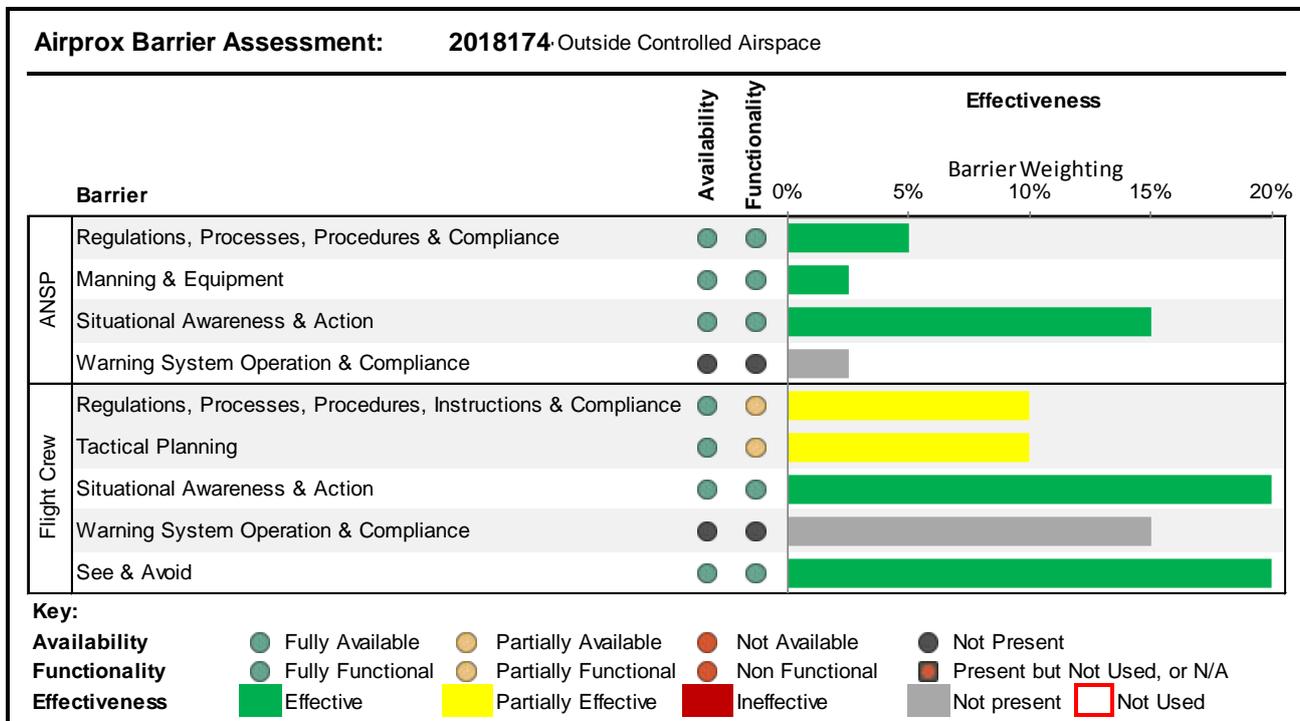
In assessing the effectiveness of the safety barriers associated with this incident, the Board concluded that the key factors had been that:

Regulations, Processes, Procedures, Instructions and Compliance were assessed as **partially effective** because the SSR transponder was not selected on.

Tactical Planning was assessed as **partially effective** because the Spitfire formation did not contact Cambridge before passing within 10nm of the instrument approach.
