AIRPROX REPORT No 2018185

Date: 25 Jul 2018 Time: 1220Z Position: 5239N 00009E Location: 1NM south of Wisbech

PART A: SUMMARY OF INFORMATION REPORTED TO UKAB

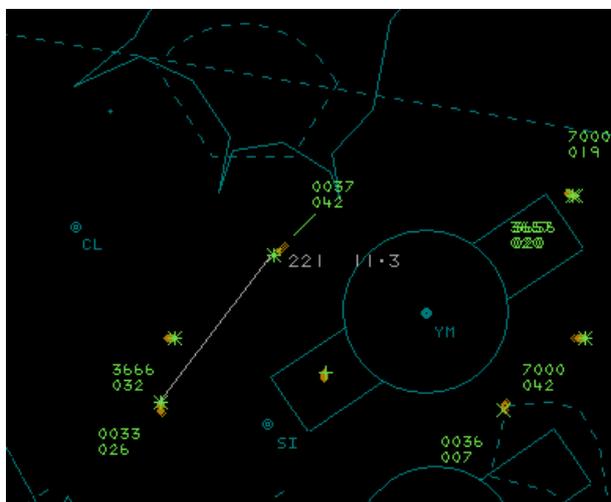
Figure 1

At 1217:37 (Figure 1), the Marham Supervisor contacted Lakenheath to ascertain the intentions of the DHC6 pilot. Separation at this point was just over 11nm.

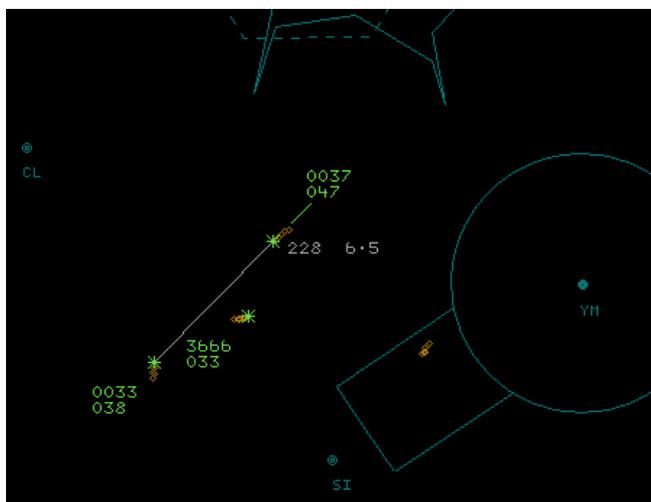
Figure 2

At 1218:33 (Figure 2), the Marham Zone Controller first passed Traffic Information to the S76 pilot. Separation was about 6.5nm laterally and 900ft vertically.

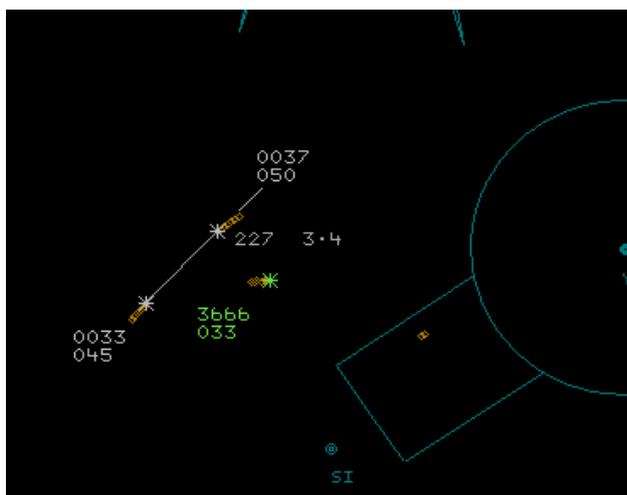
Figure 3

Traffic information was updated at 1219:18 (Figure 3), by which time the recorded separation had decreased to about 3.5nm and 500ft.

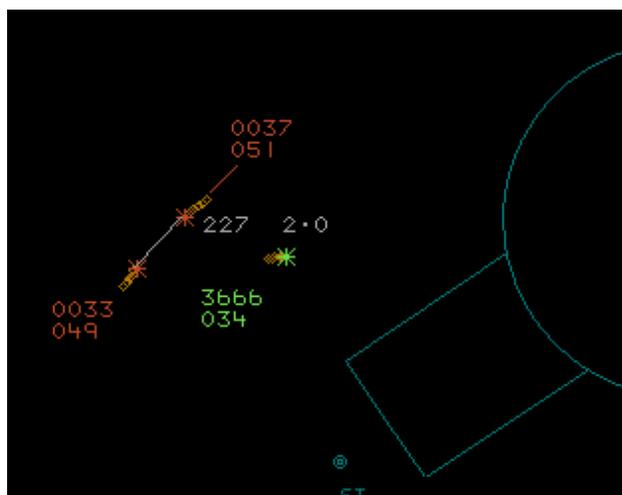
Figure 4

Traffic information was again updated some 20sec later at 1219:41 (Figure 4). This was accompanied by a suggested heading change onto 300° and appears to have coincided with the S76 pilot receiving a TCAS TA.

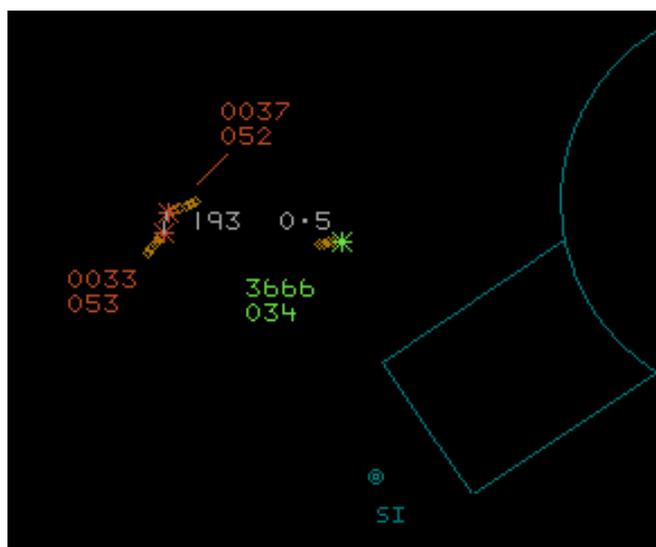
CPA occurred at 1220:06 (Figure 5), measured at 0.5nm lateral and 100ft vertical separation.

Figure 5 - CPA
