AIRPROX REPORT No 2018186

Date: 27 Jun 2018 Time: 1510Z Position: 5257N 00033W Location: Barkston Heath

PART A: SUMMARY OF INFORMATION REPORTED TO UKAB

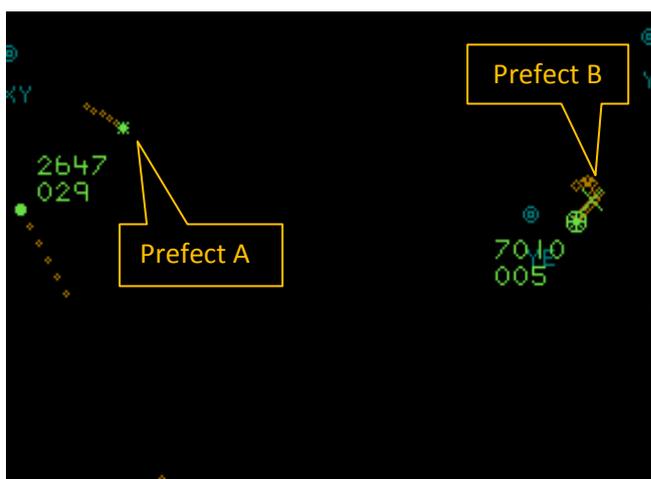
Figure 1 - 1506:40

At 1506:40 (Figure 1), Prefect(A) pilot requested an overhead join for RW06RH and was cleared to join overhead. The controller advised that there was one aircraft joining for a PFL and one aircraft in the visual circuit. The pilot acknowledged the joining instructions and said that they were aware of the traffic.

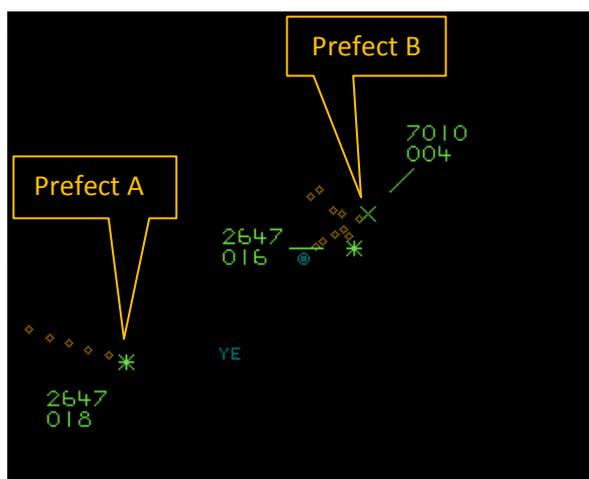
Figure 2 - 1507:50

At 1507:50 (Figure 2), Prefect(B) pilot called extending upwind for PFL traffic and then 'fanstop extending upwind', this was acknowledged by the controller.

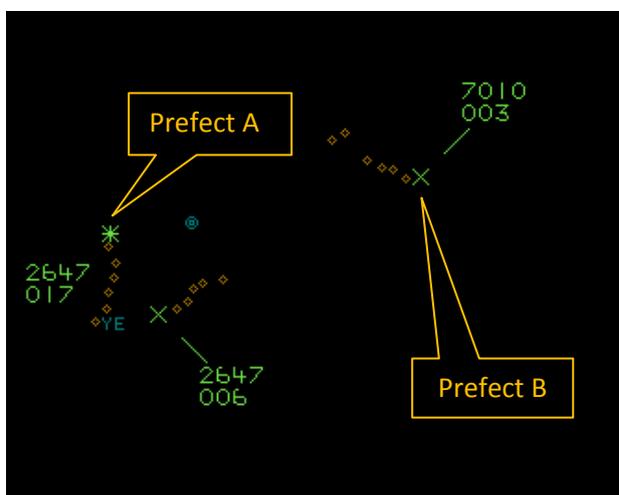
Figure 3 - 1508:34

At 1508:34 (Figure 3), Prefect(A) pilot called deadside descending and was advised by the controller that there was one aircraft on final and one crosswind. There was then an unreadable dual-aircraft transmission and the controller advised “two at once” and instructed the PFL aircraft to check gear, followed by clearing them for a touch-and-go. The controller then issued a line-up (and wait) clearance to a departing aircraft.

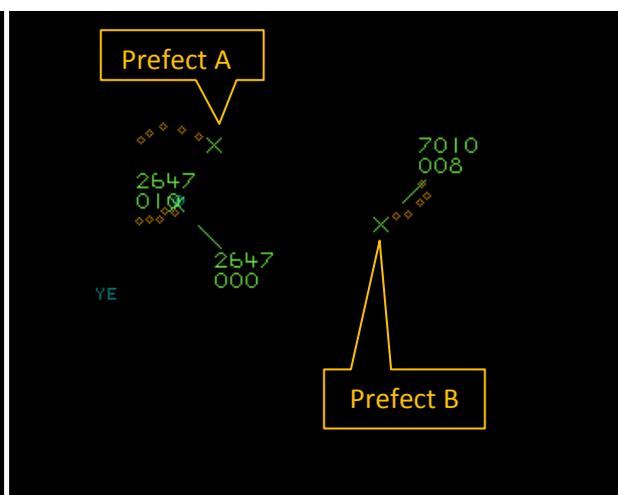
Figure 4 - 1509:19

Prefect(B) pilot called joining downwind flapless at 1509:19 (Figure 4), and was advised by the controller that there was one on a touch and go, one on departure and one deadside. The pilot acknowledged this.

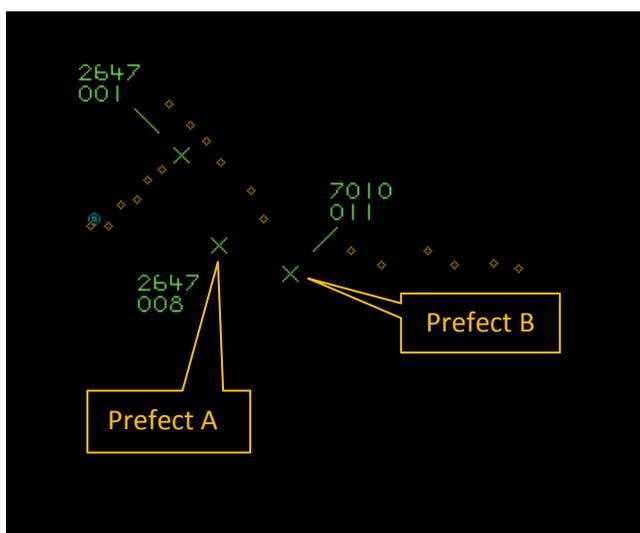
Figure 5 – 1509:45

At 1509:45 (Figure 5), Prefect(A) pilot called downwind to land and the PFL-aircraft called flapless low-level. Both transmissions were acknowledged by the controller.

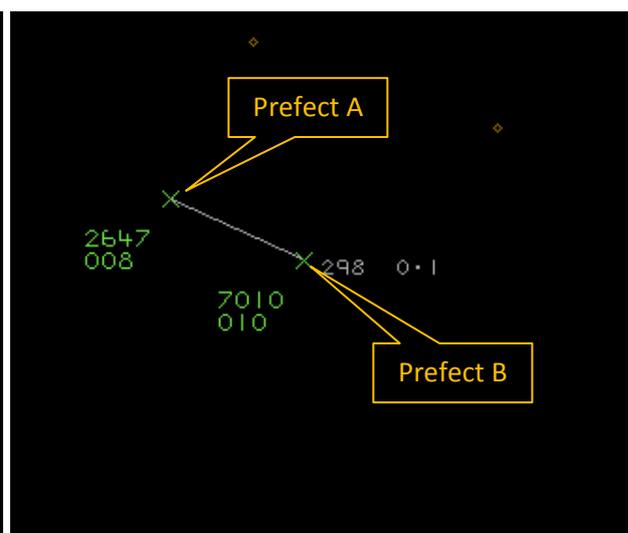
Figure 6 – 1510:00

At 1510:00 (Figure 6), Prefect(B) pilot called downwind flapless for a touch-and-go and advised the controller that they were extending for the traffic ahead of them. The controller replied, “copied, the other one is a solo” and the pilot responded roger “we will go out to initials and re-join”. The controller acknowledged this and said thank you.
