AIRPROX REPORT No 2018188

Date: 28 Jul 2018 Time: 1033Z Position: 5112N 00114W Location: ivo Popham airfield

PART A: SUMMARY OF INFORMATION REPORTED TO UKAB

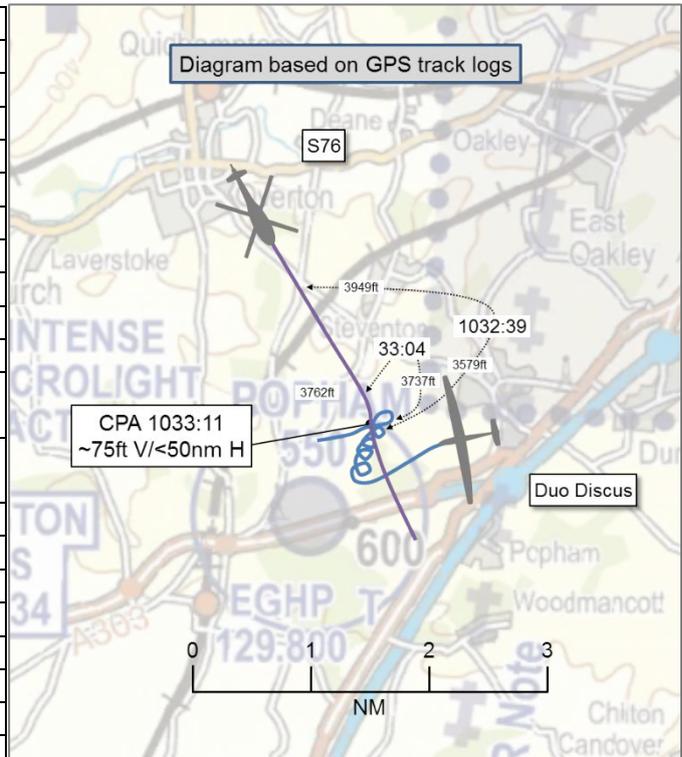
Recorded	Aircraft 1	Aircraft 2
Aircraft	Duo Discus	S76
Operator	Civ Gld	Civ Helo
Airspace	London FIR	London FIR
Class	G	G
Rules	VFR	VFR
Service	None	Basic
Provider	N/A	Solent Radar
Altitude/FL	~3673ft	~3747ft
Transponder	SSR off	A,C,S
Reported		
Colours	White, high viz stripe on tail fin	Green, white, yellow
Lighting	Nil	Nav, red strobes, HISLs
Conditions	VMC	VMC
Visibility	>10km	10nm
Altitude/FL	3723ft	3735ft
Altimeter	QNH	QNH
Heading	255°	150°
Speed	55kt	140kt
ACAS/TAS	FLARM	TAS
Alert	None	None
Separation		
Reported	150ft V/100m H	300ft V/0.5nm H
Recorded	~75ft V/<50m H

THE DUO DISCUS GLIDER PILOT reports thermaling in the vicinity of Popham Airfield, climbing from 2800-3723ft (GPS height) when he became aware of the sound of a powered aircraft. As he turned, he saw a helicopter approaching at high-speed, at a similar height. He immediately took evasive action by diving left to avoid a collision. The helicopter passed overhead by no more than 150ft and he noticed no discernible change in its direction or height which left him to believe that its pilot had not seen him. On return to his airfield 3hrs later he spoke to the CFI, who suggested that he file an Airprox report.

THE SIKORSKY S76 PILOT reports that he saw a glider 30° degrees left of his helicopter in a turn at a range of about 1nm. He banked right to give a wider berth and then resumed his track for HANKY.

It would seem from the track information provided that the helicopter pilot saw a different glider to that involved in the Airprox. Gliders will frequently congregate in areas of good conditions; if you see one, look particularly carefully for others.

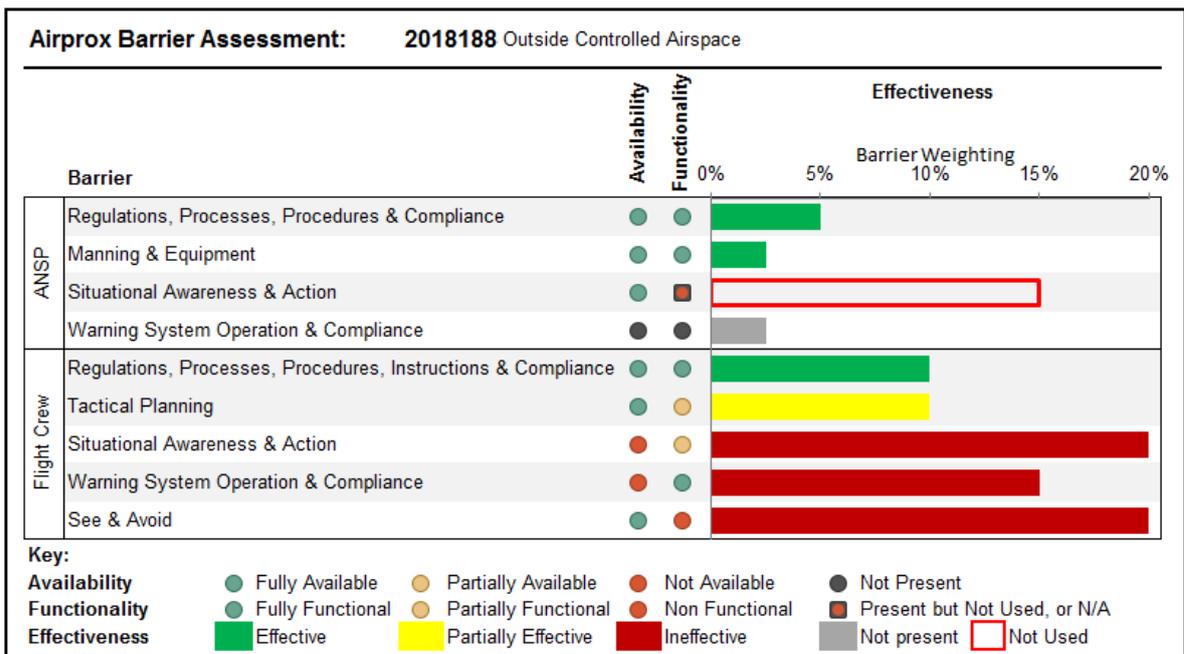
Safety Barrier Assessment³

Tactical Planning was assessed as **partially effective** because the Duo Discus pilot had switched off his transponder.

Situational Awareness and Action were assessed as **not available** because neither pilot was in receipt of a service that could provide Traffic Information.

Warning System Operation and Compliance were assessed as **ineffective** because the glider's FLARM was not compatible with the S76's TAS, and the Duo Discus pilot had switched off his transponder thereby effectively rendering the S76 TAS as unavailable.

See and Avoid was assessed as **ineffective** because although he saw the S76 very late and dived away, the Duo Discus pilot probably only managed to minimally increase separation and the S76 pilot probably did not see the Duo Discus.
