AIRPROX REPORT No 2018217

Date: 15 Aug 2019 Time: 1514Z Position: 5121N 00103W Location: 3nm N Basingstoke

PART A: SUMMARY OF INFORMATION REPORTED TO UKAB

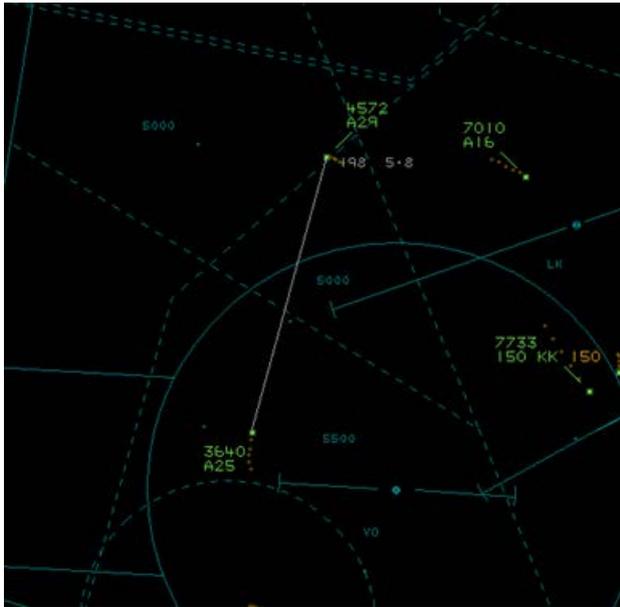
Figure 1
(Chinook Squawking 3640, C150 Squawking 4572)

Figure 1, timed at 1509:00, was the first time Traffic Information was passed to the Chinook. The Chinook reported that the traffic was 'not sighted'. Figure 2, timed at 1510:16 was the point at which the Traffic Information was updated. This time, the Chinook reported the traffic as in sight.

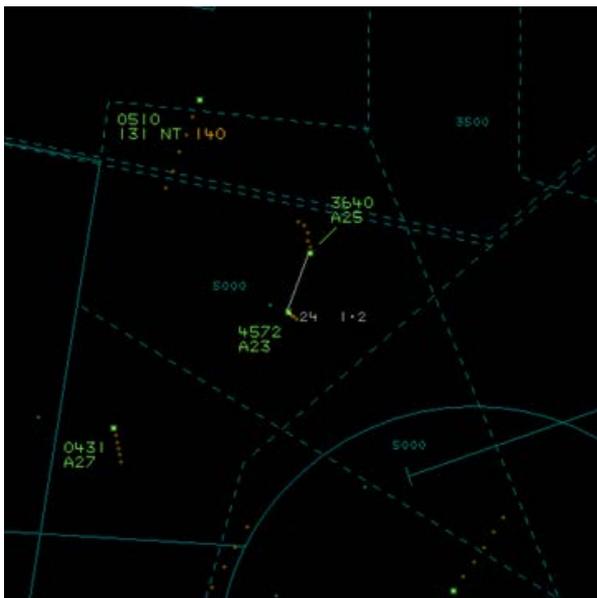
Figure 3

Figure 3, timed at 1513:40, was the time at which Traffic Information was passed for a final time. The Chinook again reported visual with the traffic called. Figure 4 depicts CPA, which occurred at 1514:23. CPA was measured as 0.1nm lateral and 0ft vertical separation.

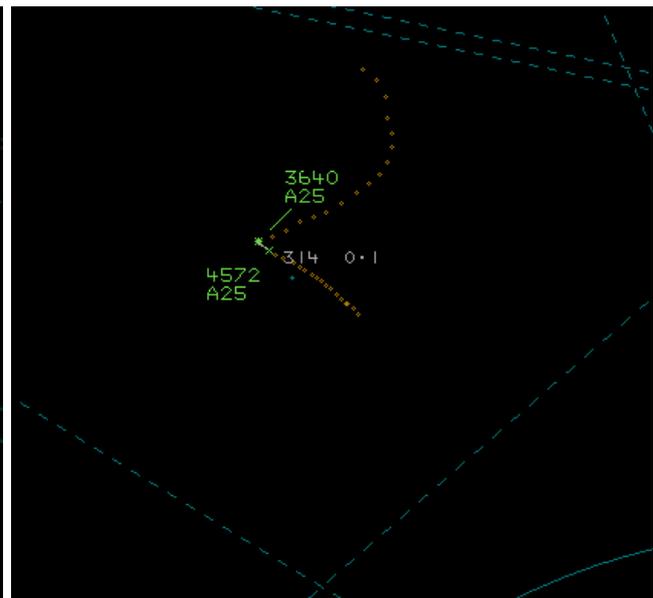
Figure 4 – CPA

Cause: The Chinook pilot turned into conflict with the C150.

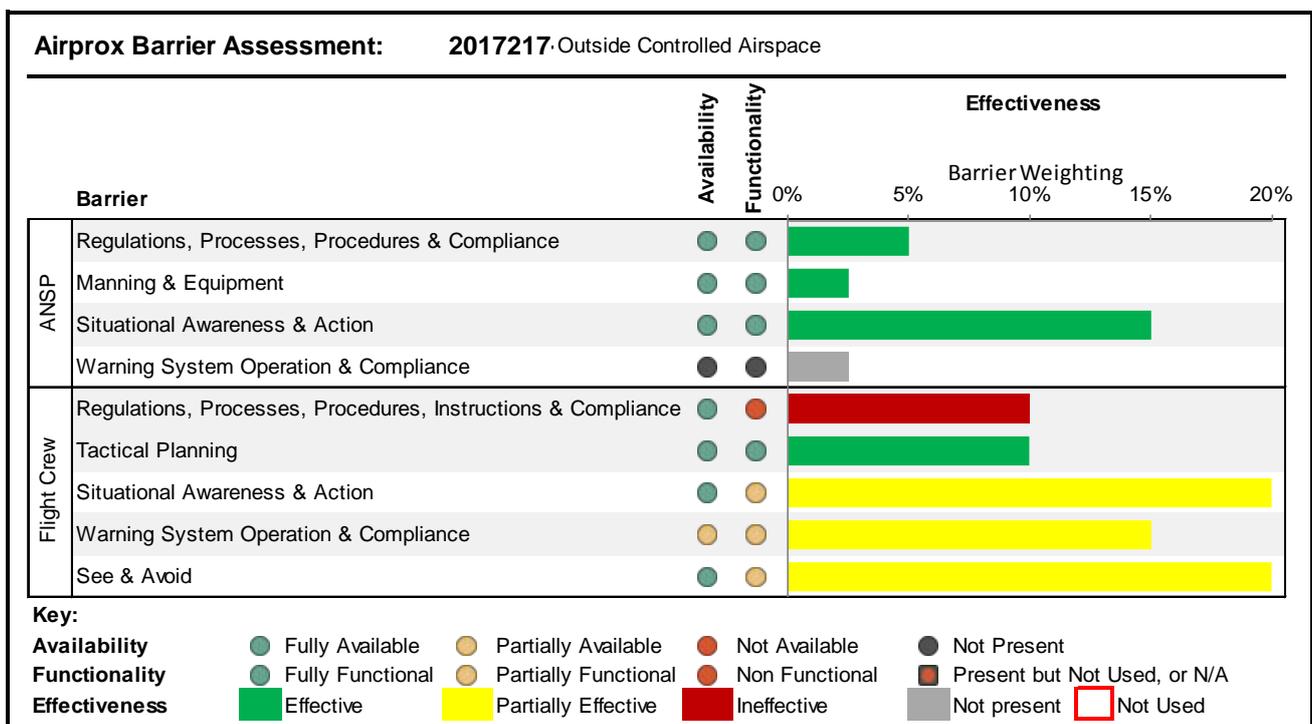
Regulations, Processes, Procedures, Instructions and Compliance were assessed as **ineffective** because the Chinook pilot was required not to pass in such proximity as to create a collision hazard.

Situational Awareness and Action were assessed as **partially effective** because the Chinook pilot didn't act sufficiently on the situational awareness provided by ATC.

Warning System Operation and Compliance were assessed as **partially effective** because although he had TAS information, the Chinook pilot didn't act sufficiently upon it.

See and Avoid were assessed as **partially effective** because although the Chinook pilot had the C150 in sight, he still passed in front of it at a distance of 0.1nm.
