AIRPROX REPORT No 2018221

Date: 13 Aug 2018 Time: 1428Z Position: 5006N 00540W Location: Lands End ATZ

PART A: SUMMARY OF INFORMATION REPORTED TO UKAB

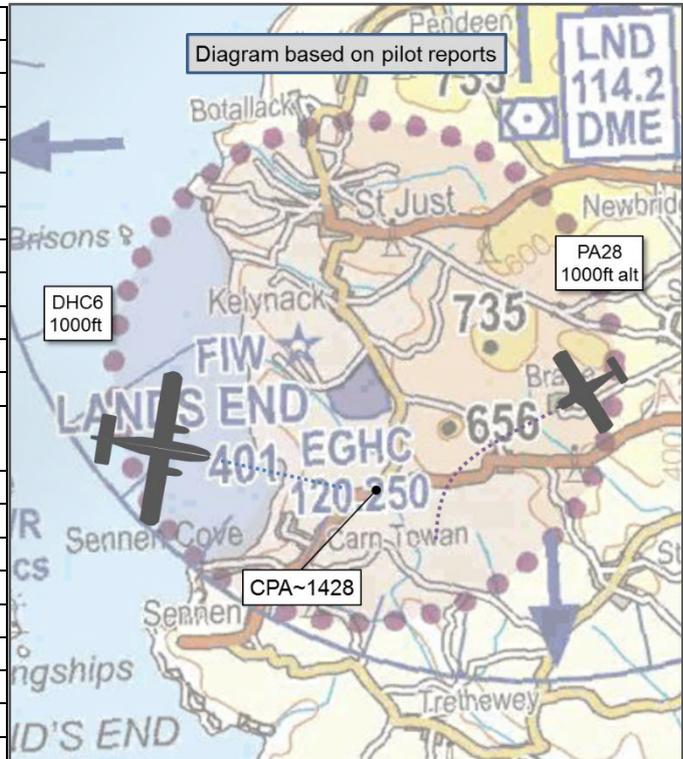
THE DHC6 PILOT reports that on first contact with ATC he was given airfield conditions, joining instructions for landing and details of another aircraft joining from the east. He was told he was No1 for landing and continued to join left-base RW34, maintaining a good look-out for the other aircraft joining right-base. On coasting-in, they heard the other pilot report that he was not yet visual with the airfield, or with them. Although they were also not visual with the other aircraft, it's pilot had reported it was in the Penzance vicinity, so they expected it to be a few minutes behind their arrival time. They then saw the other aircraft as the pilot reported 'field in sight' and ATC instructed him to commence a left turn to keep clear. The other pilot reported visual with them as he turned away to the south, there was no need for the DHC6 pilot to take avoiding action because the other pilot was turning away from them and their intended flight path. The other pilot appeared to have taken a much tighter base leg and joined sooner than he had expected.

THE LANDS END CONTROLLER reports that the PA28 pilot called for join, was given the airfield information, and was asked to report field in sight. The DHC6 pilot called and was also given the airfield details and joining instructions for left-base. Traffic Information was passed to both pilots and the DHC6 pilot was told he was No1 and the PA28 pilot No2. At this stage neither were visual with the other. The PA28 reported 6mins until arrival and was instructed to join right-base RW34; he was reminded that he was No2, and was told that the quicker DHC6 was joining left-base. The controller was visual with both aircraft and saw the PA28 pilot join mid-point downwind and begin to turn onto base leg. He had arrived sooner than the 6mins that he had reported, and the controller instructed him to make a left-turn towards the south coast before turning back onto final behind the DHC6. The pilot complied and then reported

visual with the DHC6. The DHC6 pilot also reported visual with the PA28 as it turned away and estimated the two aircraft were 2kms away. The DHC6 landed at 1429 and the PA28 at 1432.

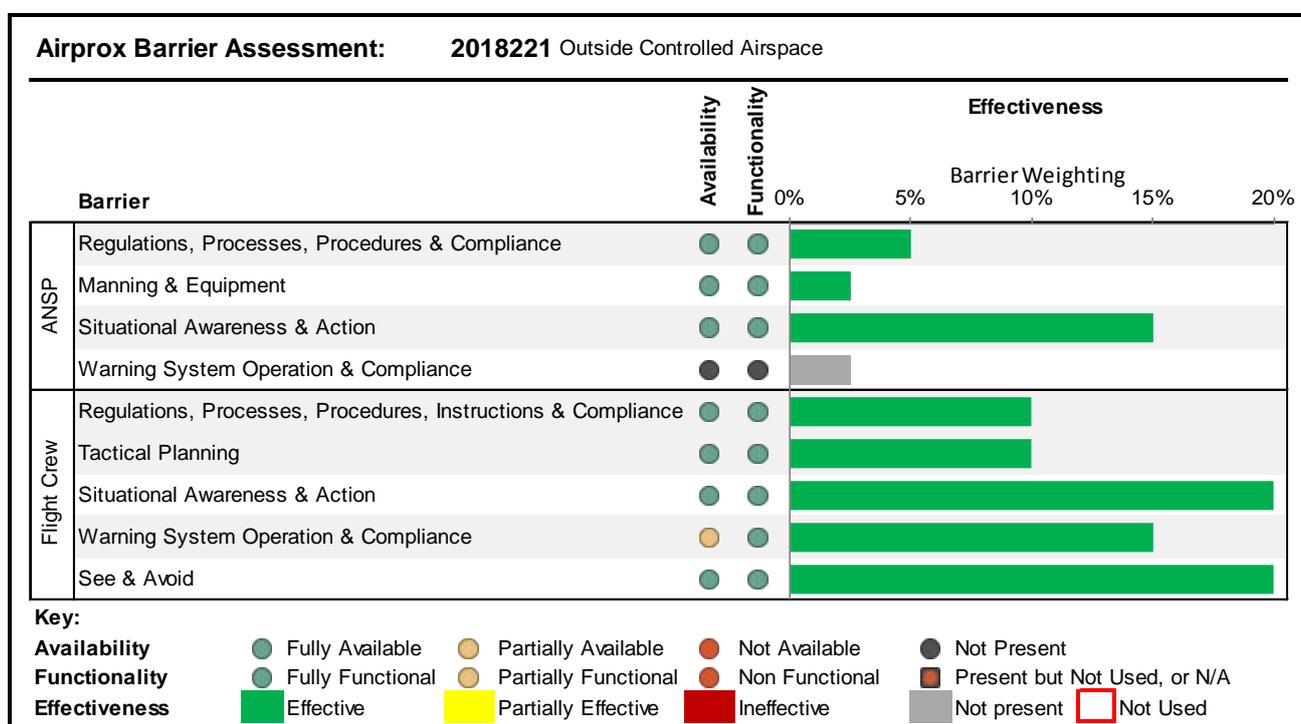
Safety Barrier Assessment³

In assessing the effectiveness of the safety barriers associated with this incident, the Board concluded that all the safety barriers had operated effectively.
