**AIRPROX REPORT No 2018229**

Date: 20 Aug 2018 Time: 1338Z Position: 5155N 00153W Location: 11nm E Gloucester airport

**PART A: SUMMARY OF INFORMATION REPORTED TO UKAB**

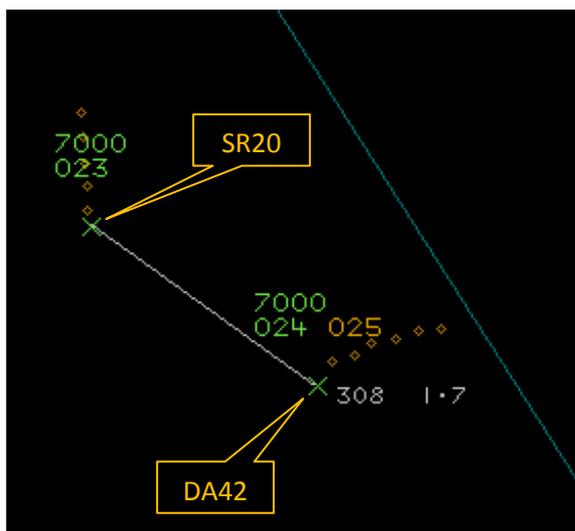
Figure 1 - 1337:50.

At 1337:50, the DA42 pilot made initial contact with the controller and advised that they were returning to the Airfield at 2500ft on QNH1019hPa and requested a straight in approach to RW27. The controller requested a range check and the pilot responded with 11nm (Figure 1).

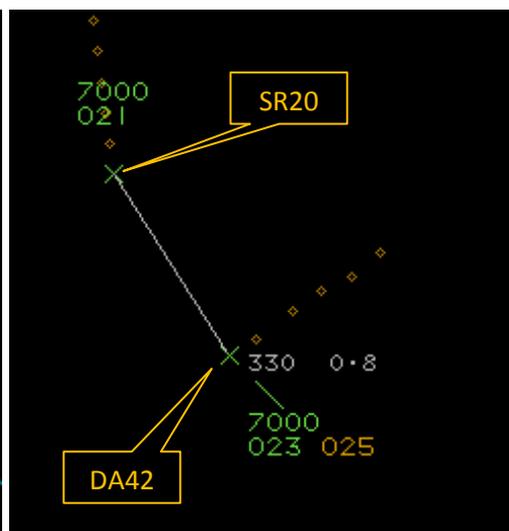
Figure 2 - 1338:20.

At 1338:20 (Figure 2), the controller instructed the DA42 pilot to take up delaying action to the east of the airfield and explained that the Instrument Approach was active with an SR20 routing from the northeast to turn at NIRMO, 10nm east of the airfield. The pilot responded, but the R/T was not clear enough to determine whether the pilot said that they had the field or the traffic in sight.

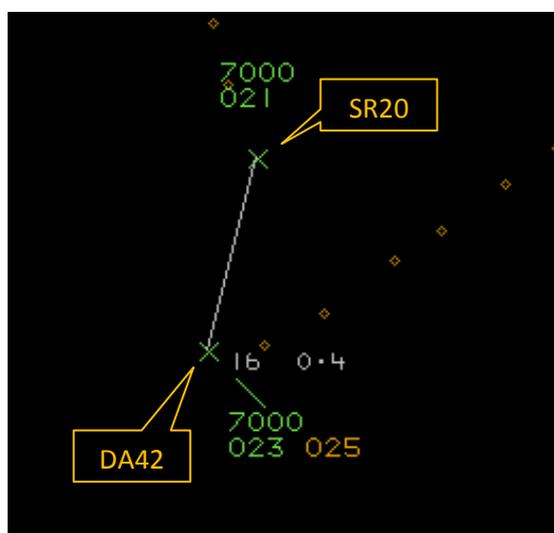
Figure 3 CPA - 1338:30.

At 1338:30, CPA occurred with the aircraft separated by 0.4nm laterally and 200ft vertically (Figure 3). The controller passed Traffic Information to the SR20 pilot advising that the traffic was a DA42 aircraft, 11nm east of the airfield. The pilot did not initially respond. The controller then asked if the pilot had copied the traffic and the pilot responded that they had just taken avoiding action and were just turning back on track for NIRMO. The pilot was instructed to report at the Final Approach Fix and asked if they would like to file an Airprox. The pilot responded with probably not but that they would think about it and talk to the controller later (Figure 3).
