AIRPROX REPORT No 2018235

Date: 31 Aug 2018 Time: ~1005Z Position: 5218N 00047W Location: Sywell ATZ

PART A: SUMMARY OF INFORMATION REPORTED TO UKAB

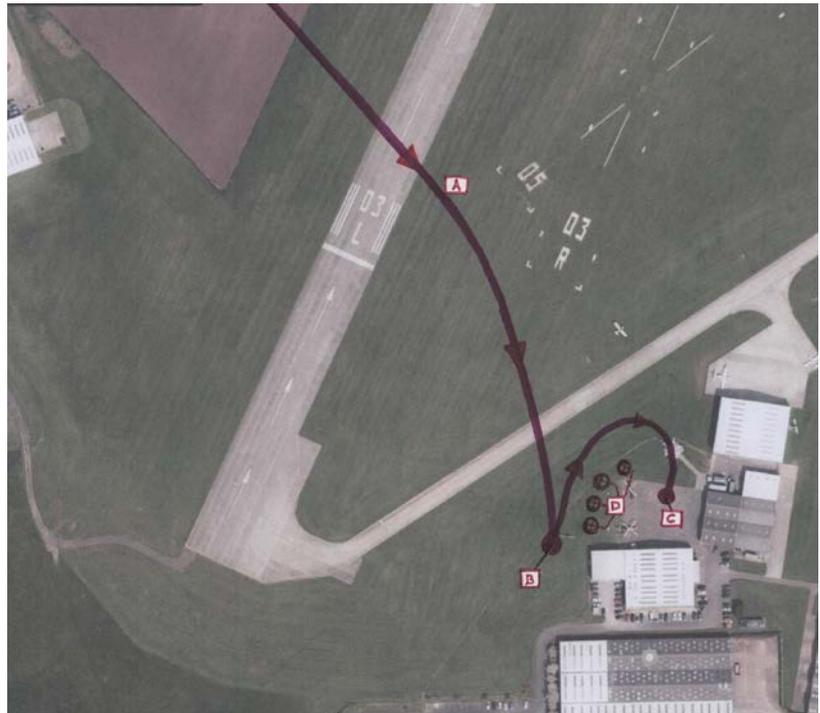
Figure 1: A109 pilot's diagram

RA(T) at 480ft and followed the route procedure to the western aerodrome boundary. He turned on his landing light and reported at the aerodrome boundary, at which point Sywell Radio [UKAB Note: Sywell Information] told him that now was a good opportunity to cross the runways and informed him of an aircraft which hadn't yet made its call on Final. He confirmed he was visual with the aircraft to Sywell Radio. With the fixed-wing aircraft continually in sight, he then continued to descend and cross the active runways; mindful of the fact that he wanted to create as little downwash as possible, he kept his speed up and expedited the crossing. At this point the fixed-wing pilot called finals and questioned the helicopter he saw with Sywell Radio. Sywell Radio informed the fixed-wing pilot that the helicopter pilot had him in sight. At this point (A on diagram) he was approximately mid-way between RW03L and RW03R with the fixed-wing aircraft still in sight, and still a large distance away as far as he was concerned. He proceeded at speed with his landing gear up at a height of approximately 50ft to clear the active runways, still well clear of the other fixed-wing aircraft. As he cleared the active runways he confirmed this with a call to the Tower, came to a high hover (B on diagram) and, with the fixed-wing aircraft still in sight, selected gear down whilst pedal-turning to the right and descending. He then hover-taxied to the parking area whilst remaining clear of the approaching aircraft and RW03. The approach was performed to give the largest separation from parked aircraft (D on diagram) and a safe transition to a hover, avoiding all parked aircraft and people, and with a possibility to reject the arrival into an open area in the event of a failure. At this point he was descending to about 15ft and was taxiing forward towards the pad, as per the diagram. Sywell Radio called "Check gear" twice, the gear takes a few seconds in transit, and although selected down he presumed it was not visible to the AFISO. He confirmed the gear was down and continued taxiing at about 8-10ft and landed on the Heli-Pad (C on diagram).

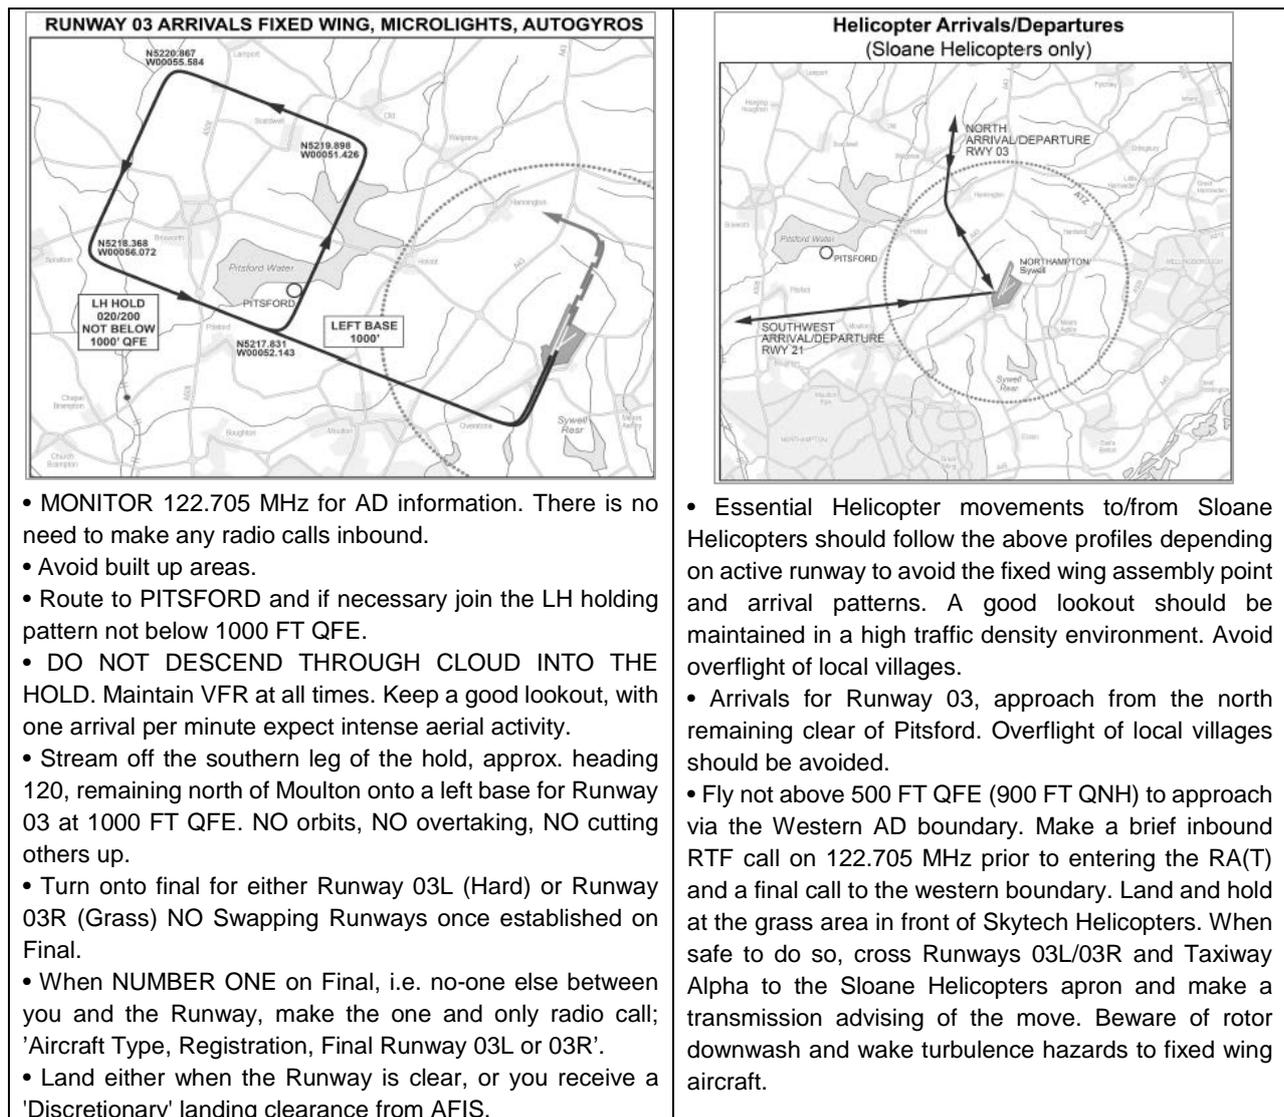
Figure 2: AIC Y 074/2018 Extract

The Sywell Arrival/Departure procedures for the LAA Rally (AIC Y 074/2018) are reproduced below:

others opined that the intensity of the traffic would saturate the R/T and so an Aerodrome Control Service would not be a viable alternative. Notwithstanding, members agreed that by routing helicopters in from the north, the Sloane Helicopter Procedure was creating the potential for an unsafe situation given the high number of arriving and departing aircraft during the LAA Rally. The Board felt that this procedure should be suspended during the LAA Rally, and that all helicopters would be better served by arriving and departing to the south, away from the fixed-wing pattern. The Board therefore agreed to make a recommendation that Sywell revise the use of the 'Sloane helicopter procedures' during the LAA Rally.

Regulations, Processes, Procedures and Compliance were assessed as **partially effective** because the Sloane Helicopter procedure in the AIC does not effectively separate helicopters from light-aircraft utilising both the hard and grass runways.

1. Sywell revise the use of the 'Sloane helicopter procedures' during the LAA Rally.
2. Sywell review the AIC to emphasise the importance of going-around if in conflict with other traffic.
3. Sywell review the AIC to emphasise that pilots will not be in receipt of an Aerodrome Control Service.
