AIRPROX REPORT No 2018248

Date: 05 Sep 2018 Time: 1429Z Position: 5302N 00050W Location: 5nm east Syerston

PART A: SUMMARY OF INFORMATION REPORTED TO UKAB

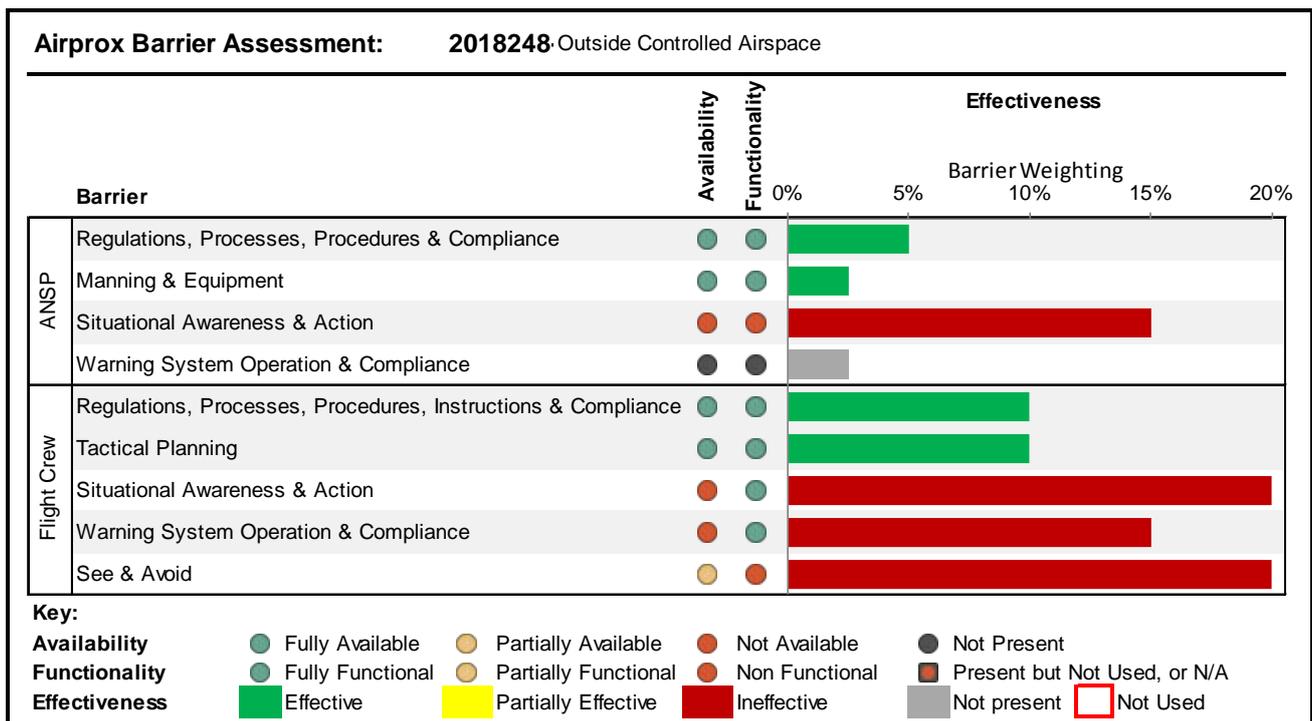
Situational Awareness and Action were assessed as **ineffective** because the unidentified microlight did not produce a secondary or significant primary return and therefore the controller could not have been aware of its presence.

Situational Awareness and Action were assessed as **ineffective** because the Sentinel crew had no information to make them aware of the microlight until they saw it.

Warning System Operation and Compliance were assessed as **ineffective** because the microlight was not electronically conspicuous to the Sentinel and reported separation was such that it was considered unlikely that the microlight pilot was aware of the approaching Sentinel.

See and Avoid were assessed as **ineffective** because the IMC Sentinel pilot did not see the microlight until about CPA, and the speed of approach, reported separation and weather conditions were such that it was considered unlikely the microlight pilot had seen the Sentinel in time to take avoiding action.
