AIRPROX REPORT No 2018254

Date: 23 Aug 2018 Time: 1610Z Position: 5345N 00105W Location: Burn airfield – elev 20ft

PART A: SUMMARY OF INFORMATION REPORTED TO UKAB

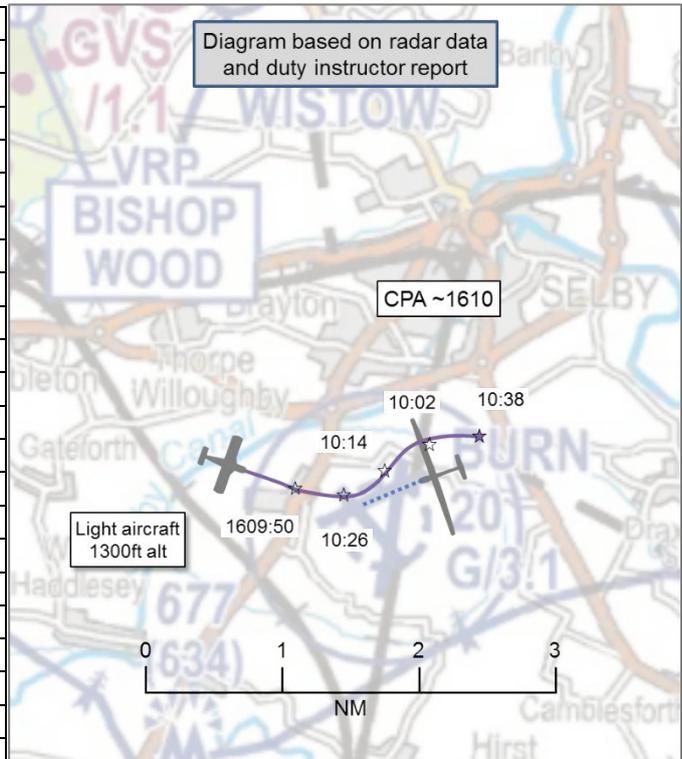
THE GLIDING CLUB DUTY INSTRUCTOR reports observing a winch-launch on RW25. The glider pilot was experienced and so were the ground crew launching the glider. As the PW-5 progressed toward the top of the launch, a low-wing, single-engine, light-aircraft with ‘retractable gear’ approached the glider on an approximate heading of 160°. Separation reduced before the approaching aeroplane turned towards the east to avoid collision. He opined that at this stage of the launch, the aeroplane would not have been visible to the PW-5 pilot; as the launch progressed, the aeroplane would have become visible as it was carrying out its turn. After the turn, the aeroplane returned to its original course. He surmised that the aeroplane was high-performance and was flying head-on towards the airfield, which, he rationalised, goes some way to explain why it was not seen when checking whether it was clear to launch the PW-5.

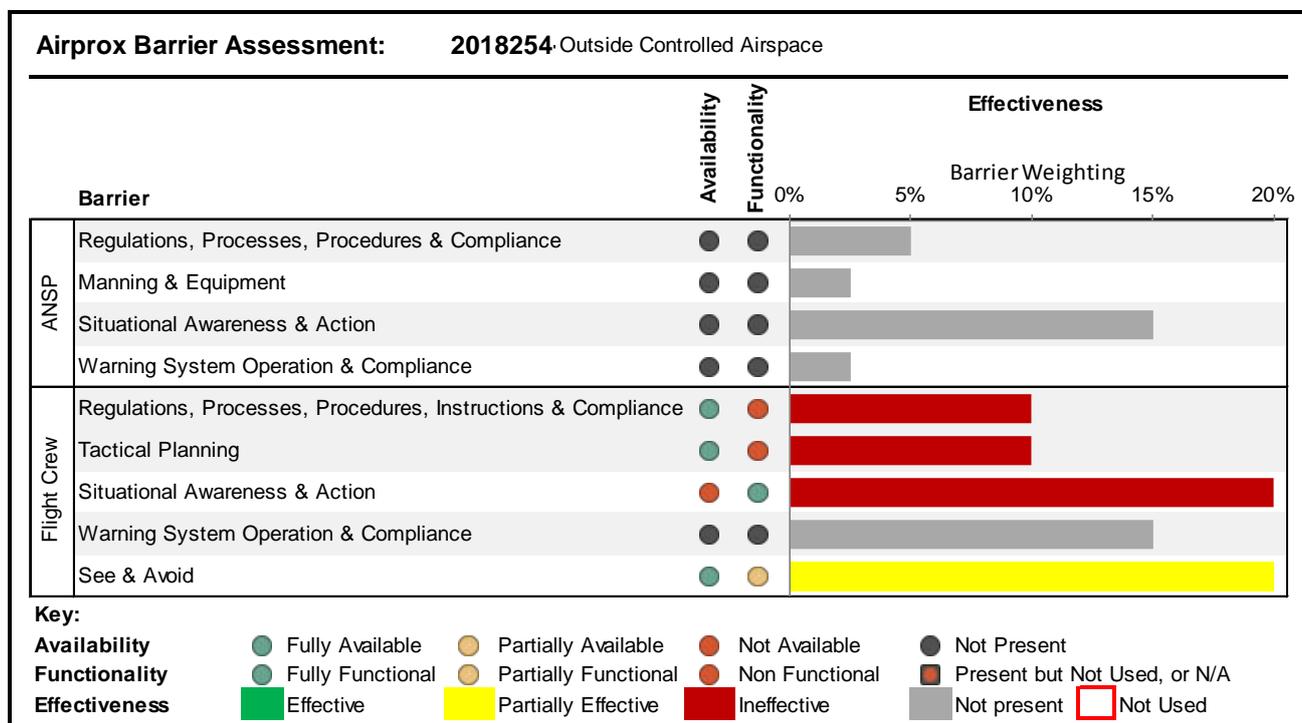
Regulations, Processes, Procedures, Instructions and Compliance were assessed as **ineffective** because the light aircraft pilot flew through a promulgated and active glider site, potentially endangering other airspace users.

Tactical Planning was assessed as **ineffective** because the light aircraft pilot’s plan did not route around or above the glider site.

Situational Awareness and Action were assessed as **ineffective** because the PW-5 pilot was not aware of the approaching light aircraft and the light aircraft pilot was apparently unaware of the launching PW-5 until at a late stage.

See and Avoid were assessed as **partially effective** because although the PW-5 pilot did not see the light aircraft, the light aircraft pilot most likely saw the glider at a late stage, when avoiding action was necessary.
