AIRPROX REPORT No 2018255

Date: 13 Sep 2018 Time: 1042Z Position: 5204N 00031E Location: 1nm NW Ridgewell Gliding Site.

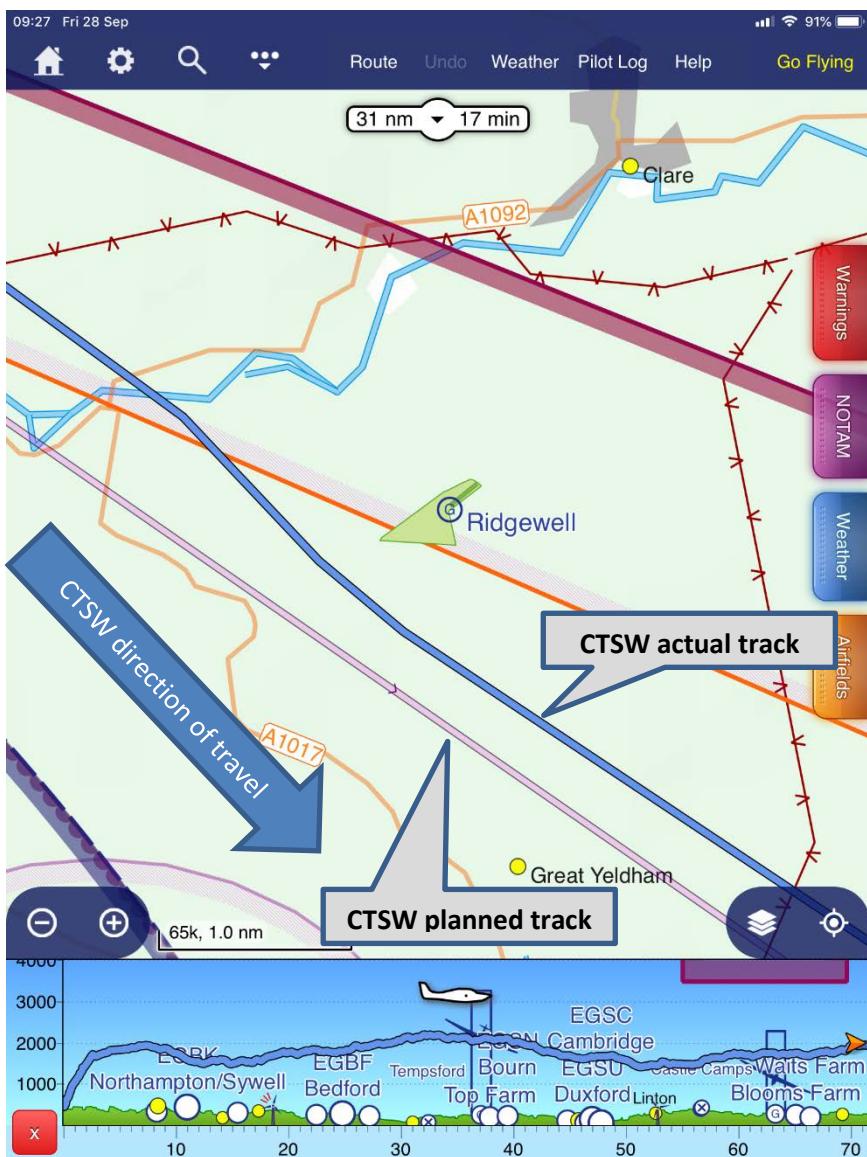
Figure 1 CTSW pilot's recorded GPS track.

THE CTSW PILOT reports that as shown on his GPS track (Figure 1) he was 'well south' of Ridgewell gliding site. He did note a glider and tug in the distance, but did not see it as any issue. The CTSW pilot declined to submit a completed Airprox report form or to offer any information on the second aircraft.

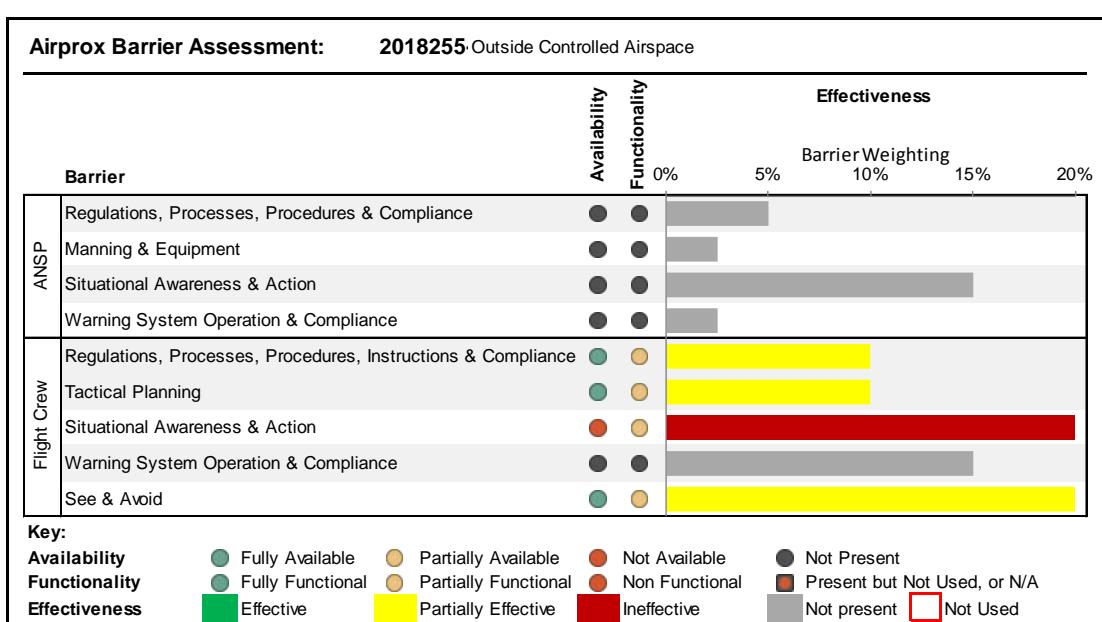
Regulations, Processes, Procedures, Instructions and Compliance were assessed as partially effective because the CTSW and an unknown aircraft did not sufficiently give way to the PA25 towing a glider.

Tactical Planning was assessed as **partially effective** because the 2 light-aircrafts' planned route took them close to an active and promulgated glider site.

Situational Awareness and Action were assessed as **ineffective** because neither aircraft had any awareness of the other before visually sighting each other.

See and Avoid were assessed as **partially effective** because the 2 light-aircraft approached from behind the PA25 and did not sufficiently give way despite seeing it 'in the distance' as they passed.
