AIRPROX REPORT No 2018279

Date: 13 Sep 2018 Time: 1239Z Position: 5157N 00046W Location: 1nm SW Milton Keynes

PART A: SUMMARY OF INFORMATION REPORTED TO UKAB

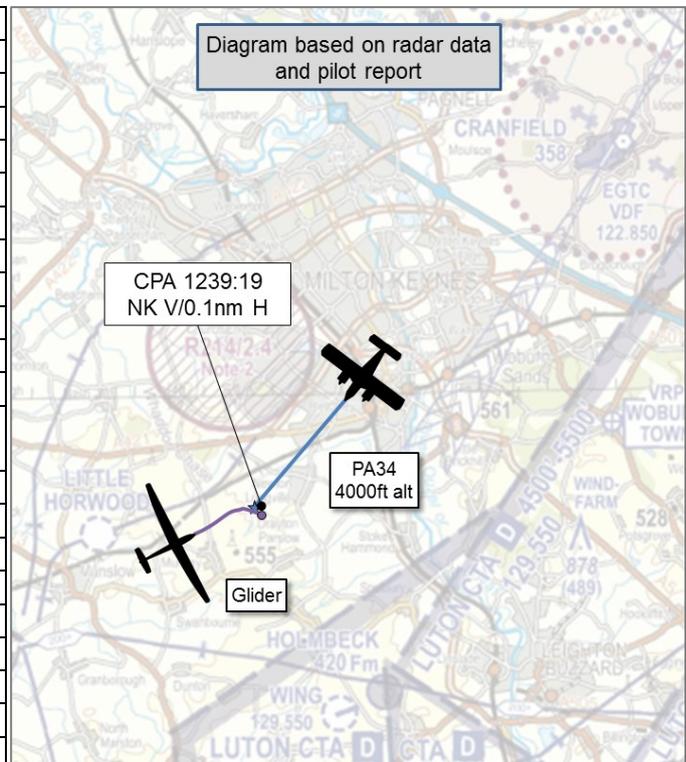
THE PA34 PILOT reports that Oxford Radar had passed Traffic Information, but they did not see the glider until it was at a very close range, just above and ahead of him. They passed the glider within 3 to 4 secs. There was no risk of collision, but the proximity didn't allow for much time to react.

The instructor responded to the traffic information from Oxford Radar by looking for the glider but didn't acquire it visually until it was already too late to make any useful manoeuvre as the glider passed. The rear-seat student observer did not see the glider either. No TAS alert was generated. Although Oxford Radar detected the glider and passed Traffic Information, neither the instructor nor the rear-seat observer acquired the glider visually until a late stage. Gliders can be, as is well known, notoriously difficult to acquire visually due to their small frontal profile and generally white colour which provides low contrast. No TAS alert was generated presumably because the glider was not transponding. This occurrence provides further evidence of the need for effective, standardised, electronic conspicuity means as an adjunct to visual 'see-and-avoid'.

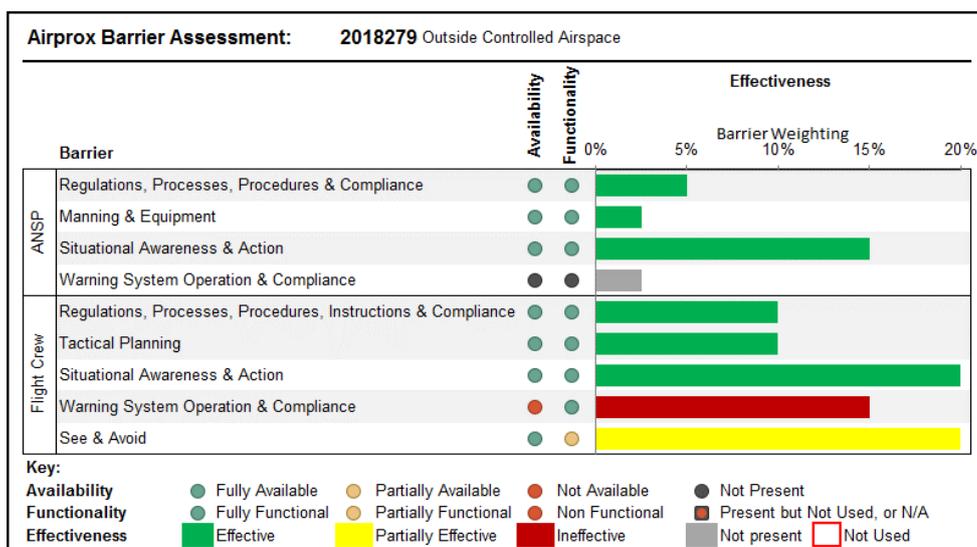
Warning System Operation and Compliance were assessed as **ineffective** because the PA34's TAS could not detect the non-transponding Glider.

See and Avoid were assessed as **partially effective** because the PA34 pilot saw the glider late. It is not known for certain if the glider pilot saw the PA34 but it is assumed not.
