AIRPROX REPORT No 2018284

Date: 21 Oct 2018 Time: 1551Z Position: 5117N 00015E Location: 2nm NE Sevenoaks

PART A: SUMMARY OF INFORMATION REPORTED TO UKAB

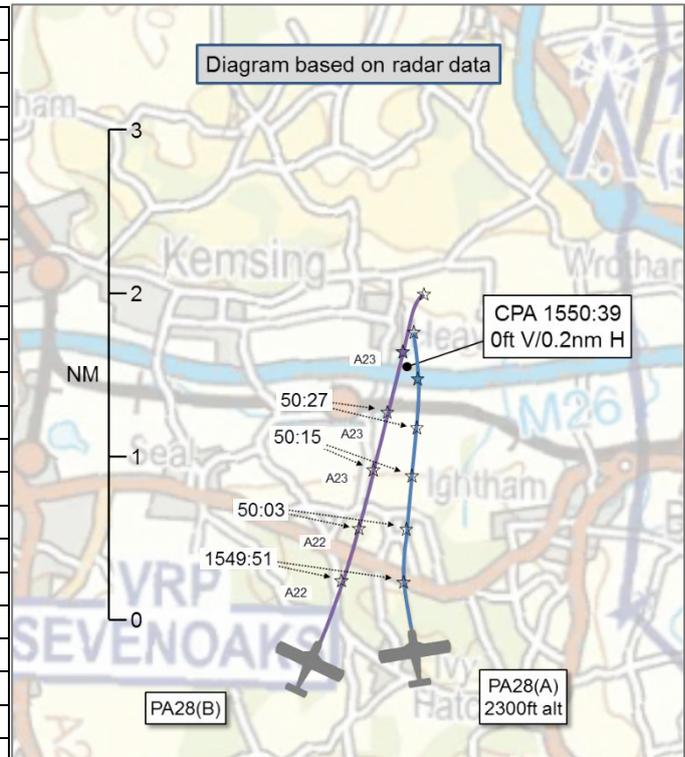
THE PA28(A) PILOT reports being in straight-and-level cruise. He was aware of ATC trying to contact a pilot who had entered Class A, and was also visual with another aircraft passing down his right side when ATC alerted him to an aircraft approaching from behind on the left and converging at the same level. He looked over his shoulder and immediately saw the other aircraft, at a range of less than 500m. It was not clear what the other pilot was doing but he could gauge its heading and speed, and that it was going to pass ahead of him. As it drew ahead he considered turning right or descending but did not want to lose sight of it so he turned behind to ensure they were clear. He saw it continue to his right-hand side and it appeared to descend. No radio communication was heard from the other aircraft and ATC did not contact it so he did not believe it was in contact with anyone. The pilot noted that the incident took him by surprise and he did not think to report until after he had landed.

THE PA28(B) PILOT reports that his recollection of the event was not completely clear because it had occurred 2½ weeks previously. He was in straight-and-level cruise when he became concerned by another aircraft in the 3 o'clock position at a similar altitude. The aircraft also appeared to be straight-and-level on a similar but slowly converging course. His impression was that it would eventually pass behind him, because the aircraft seemed to be traveling slightly slower. It did not appear to be an immediate threat at that time, but he felt that action was required to increase separation. His instinctive reaction was to adjust course slightly to the left (to slow the rate of convergence) and increase power in order to track more quickly ahead of the other aircraft. The 2 aircraft flew on almost parallel headings for 30-60 seconds, and he kept a close watch on the other aircraft as it moved further behind towards the 5 o'clock position, still at a similar level. Horizontal separation appeared to be increasing and he recalled that he began a shallow descent to increase separation vertically at this point. Once he saw the other aircraft pass behind he adjusted heading slightly to the right to ensure that their tracks diverged more quickly. Afterwards, he felt that separation had been consciously maintained, but in the

heat of the moment he had not fully considered that the other aircraft passing behind would take it through the blind spot in his 6 o'clock. He understood that if the geometry is considered to be converging then it was his responsibility to keep out of the way of the other aircraft. In retrospect he felt that a better course of action may have been to immediately descend and turn left to quickly achieve vertical and horizontal spacing, remain visual, and be in active control of separation throughout the encounter.

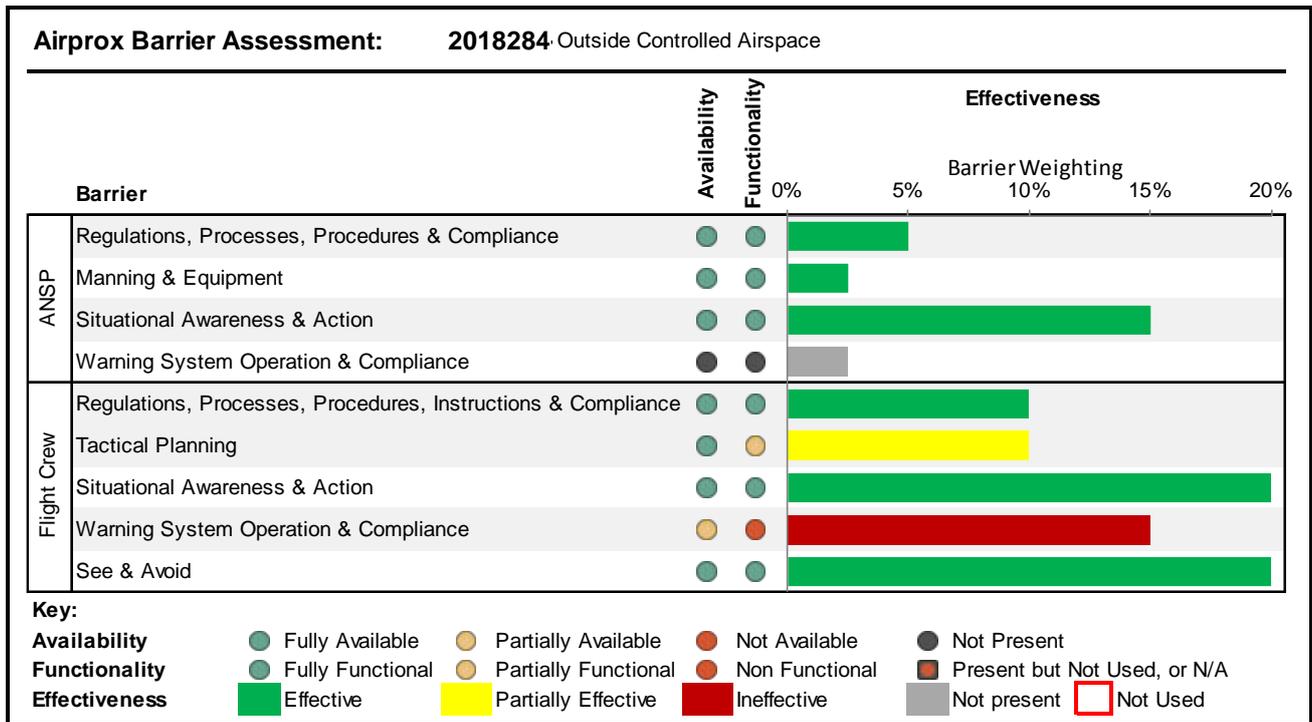
Safety Barrier Assessment⁵

In assessing the effectiveness of the safety barriers associated with this incident, the Board concluded that the key factors had been that:

Tactical Planning was assessed as **partially effective** because it was felt that the PA28(B) pilot could have avoided the PA28(A) by a greater margin, laterally and/or vertically.

Warning System Operation and Compliance were assessed as **ineffective** because the PA28(A) PilotAware TAS did not alert (or was not reported as having alerted) as would be expected.
