**AIRPROX REPORT No 2018292**

Date: 10 Oct 2018 Time: 1410Z Position: 5104N 00057W Location: 2nm NW Colemore Common

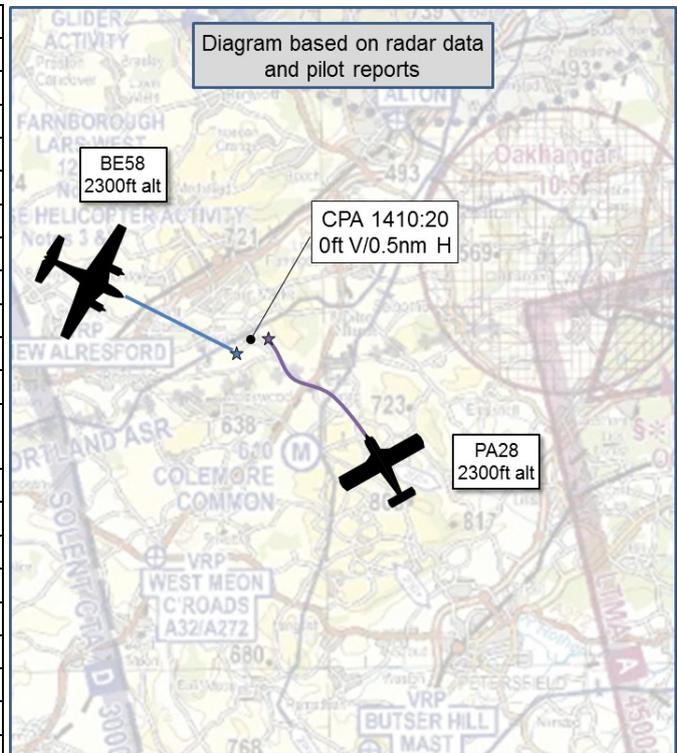
Recorded	Aircraft 1	Aircraft 2
Aircraft	PA28	BE58
Operator	Civ FW	Civ FW
Airspace	London FIR	London FIR
Class	G	G
Rules	VFR	VFR
Service	Listening Out	Traffic
Provider	Solent	Farnborough
Altitude/FL	2300ft	2300ft
Transponder	A, C	A, C, S
Reported		
Colours	White, Red	White, Burgundy
Lighting	Beacon	Strobe, Beacon, Nav, Landing
Conditions	VMC	VMC
Visibility	>10km	7km
Altitude/FL	2300ft	2400ft
Altimeter	QNH	QNH (1009hPa)
Heading	300°	110°
Speed	115kt	168kt
ACAS/TAS	PilotAware	PilotAware
Alert	TA	None
Separation		
Reported	70ft V/0.4nm H	0ft V/0.7nm H
Recorded	0ft V/0.5nm H

**THE PA28 PILOT** reports that he was flying in CAVOK conditions, across the sun, and using a listening squawk with Solent Radar. He was looking out and, when he glanced at his iPad (no audio warnings available) he saw traffic indicated from his PilotAware unit at about 2nm range. He looked up again and saw the other aircraft at the same altitude heading straight towards him. He manoeuvred to avoid, turning right and descending slightly.

**THE BE58 PILOT** reports that he was aware that the conditions were such that the visibility and contrast would make it difficult to spot other traffic and so he maintained a sharp lookout, requested a Traffic Service from Farnborough, and turned all external lighting on for conspicuity. Farnborough advised that the Traffic Service was restricted due to controller workload and volume of traffic, with late or no warnings given; he acknowledged this. He spotted the other aircraft between 1.5nm and 2nm in his 11 o’clock. It appeared to be tracking NE and he estimated he would pass comfortably behind. Their closure rate was relatively high, and he thinks the other aircraft’s pilot may have adjusted his heading slightly, so they passed more on a parallel track, still with adequate separation. The Farnborough controller passed Traffic Information at about 0.5nm, which he thinks was given as being in his 11 o’clock, although it was more like 10 o’clock, possibly due to his heading to offset drift. He had already been visual with the traffic some seconds before the Traffic Information was passed and it was clear there was no conflict, so he acknowledged that he was visual with the reported traffic.

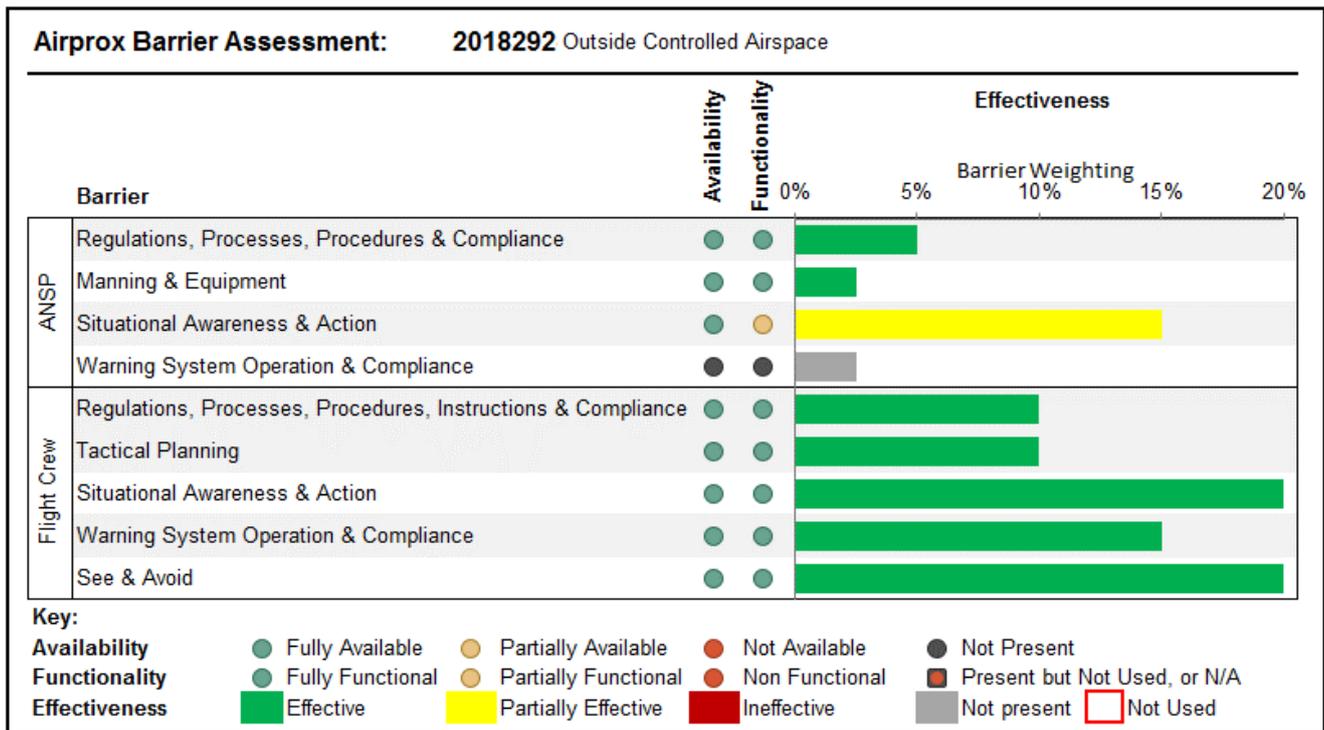
In assessing the effectiveness of the safety barriers associated with this incident, the Board concluded that the key factors had been that:

**ANSP:**

**Situational Awareness and Action** were assessed as **partially effective** because the BE58 pilot was receiving a Traffic Service from Farnborough, reduced due to workload and traffic density, which meant that the controller passed Traffic Information to the BE58 pilot late.
