AIRPROX REPORT No 2018302

Date: 14 Nov 2018 Time: 1146Z Position: 5138N 00131W Location: Stanford in the Vale

PART A: SUMMARY OF INFORMATION REPORTED TO UKAB

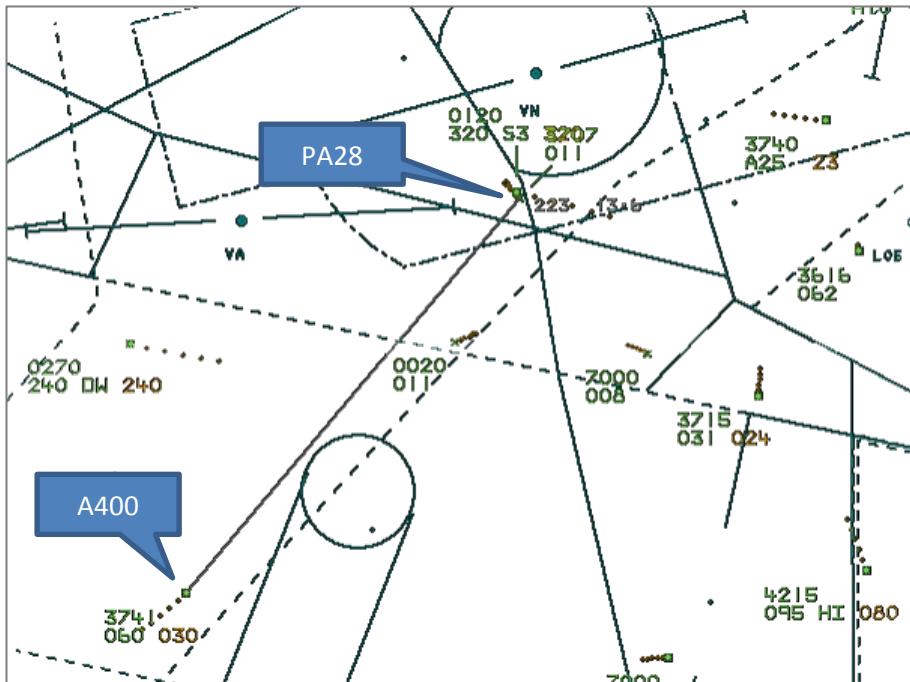
Figure 1 depicts the point at which the A400 (squawk 3741) was given a positioning turn and descent in preparation for its instrument recovery. At this time, the Brize Zone controller had not ascertained the intentions of the PA28 (squawk 3707) which was still within the Brize Class D airspace.

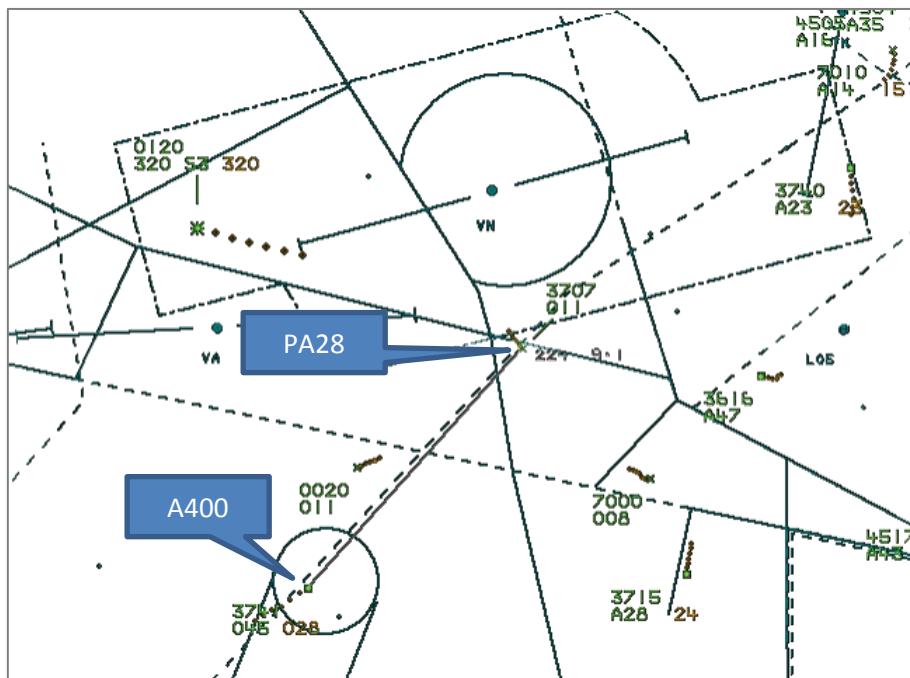
Figure 2

As the PA28 left CAS (Figure 2), the Brize Zone controller established that the PA28 intended to operate to the south of Brize (known locally as the southern training area) up to an altitude of 5000ft. Separation at this point was 9nm and 3400ft, decreasing; Traffic Information was not passed to the A400 at this point.

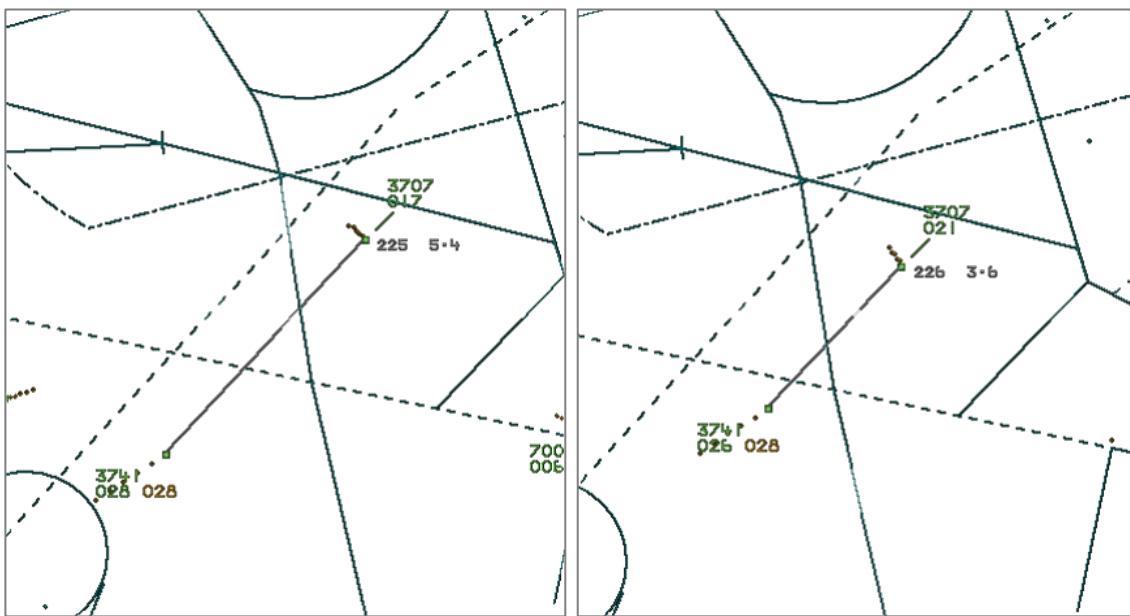
Figure 3

Approximately 50sec later (Figure 3), the Brize Zone Controller initiated a liaison call to Brize Tower concerning an aircraft at 8nm from touchdown. Separation between the A400 and PA28 had decreased to 5.4nm and 1100ft.

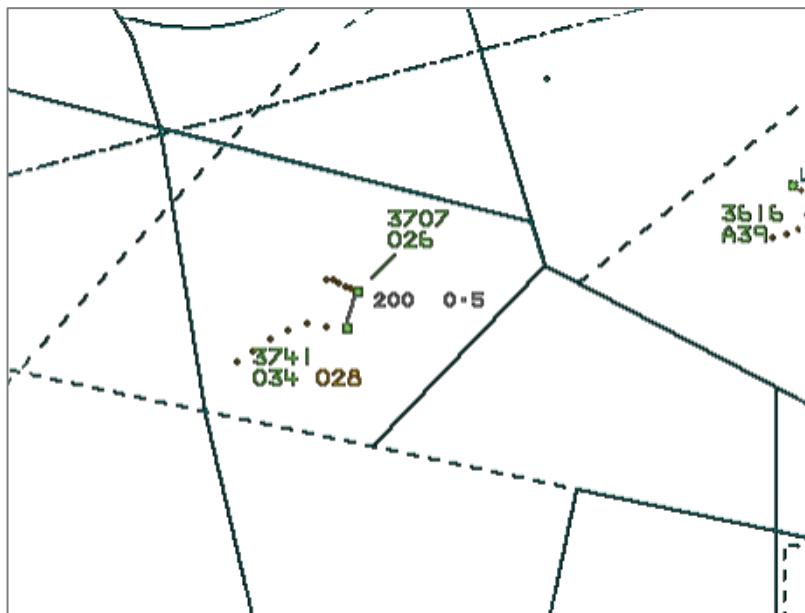
Figure 5 – CPA

30sec later the A400 requested a right turn which was approved by the controller. Shortly afterward the A400 announced that they had a TCAS RA. CPA occurred at 1145:39 (Figure 5), some 13sec after the request for the right turn, and was measured at 0.5nm and 800ft.
