**AIRPROX REPORT No 2018303**

Date: 29 Sep 2018 Time: 1315Z Position: 5035N 00409W Location: Dartmoor

**PART A: SUMMARY OF INFORMATION REPORTED TO UKAB**

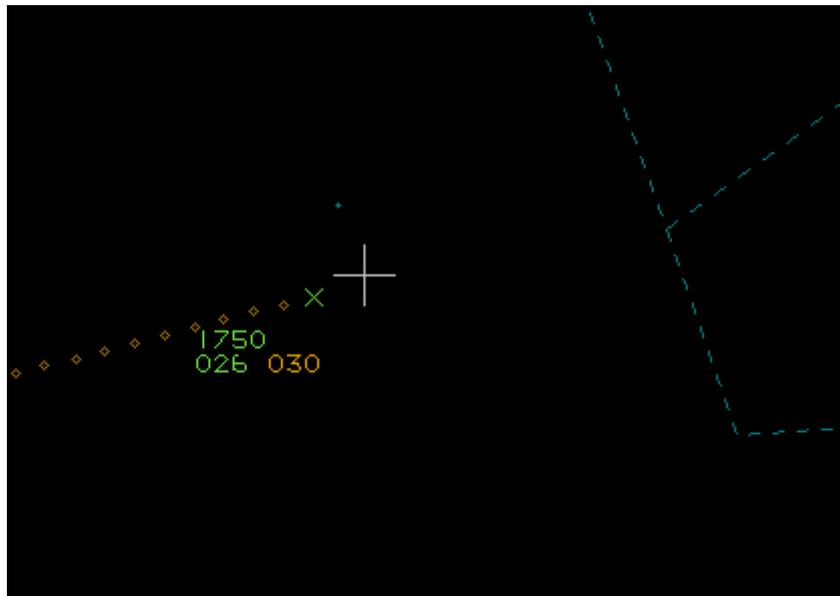
Although the Newquay radar was not available, the NATS radar did show the C525 on his transit. The radar is showing the C525 at FL026, the LON QNH was 1027hPa, giving a 378ft difference and putting the C525 at 3000ft. The gliders could not be seen on the NATS radar.

Figure 1: 1315:01 Brent TOR glider site marked by the white cross
