AIRPROX REPORT No 2018304

Date: 17 Nov 2018 Time: 1124Z Position: 5135N 00104W Location: RAF Benson - elev 203ft

PART A: SUMMARY OF INFORMATION REPORTED TO UKAB

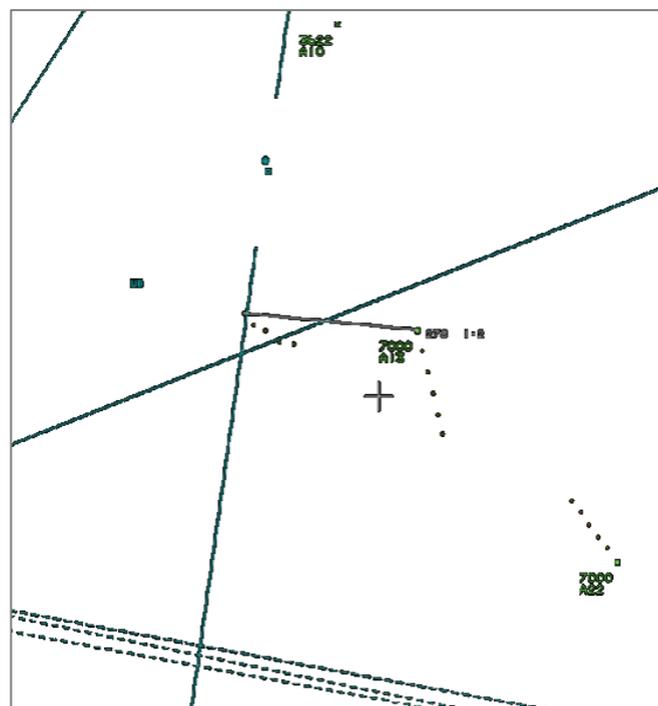
1124:45.

At 1124:45, the Tutor pilot (squawk 3720) reported that there was a helicopter (squawk 7000) 1nm east of him going northbound opposite to the downwind leg.
