AIRPROX REPORT No 2018306

Date: 21 Nov 2018 Time: 1024Z Position: 5005N 00547W Location: Land's End

PART A: SUMMARY OF INFORMATION REPORTED TO UKAB

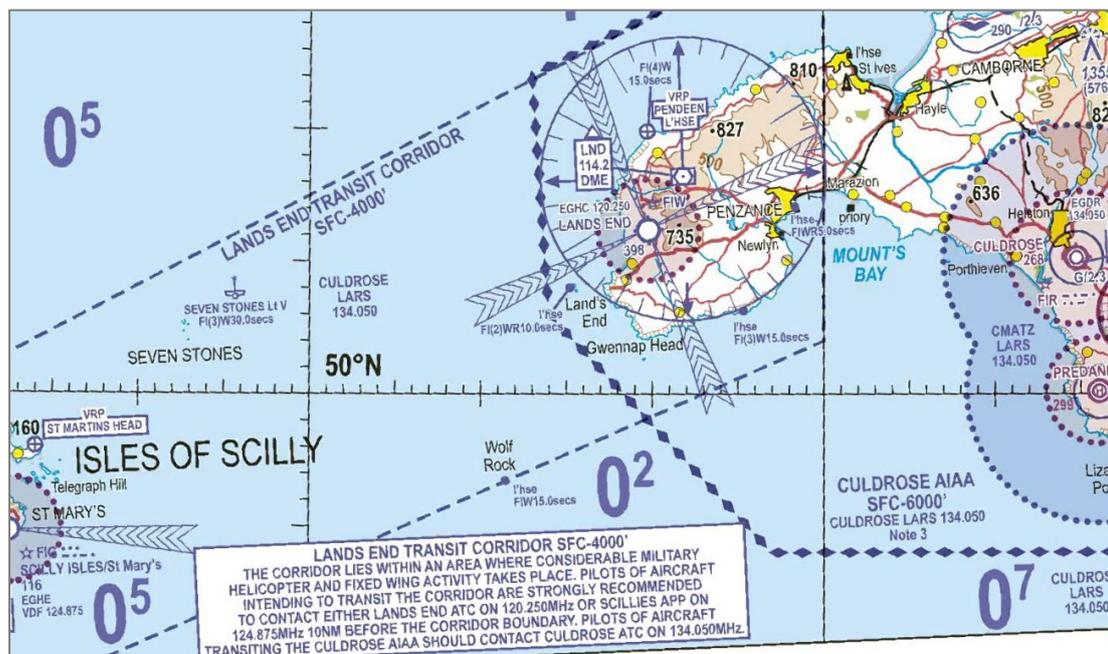
Portion of the CAA VFR Southern Chart depicting the Lands End Transit Corridor

This report has revealed a potential area of confusion: The Lands End Transit Corridor, as described above on the Civil VFR chart, is also shown on military low flying charts, although without any description. However, on page 2-2-3 of the UKMLFHB under LFA2, it is referred to as a Civil Helicopter Route to the Isles of Scilly, and not mentioned at all in the entry for LFA3, in which it also lies. Further, the corridor is not depicted on the UKMLFHB LFA3 chart (page 2-3-3).

Finally, the Board noted the inconsistent documentation of the Lands End Transit Corridor within the UKMLFH as highlighted in the USAFE comment and were heartened that the HQ Air Command Low Flying Cell member had instigated action to correct it.

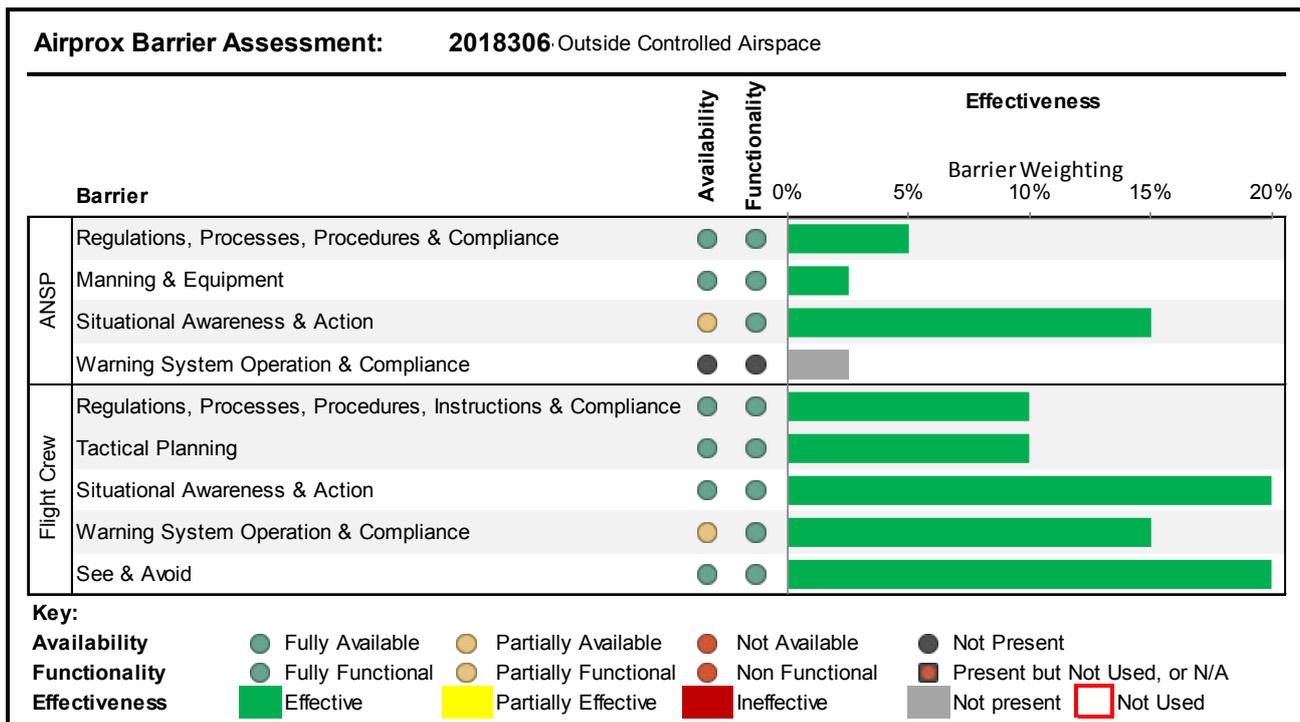
In assessing the effectiveness of the safety barriers associated with this incident, the Board concluded that all barriers had been effective, albeit that the lack of radar at Lands End had reduced the availability of SA to the DHC6 crew, and only the DHC6 was equipped with a TCAS/TAS.
