**AIRPROX REPORT No 2018313**

Date: 30 Nov 2018 Time: 1330Z Position: 5046N 00150W Location: Bournemouth

**PART A: SUMMARY OF INFORMATION REPORTED TO UKAB**

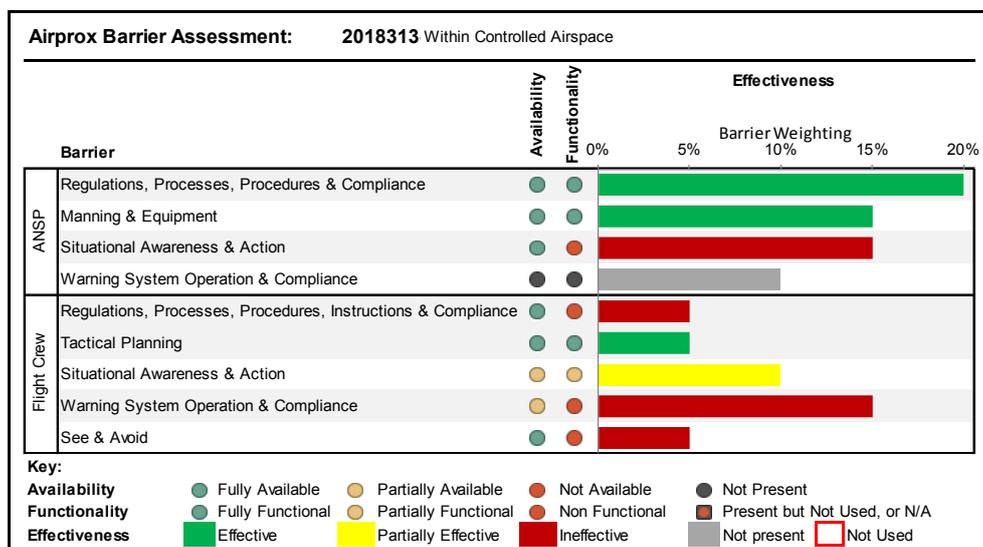
Safety Barrier Assessment<sup>2</sup>

**Situational Awareness and Action** were assessed as **ineffective** because the Bournemouth Radar and Tower Controllers were not aware that the BE23 had flown into the visual circuit.

**Regulations, Processes, Procedures, Instructions and Compliance** were assessed as **ineffective** because although the BE23 pilot flew the join procedure he had been given, he did not call at the Sandbanks VRP; and he could not integrate with the DA42 because he did not know of its presence.

**Situational Awareness and Action** were assessed as **partially effective** because although the BE23 pilot knew he was approaching the visual circuit, he joined without contacting the Tower frequency and therefore did not know about the DA42 that he should have integrated with.

**Warning System Operation and Compliance** were assessed as **ineffective** because the PCAS on the BE23 did not alert (potentially due to the DA42 SSR antenna being blanked from the PCAS with the DA42 being below the BE23 as they approached CPA), and the TAS on the DA42 could not alert due to the failure of the BE23's transponder.

**See and Avoid** were assessed as

**ineffective** because neither pilot saw the other in time to take any action.
