AIRPROX REPORT No 2018002

Date: 04 Jan 2018 Time: 1345Z Position: 5302N 00024W Location: RAF Cranwell MATZ

PART A: SUMMARY OF INFORMATION REPORTED TO UKAB

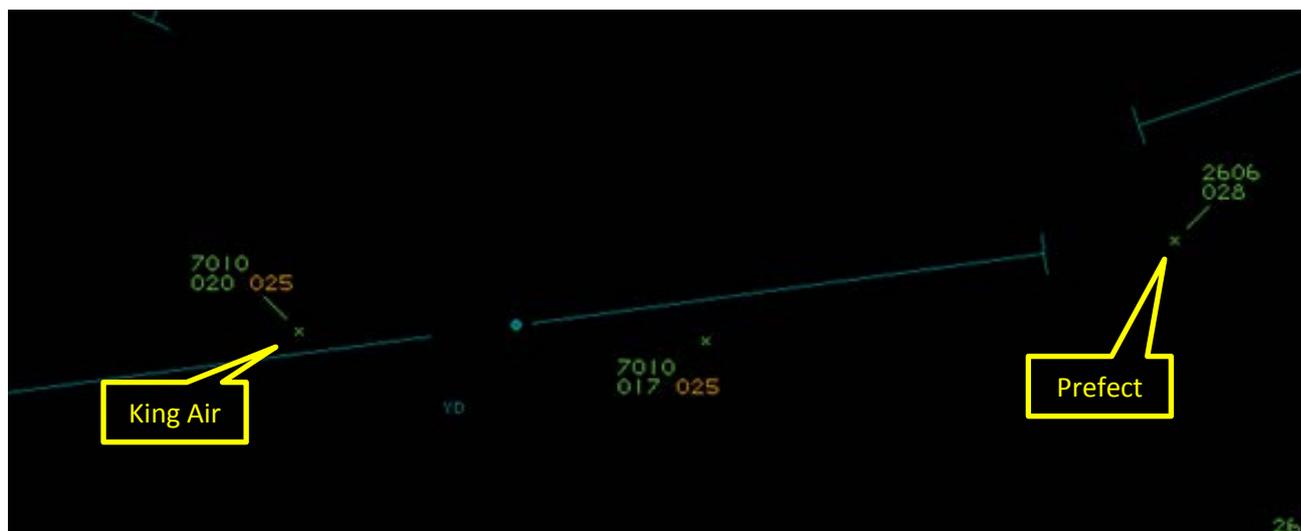
Figure 1: Geometry at 13:42:29

At 13:42:29 (Figure 1), the Cranwell ADC made a broadcast on the ‘Tower’ frequency stating that there was a Prefect at 6nm, with the intention to touch-and-go for further instrument approaches.

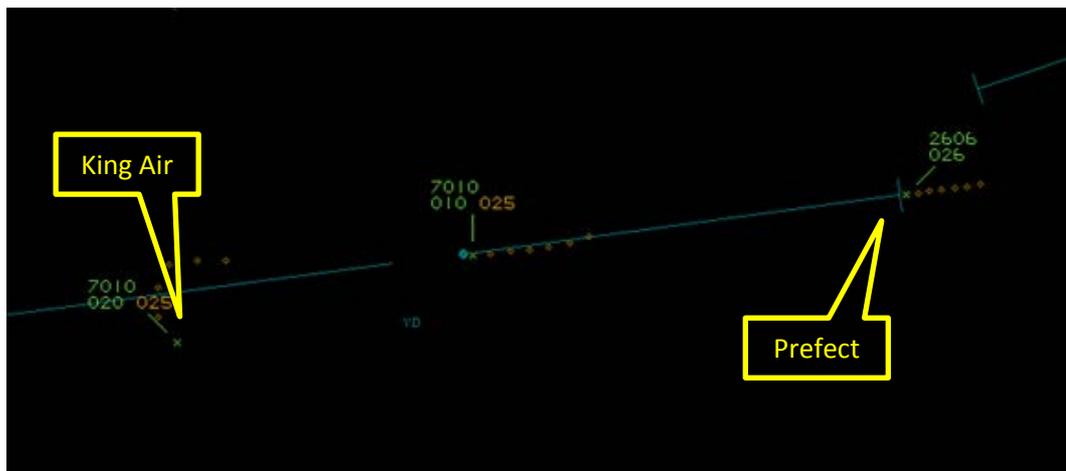
Figure 2: Geometry at 13:43:25

At 13:43:25 (Figure 2), in response to the King Air pilot reporting downwind, the Cranwell ADC informed the King Air pilot that there was an aircraft on the runway and that the Prefect radar traffic was at range 5nm from touchdown.

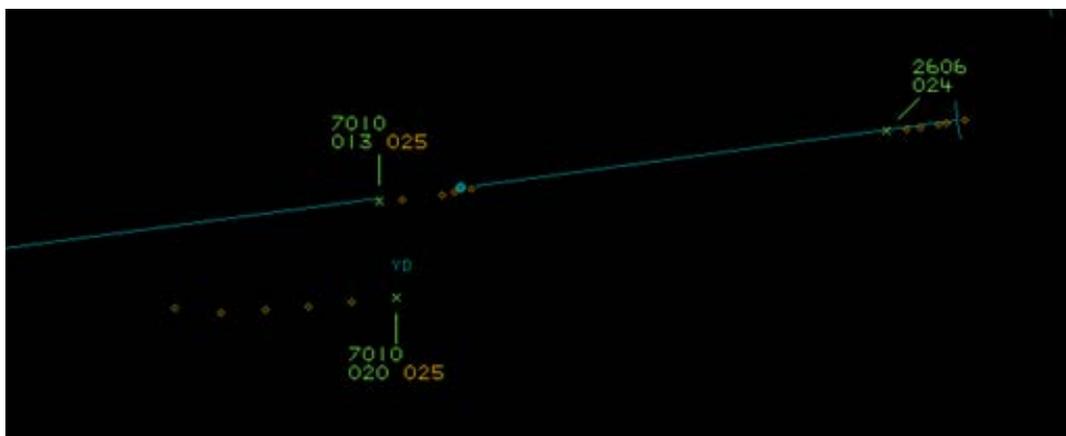
Figure 3: Geometry at 13:44:06

At 13:44:06 (Figure 3), in response to the King Air pilot reporting downwind (simulated asymmetric), the Cranwell ADC informed the King Air pilot that there was one aircraft ahead of him for the runway, the Prefect radar traffic at 4nm from touchdown.

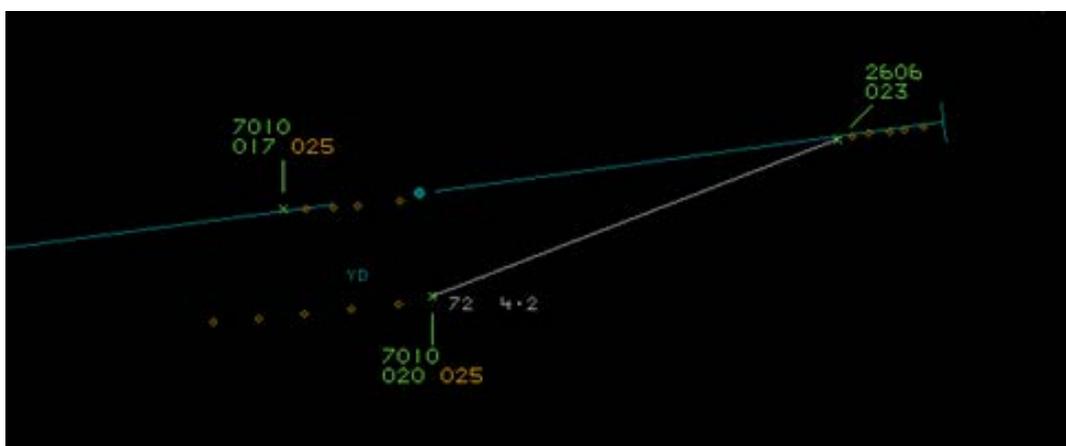
Figure 4: Geometry at 13:44:27

At 13:44:27 (Figure 4), the Cranwell ADC reiterated to the King Air pilot that he had one aircraft ahead of him to use the runway, the Prefect radar traffic by then inside 4nm, and asked the pilot if he would be initiating a go around. The King Air pilot responded that he was going around at circuit height.

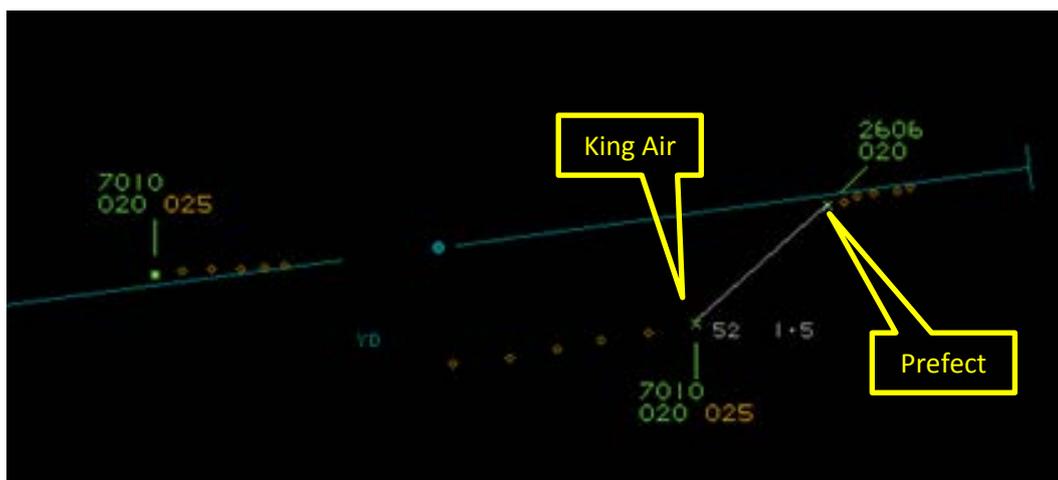
Figure 5: Geometry at 13:45:03

At 13:45:03 (Figure 5), the Cranwell ADC informed the King Air pilot that the Prefect was at 3nm from touchdown.

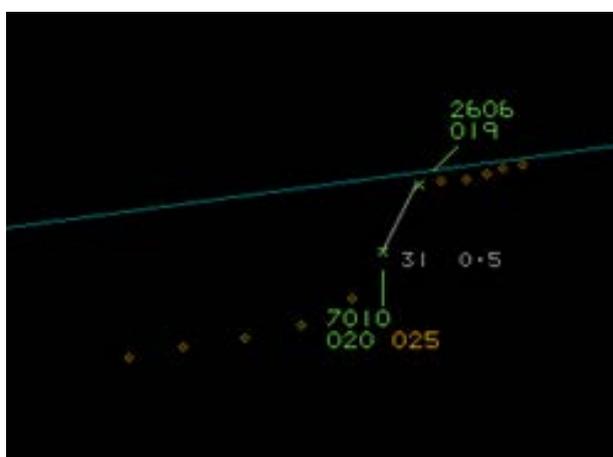
Figure 6: Geometry at 13:45:21

At 13:45:21 (Figure 6), the Cranwell Talkdown Controller informed the ADC that the Prefect was going around due to traffic.

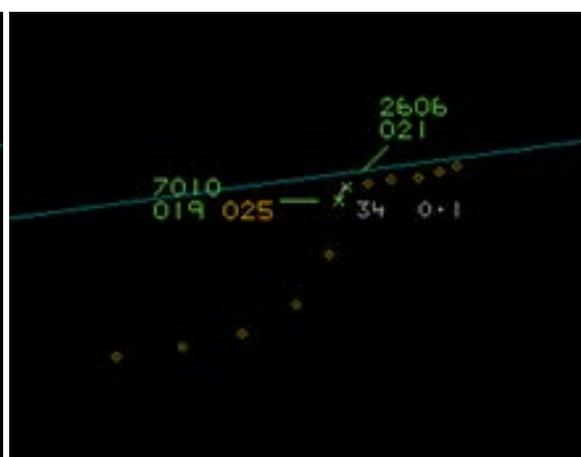
Figure 7: Geometry at 13:45:24

At 13:45:24 (Figure 7), the King Air and Prefect were at their closest point seen on radar replay, with approximately 0.1nm lateral and 200ft vertical separation.

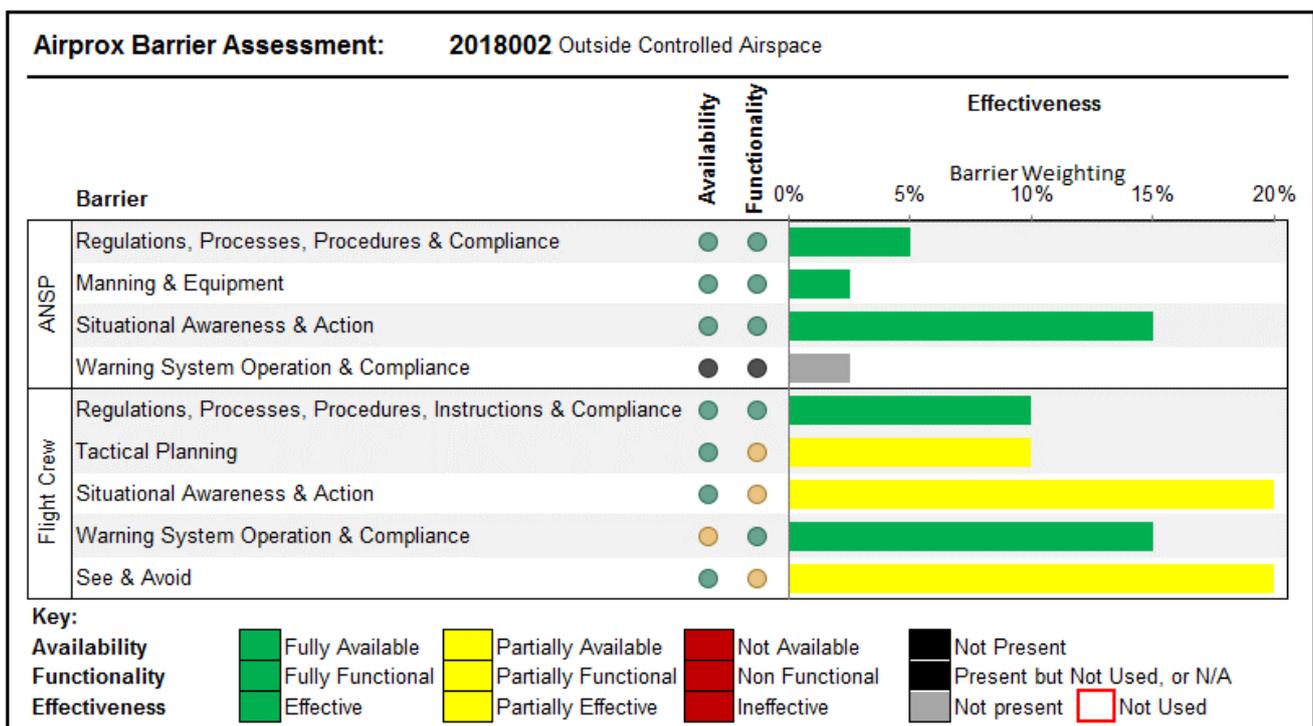
In assessing the effectiveness of the safety barriers associated with this incident, the Board concluded that the key factors had been that:

Tactical Planning was assessed as **partially effective** because although the King Air instructor questioned his student on the actions he would take with radar traffic at 4nm, the resulting plan was not appropriate to ensure adequate separation.

Situational Awareness and Action were assessed as **partially effective** because although the King Air crew were passed Traffic Information on the Prefect on a number of occasions, they did not fully use the information they received.

See and Avoid were assessed as **partially effective** because the King Air crew and Prefect pilot saw each other later than desirable and took emergency avoiding action.
