AIRPROX REPORT No 2018006

Date: 10 Jan 2018 Time: 1446Z Position: 5049N 00112W Location: Lee-on-Solent ATZ

PART A: SUMMARY OF INFORMATION REPORTED TO UKAB

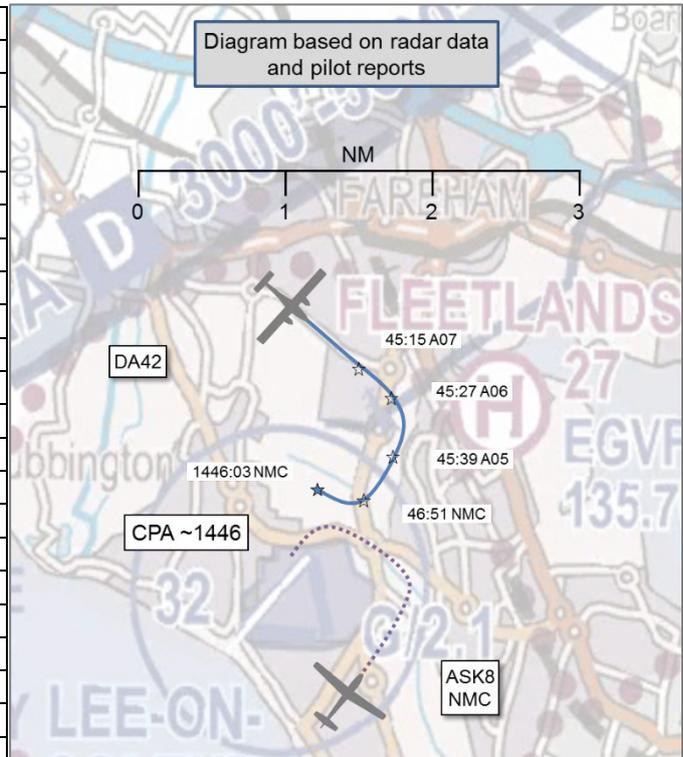
THE DA42 INSTRUCTOR reports that he was conducting circuit training to RW23RH at Lee-on-Solent with a glider in the LH glider circuit. On turning onto final, the glider crossed the centre line about ½nm ahead, causing his student to go-round. The glider turned to land on the RHS of the runway as they climbed to its left and about 500ft above.

THE LEE-ON-SOLENT A/G OPERATOR reports that the DA42 pilot had established final approach for a touch-and-go, and reported this to Lee Radio. The call was acknowledged, and the surface wind was passed. Shortly after this, the ASK8 pilot, on base leg, called Lee radio and stated that he was crossing the runway centreline and turning final. At this point, the aircraft had already passed the centreline and then made an approach to the grass to the western side of the active RWY23. The radio operator informed the DA42 pilot on final approach that a glider was crossing the centreline in front of

them, although at this point the glider had already done so. The DA42 pilot acknowledged the call, aborted their final approach and reported that they would go around. Local glider protocol states that aircraft must not cross the extended centreline into the powered circuit when there are powered aircraft on final approach. The glider pilot ignored this local rule.

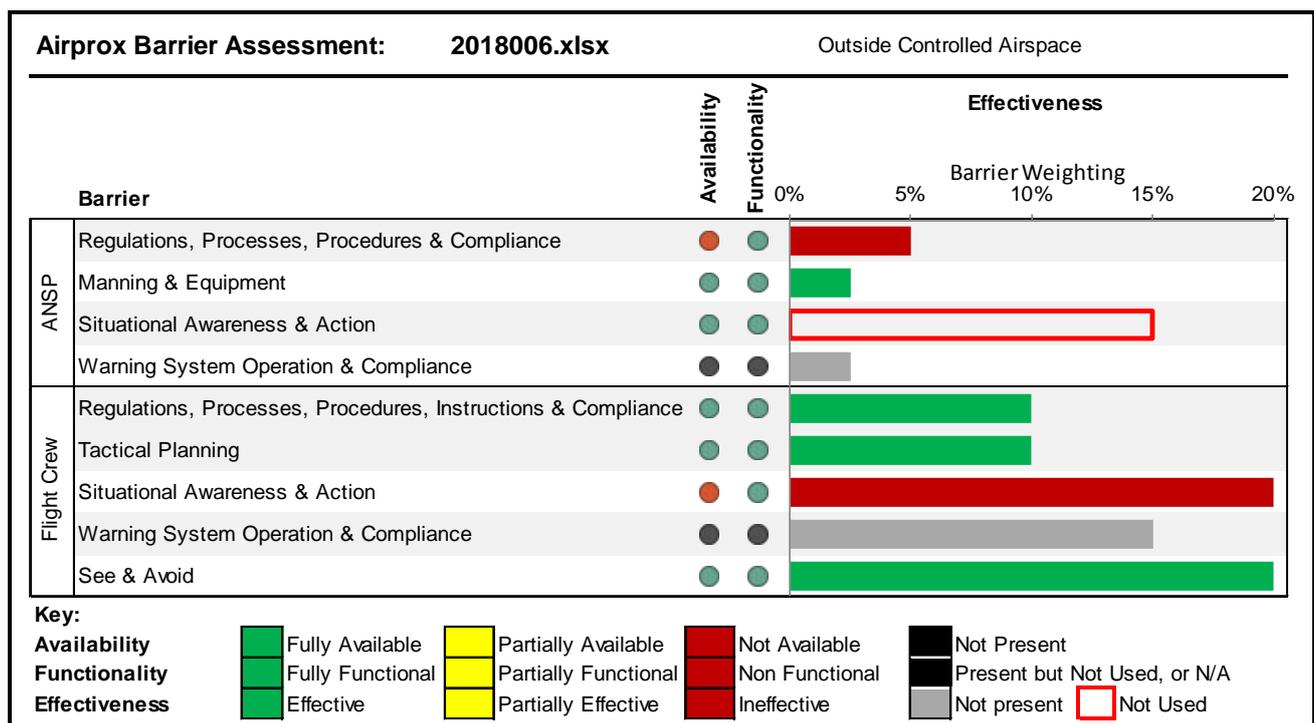
Safety Barrier Assessment⁴

Regulations, Processes, Procedures and Compliance were assessed as **ineffective** because promulgated procedures at Lee do not include the potential for glider operation on the northwest grass area.

Situational Awareness and Action were assessed as **not used** because neither pilot was in receipt of a service which required the operator to detect confliction.

Warning System Operation and Compliance were assessed as **not present** because no warning systems were fitted.

Situational Awareness and Action were assessed as **ineffective** because the DA42 pilot did not assimilate that the glider pilot's intention was to cross the centreline.

Warning System Operation and Compliance were assessed as **not present** because neither aircraft was fitted with a warning system.
