AIRPROX REPORT No 2018040

Date: 25 Mar 2018 Time: 1005Z Position: 5317N 00057W Location: Gamston

PART A: SUMMARY OF INFORMATION REPORTED TO UKAB

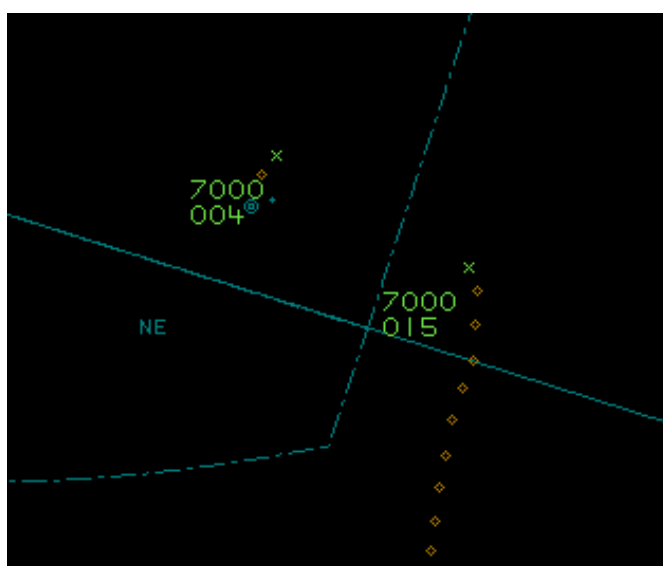
Figure 1 1004:22

Although neither aircraft was being provided with an ATS, the incident could be seen on the NATS radars. Figure 1 at 1004:22 shows the DA40 apparently re-joining from the south-east and the C182 just getting airborne, passing 400ft in the climb. At 1005:09 (Figure 2), the DA40 has turned to join cross-wind and the C182 is also turning downwind. CPA occurs just after 1005:33 (Figure 3).

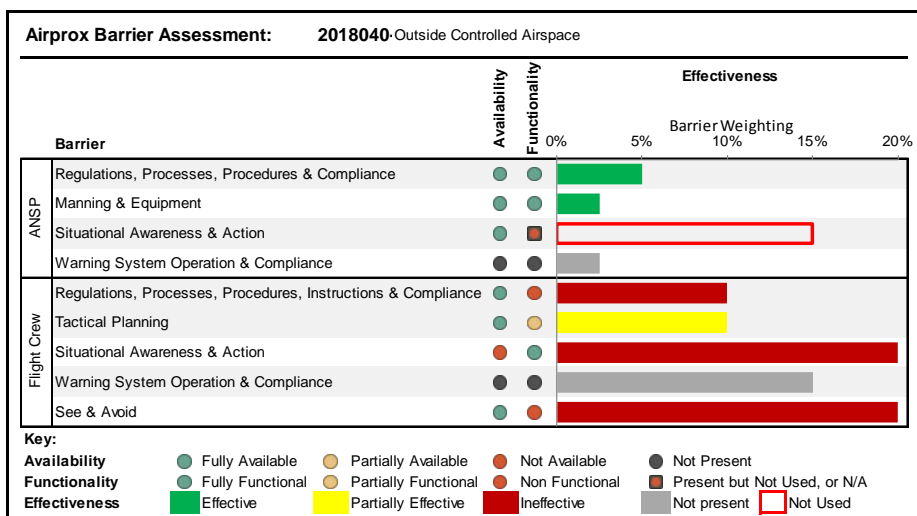
Regulations, Processes, Procedures, Instructions and Compliance were assessed as **ineffective** because the DA40 pilot did not call the air/ground operator before entering the ATZ.

Tactical Planning was assessed as **partially effective** because the DA40 did not call for circuit information and therefore did not integrate into the circuit effectively.

Situational Awareness and Action were assessed as **ineffective** because neither pilot knew about the other aircraft.

See and Avoid were assessed as **ineffective** because neither pilot saw the other much before CPA and were unable to take any avoiding action.
