AIRPROX REPORT No 2018074

Date: 28 Apr 2018 Time: 1002Z Position: 5329N 00223W Location: Barton airfield, elev. 73ft

PART A: SUMMARY OF INFORMATION REPORTED TO UKAB

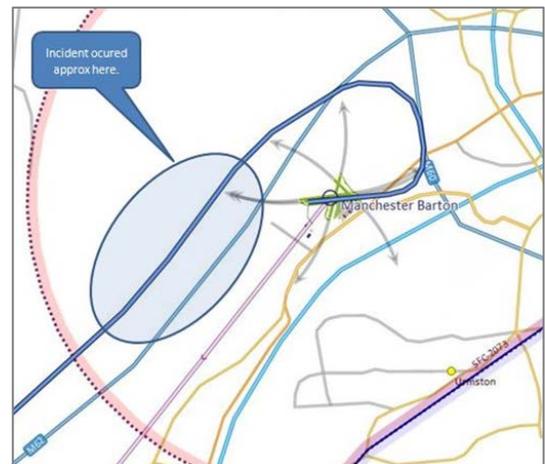
Figure 1

THE EV97 PILOT reports he had taken off from 08R, climbed to circuit height (1000ft) on the crosswind leg and then turned downwind. He continued to climb and, on passing 1200ft, was about to call leaving the circuit to the southwest when he saw a PA28 slightly below and on the left. The PA28 pilot started a turn to the right and dived. The EV97 pilot also turned right and climbed momentarily but resumed his course to the southwest as the PA28 passed below him. He contacted the AFISO and reported leaving the circuit and also reported the 'near miss'. At that time the circuit direction was left-hand on 08R so the EV97 pilot was surprised by the PA28, who's pilot appeared to be flying a right-hand circuit appearing to be crosswind from his point of view but actually on the base leg. The EV97 pilot provided a diagram of the incident (Figure 1) that indicated that he thought the incident had occurred to the southwest of Barton; radar replay showed that the incident had in fact occurred at the start of the downwind leg.

He assessed the risk of collision as 'High'.

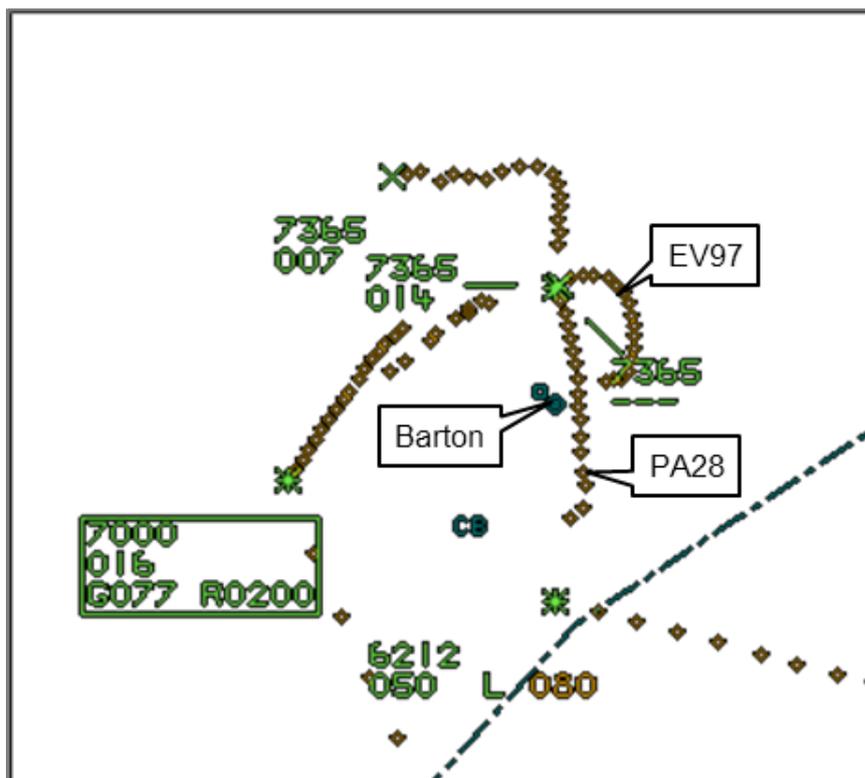
The EV97 and PA28 pilots shared an equal responsibility for collision avoidance and not to operate in such proximity to other aircraft as to create a collision hazard¹. An aircraft operated on or in the vicinity of an aerodrome shall conform with or avoid the pattern of traffic formed by other aircraft in operation². A radar replay screen capture shows that CPA occurred to the north of Barton:

Members first discussed the EV97 pilot's recollection of events and agreed that the radar picture showed that CPA had occurred at the start of the downwind leg rather than at a position downwind of the base leg, and that the PA28 pilot was conducting a normal overhead join. Nevertheless, regardless of position, it was clear that the 2 aircraft had flown into proximity and that the pilots had had to take avoiding action at a late stage. The Board spent some time discussing the requirement for pilots to integrate with other traffic in the visual circuit and to what degree that onus was shared. They agreed that both pilots were in the visual circuit, with the EV97 downwind and the PA28 crosswind and so members discussed the degree to which a pilot was established in the circuit versus joining the circuit. After much discussion it was agreed that in the circumstances of this Airprox the onus of integration was on the joining pilot, the PA28 pilot, because he was effectively still joining the circuit, whereas the EV97 was established downwind. As a result, they agreed that the cause of the Airprox had been that the PA28 pilot did not integrate with the EV97 on the downwind leg. Members also agreed that integration by the joining pilot was highly dependent on the precise geometry and relative performance of the 2 aircraft. For example, a joining aircraft at the crosswind position above the upwind threshold could integrate ahead of an aircraft already established in the visual circuit which was just turning from climb-out to crosswind, provided the established aircraft's crosswind leg was suitably upwind of the joining aircraft.

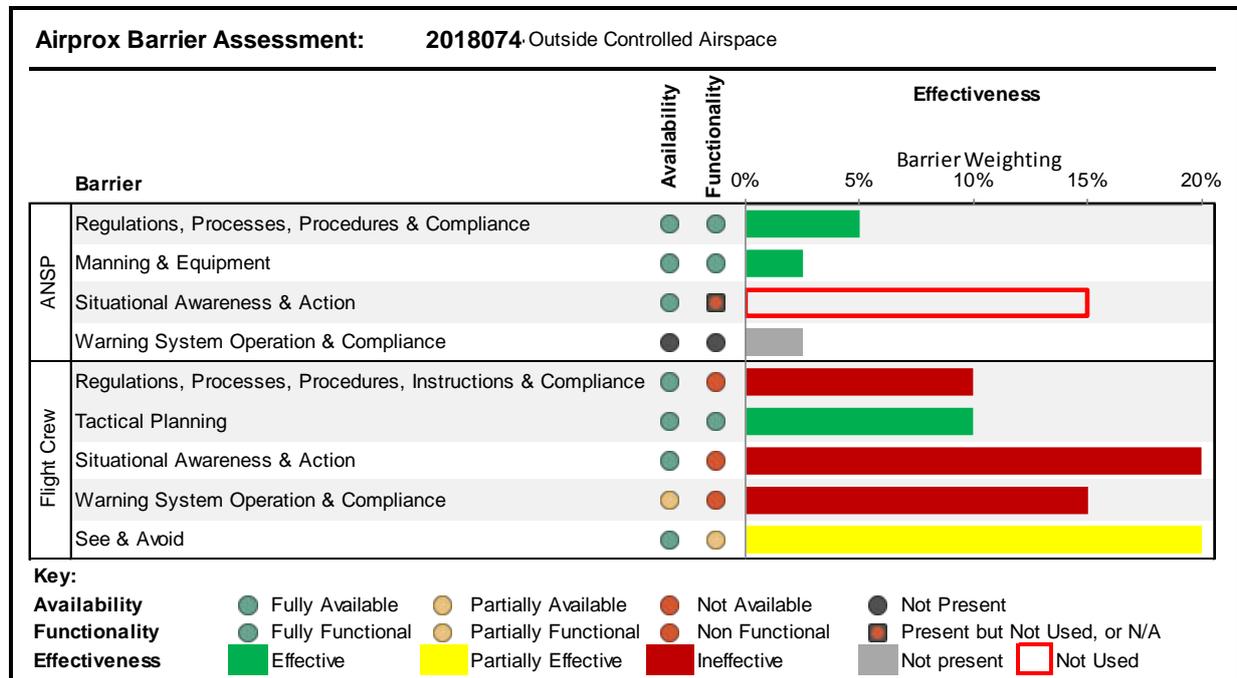
Situational Awareness and Action were assessed as **not used** because the barrier is not normally provided by an AFISO.

Regulations, Processes, Procedures, Instructions and Compliance were assessed as **ineffective** because the PA28 pilot did not integrate with the EV97.

Situational Awareness and Action were assessed as **ineffective** because neither pilot had SA of the other aircraft's position, presumably despite normal radio calls.

Warning System Operation and Compliance were assessed as **ineffective** because the EV97 TAS (PilotAware) did not alert on the PA28 transponder output.

See and Avoid were assessed as **partially effective** because each pilot saw the other aircraft at a late stage.
